# ***Beaver Valley Headwaters Preserve: SRWC Final Report***

A Compendium of Natural Resource Information  
Collected to Inform Management Decisions  
Related to Riparian Habitat, Stream Channel  
Restoration and Enhancement & Forest Health  
Resiliency

*Prepared by Scott River Watershed Council  
May 1, 2024*

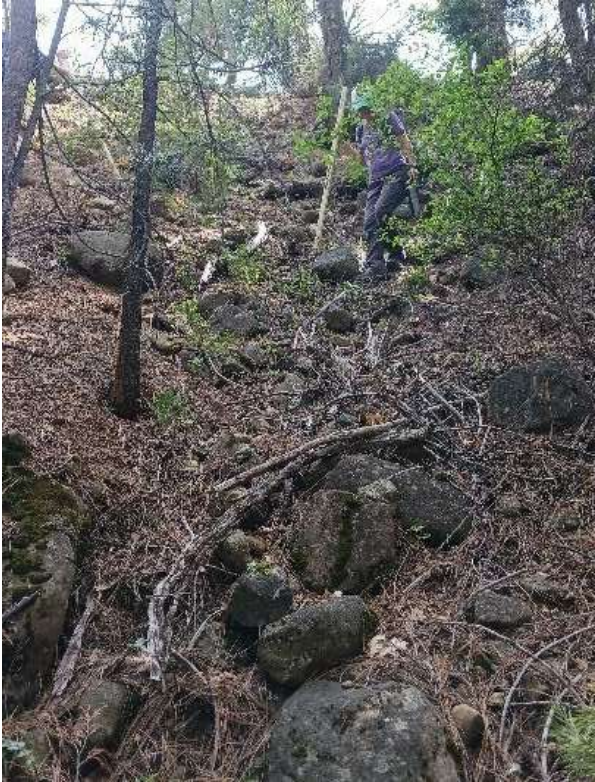
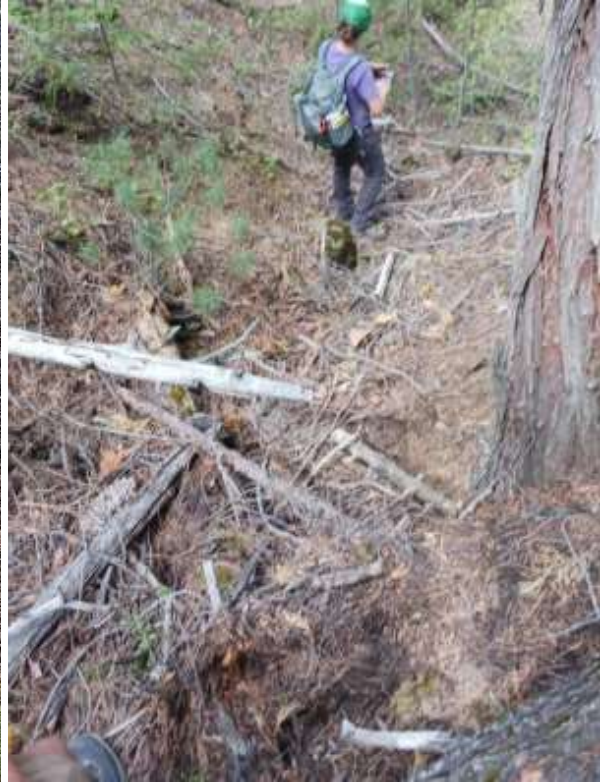
Gully Complex 6 (Table 2.10) begins slightly downslope of a berm on the downhill side of Highway 3 and bifurcates into two branches. Highway 3 does not appear to contribute to this gully system (Photo 2.21); there is no culvert or ditch. The thalweg of the gully is covered with a thick layer of duff (Photo 2.22), comparable to the forest floor around it, suggesting that it has not experienced recent erosion (Photo 2.23). It does not cause notable erosion when it crosses the dirt road. Perhaps this was a creek or swale that was cut off from its source by the construction of the highway.

Photos 2.21 and 2.22: Beginning of EFGC 6; no visible cause EFG6.1a (left photo). Significant layer of duff. EFG6g (right photo). May 29, 2023.

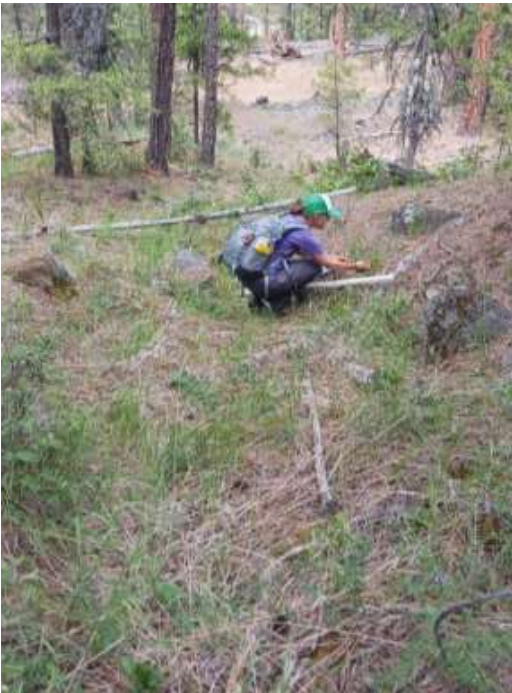
Photo 2.23: Duff and vegetation in gully. EFG6e; May 29, 2023.

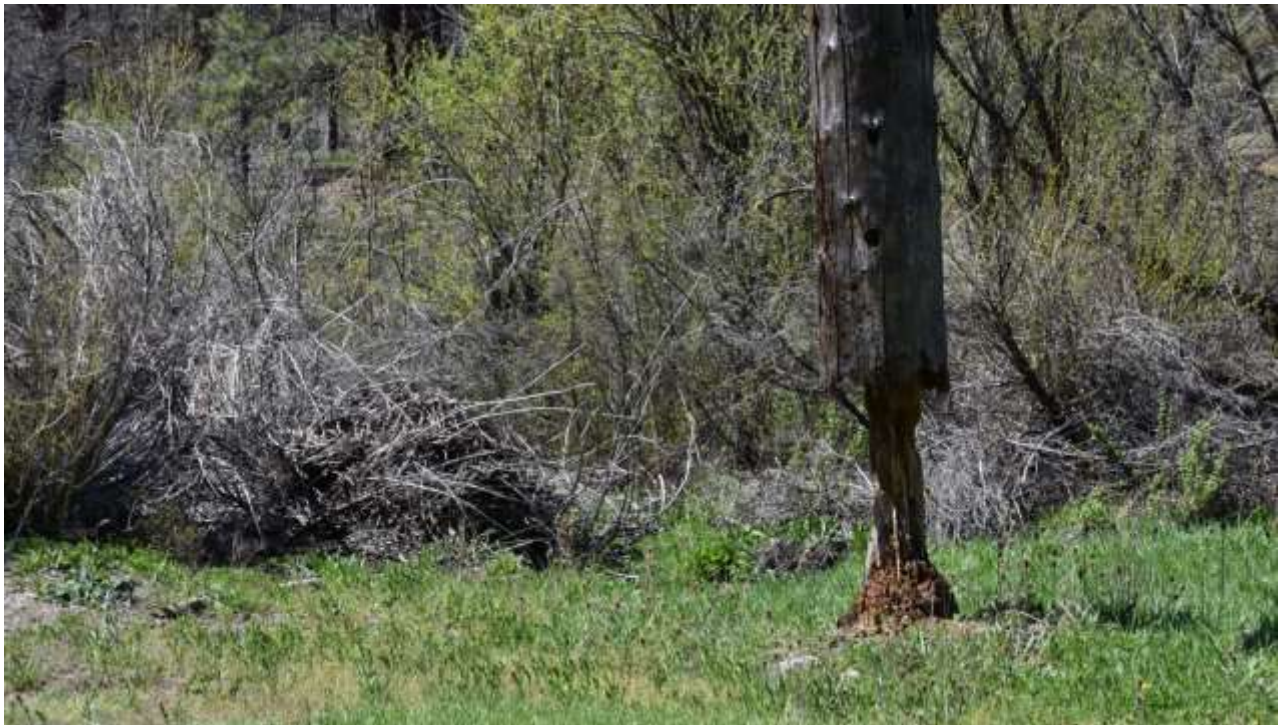
*Photo 6.1: Footprint of a formal beaver pond. The dam has broken down over time, but evidence of its structure remains. Beaver chewed a conifer that once stood in ponded water behind the beaver dam (Gilmore 2024). April 28, 2024.*

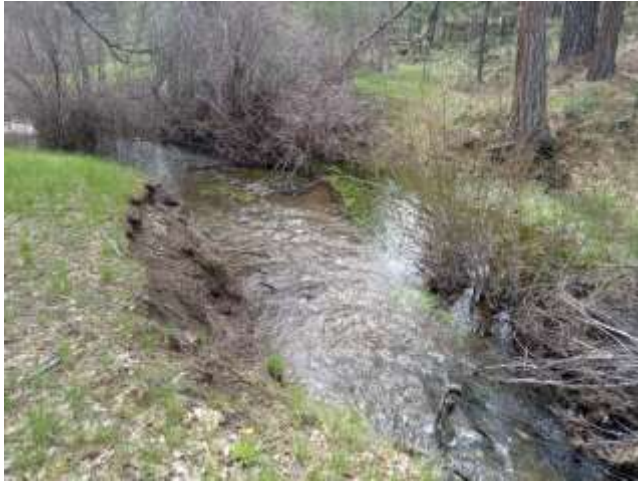
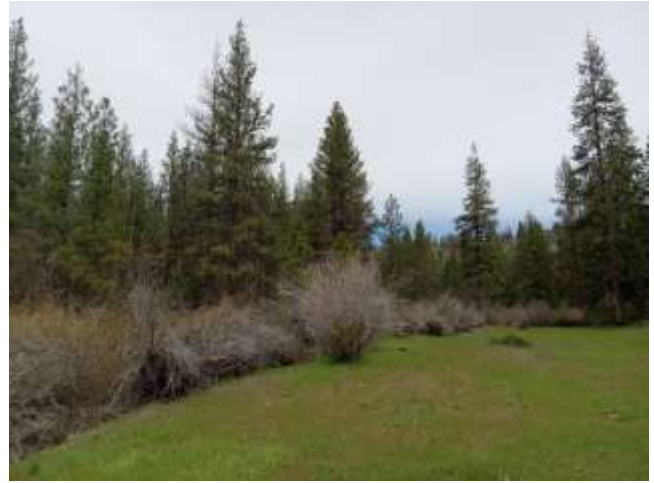
Photo 6.2 and 6.3: Eroding stream bank – Middle Noyes Valley Creek (left photo) and looking downstream (right photo). April 16, 2024.

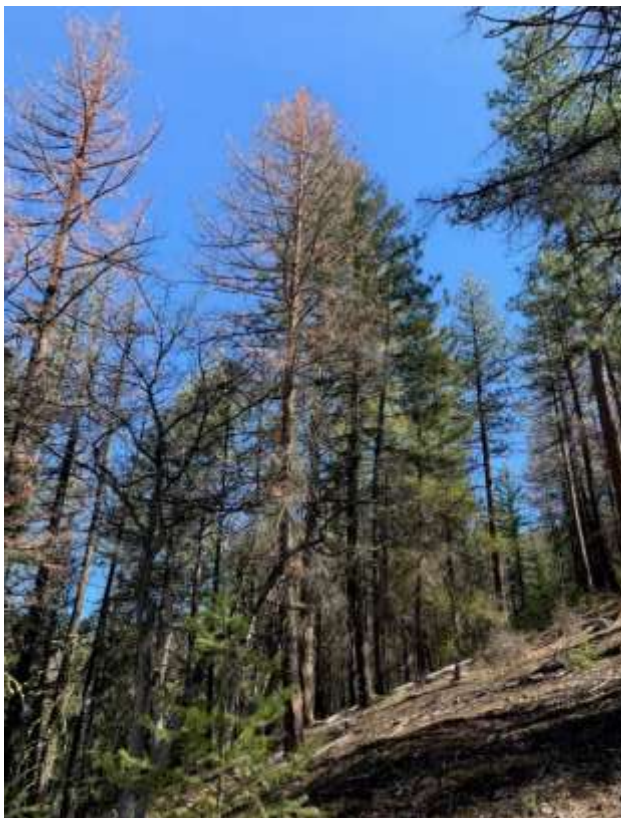
*Photo 7.3: More drought tolerant oak and pine are thriving on sites where Douglas-fir is dying. Photo credit: Mark Lancaster, BBWA, March 18, 2024.*

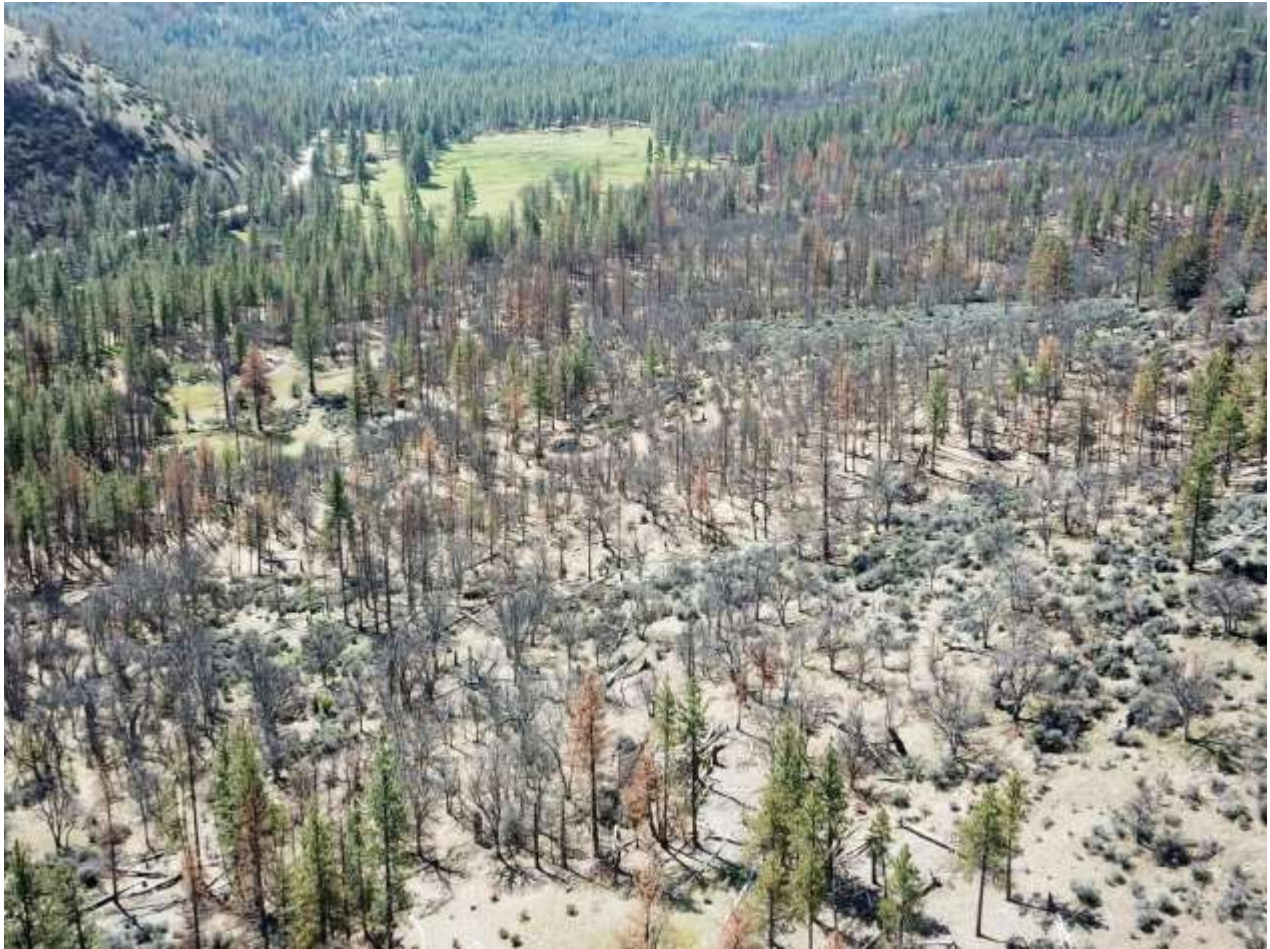
Figure 7.4: Aerial view of dying pines in Noyes Valley. March 25, 2024.

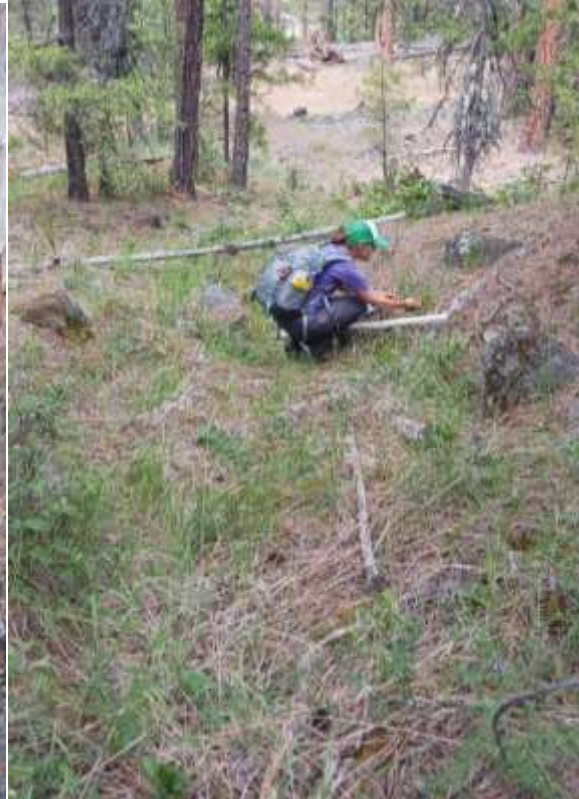
Photo 2.60: Duff and vegetation in gully. EFG6e. May 29, 2023.
