Patterson Creek – RKM 6.3 – 6.5 - Accelerated Wood Recruitment Project - Phase II
Watershed and Treatment Site Characteristics

Erich Yokel – Scott River Watershed Council

Patterson Creek Accelerated Wood Recruitment Project Field Tour - 8/11/2018

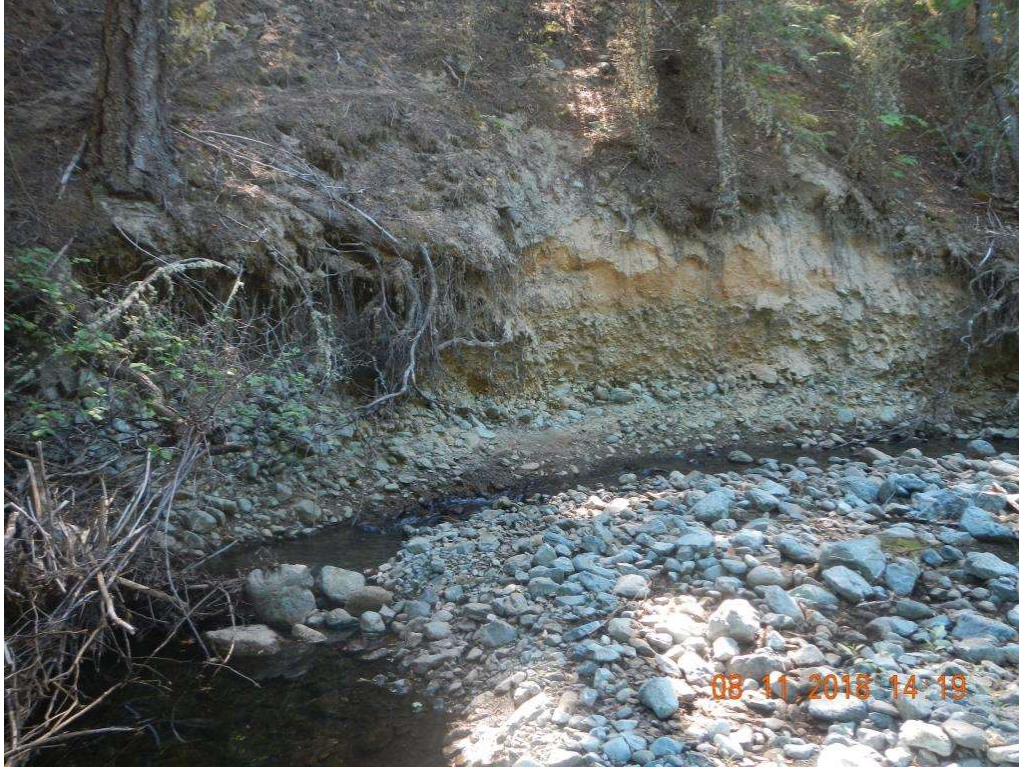
The condition of an actively eroding stream bank on river right upstream of the Phase I reach was documented (Picture 1). A lateral scour pool at the upstream end of the Phase I Treatment Reach was observed to have fine sediment deposits covering the stream bed (Picture 2). Juvenile coho salmon were observed rearing in the pool on August 11th. Surface water was connected through the Phase I Treatment Reach with the exception of a 100-foot riffle at the downstream end of the reach that was disconnected (Map 3). Surface water was present from the end of the disconnected riffle to a point approximately 650 feet downstream (Picture 3). Surface water was absent throughout the rest of the surveyed stream.

Picture 1 – Actively eroding stream bank upstream of Phase I Treatment Reach

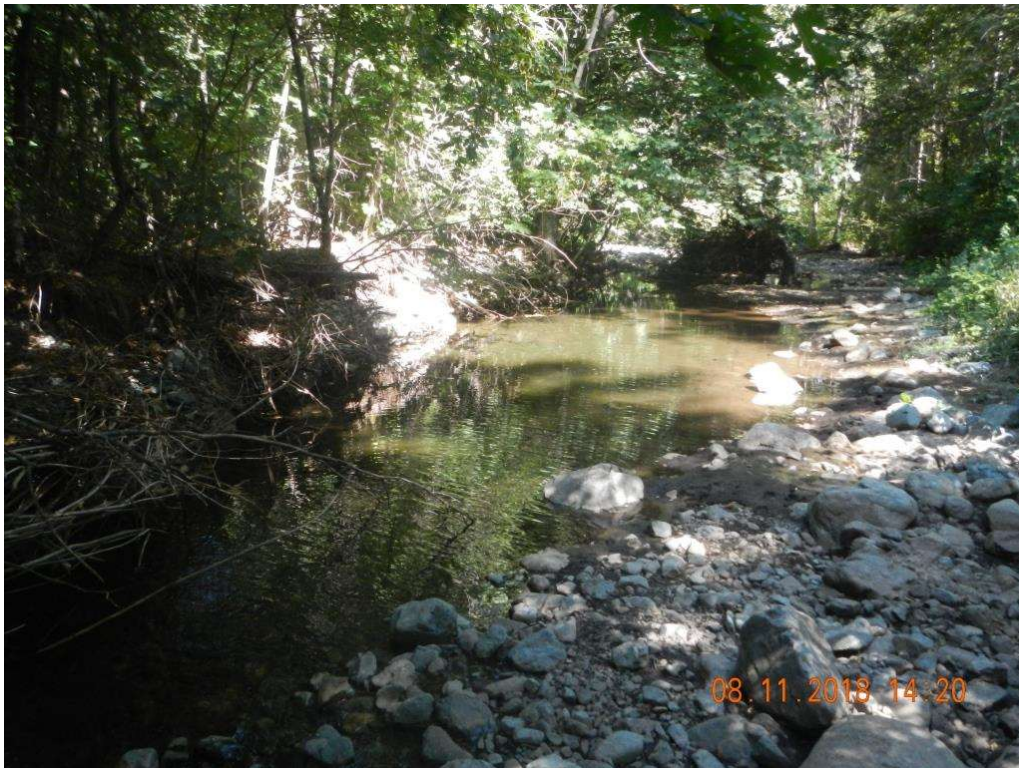
Picture 2 – Pool with documented rearing juvenile coho salmon in Phase I Treatment Reach

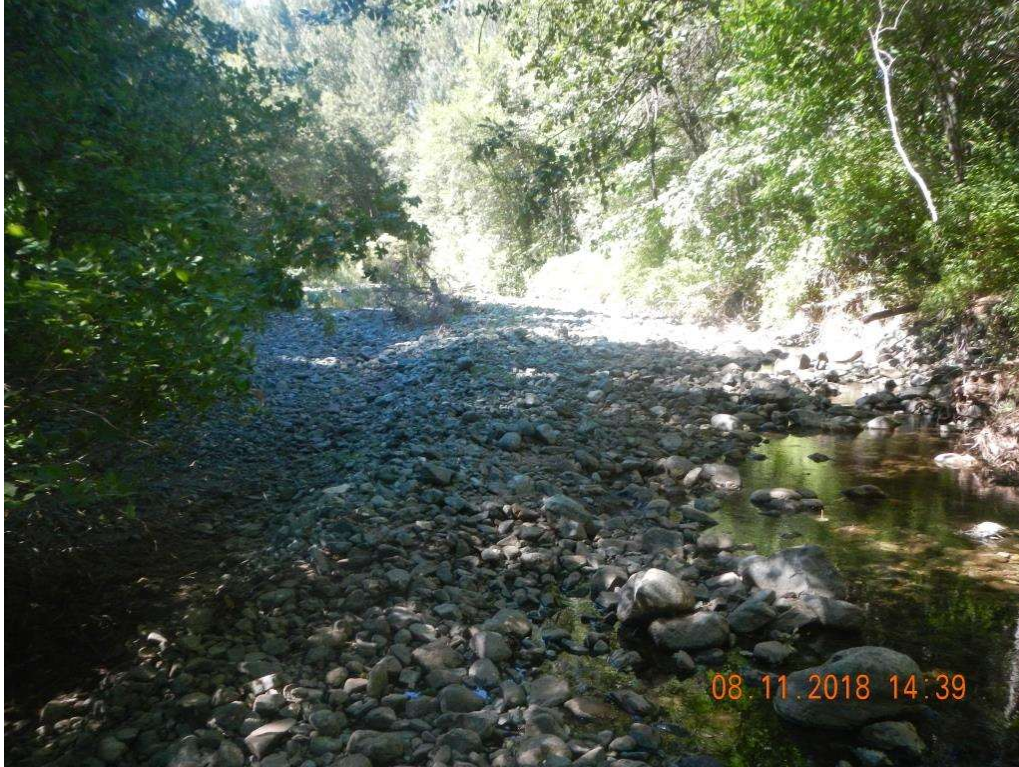
Picture 3 – End of surface water – Patterson Creek – August 11th, 2018

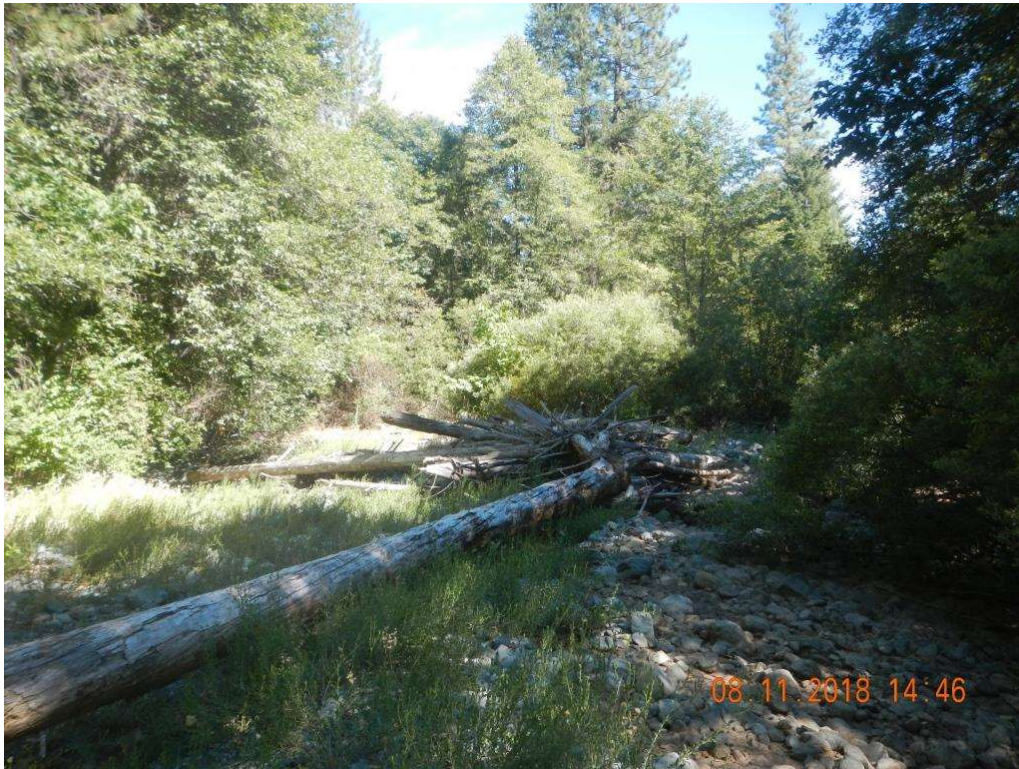
A large complex of coarse woody debris was observed at the inlet to a side channel above the Phase II Treatment Reach (Picture 4). This wood accumulation at the side channel inlet is a potential model for treatment in the Phase II reach. The inlet to the side channel in the Phase II Treatment Reach identified in the GIS model was located directly upstream from a large alder tree on the river left bank (Picture 5). There is currently a small berm between the main channel of Patterson Creek and the side channel inlet (Picture 6). Several large conifers were observed in the area of the side channel inlet that could be used in conjunction with the large alder to create a log jam downstream of the side channel inlet to direct additional flow into the side channel.

Picture 4 – Large woody debris deposit at side channel inlet upstream of Phase II Treatment Reach

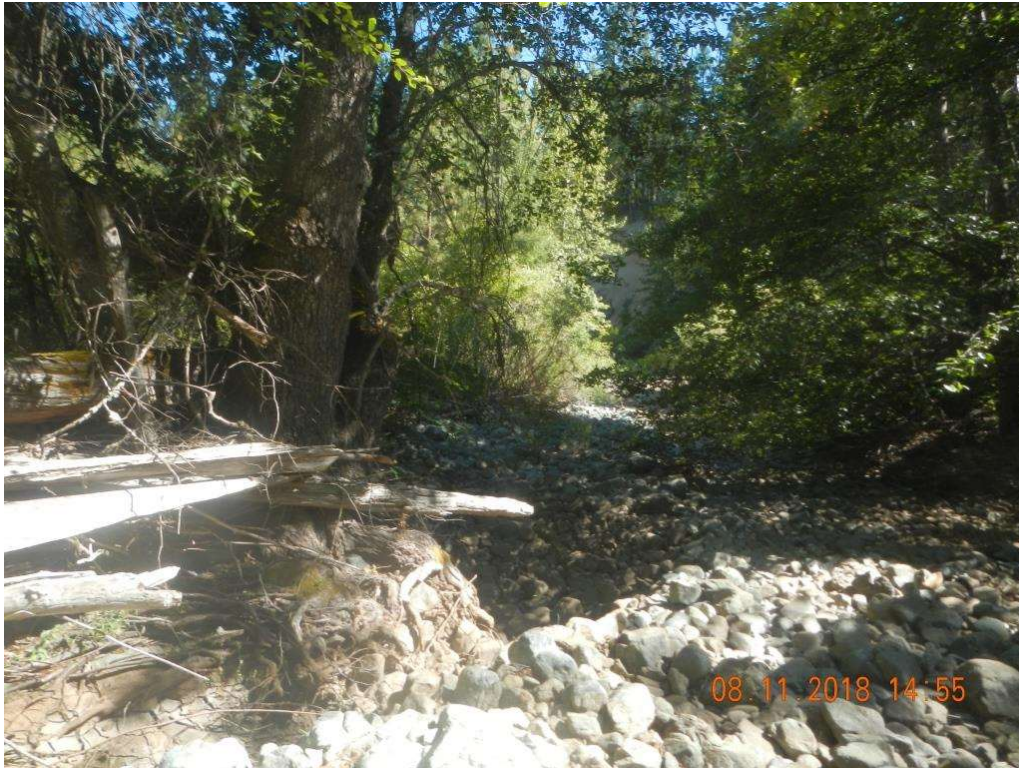
Picture 5 – Scour hole from large alder tree directly downstream of side channel inlet in Phase II reach

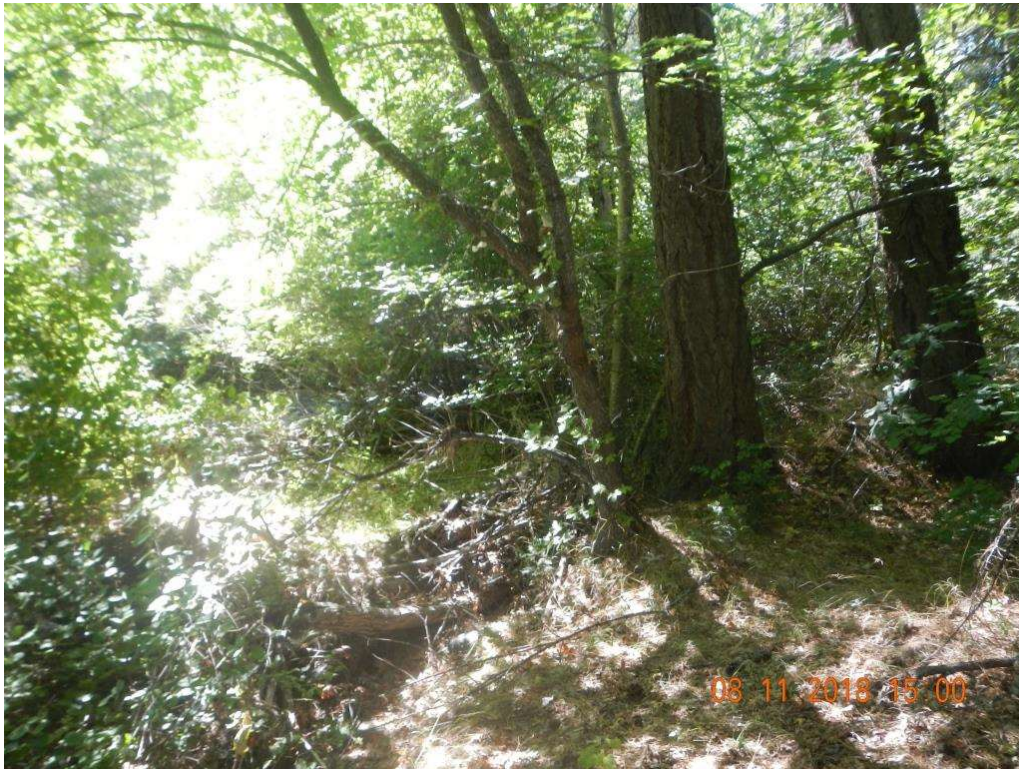
Picture 6 – Inlet to side channel (bottom left) in Phase II reach

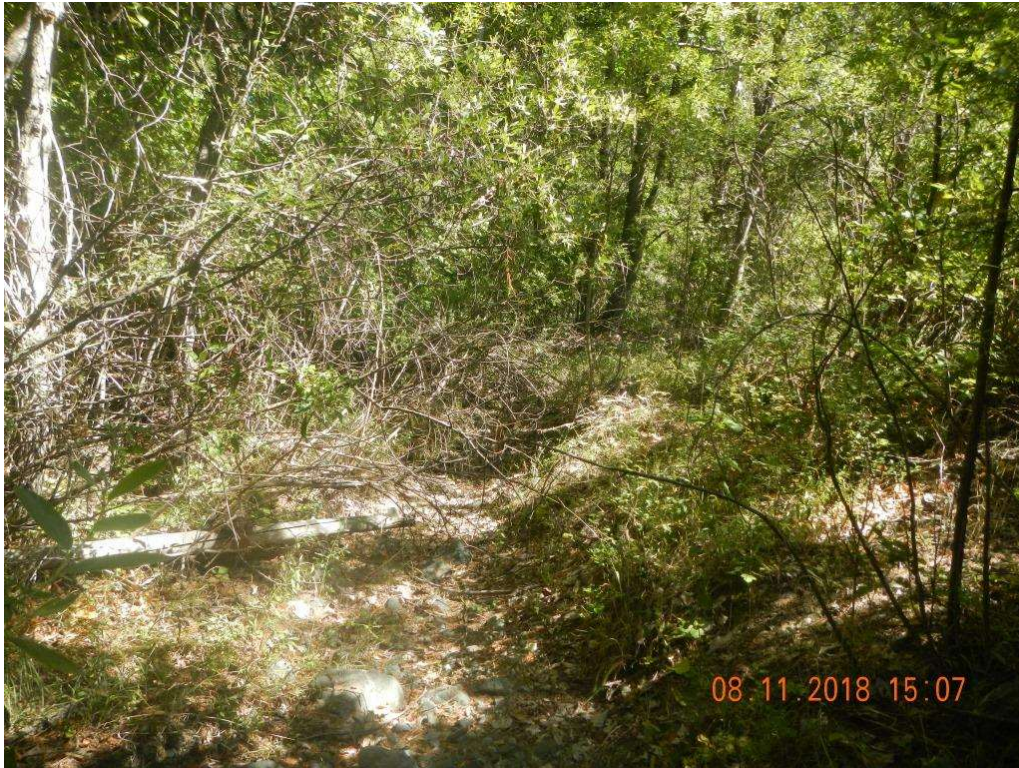
The side channel is significantly narrower than the main channel of Patterson Creek (Picture 7). Several large conifers were observed along the bank or near the bank of the side channel. The side channel outlet is wider potentially due to the backwater effect at the confluence (Picture 8). Large conifers were observed on the steep river right bank of Patterson Creek (Picture 9). These conifers could be utilized to create a log jam at in Patterson Creek downstream of the side channel outlet to potential create a backwater habitat at the outlet's confluence. Downstream of the outlet approximately 200 feet the treatment reach is ended due to a more limited availability of large conifers in near vicinity to the stream.

Picture 7 – Side channel in Phase II reach

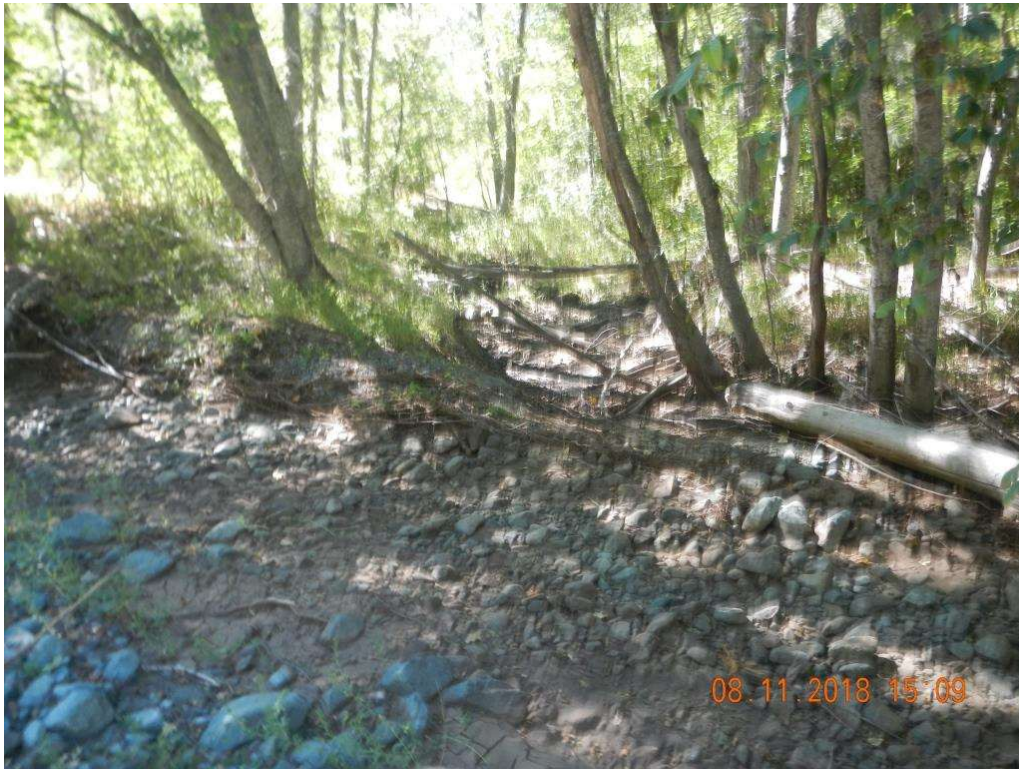
Picture 8 – Outlet of side channel (from Patterson Creek) in Phase II Reach

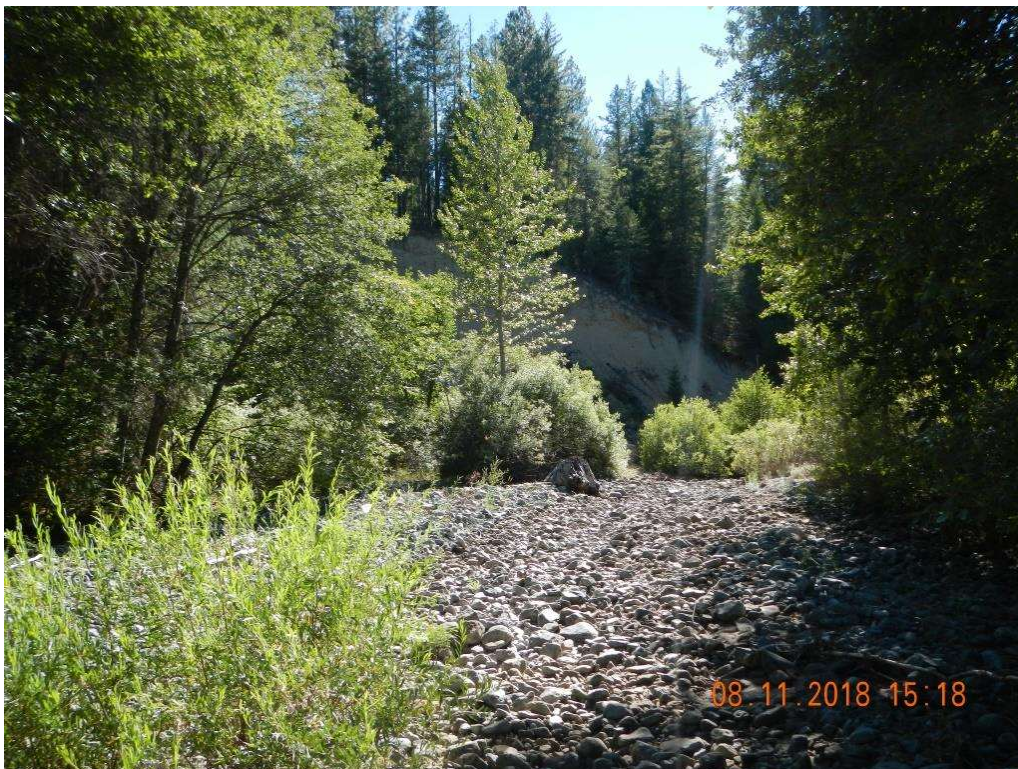
On the mainstem of Patterson Creek between the side channel inlet and outlet there is a significant actively eroding cut bank on the river right (Picture 10 & 11). There are large conifers on the top of the bank (Picture 10) and several large conifers with root wads on the face of the bank (Picture 11). The toe of the bank has some willow brush but is largely unprotected with vegetation. There is a significant amount of willow in the stream bed and banks throughout the surveyed reach of Patterson Creek that could be utilized for cuttings to plant and protect the toe of the eroding bank.

Picture 10 – Downstream extent of actively eroding river right stream bank

A structure downstream of the side channel inlet will be installed in a position with the river left downstream of the river right to direct the flow away from the upstream toe of the actively eroding bank. Placed wood structures along the toe of the eroding bank in conjunction with riparian plantings (willow cuttings) will protect the bank while promoting fine sediment deposition and long term bank stability and stream shade.

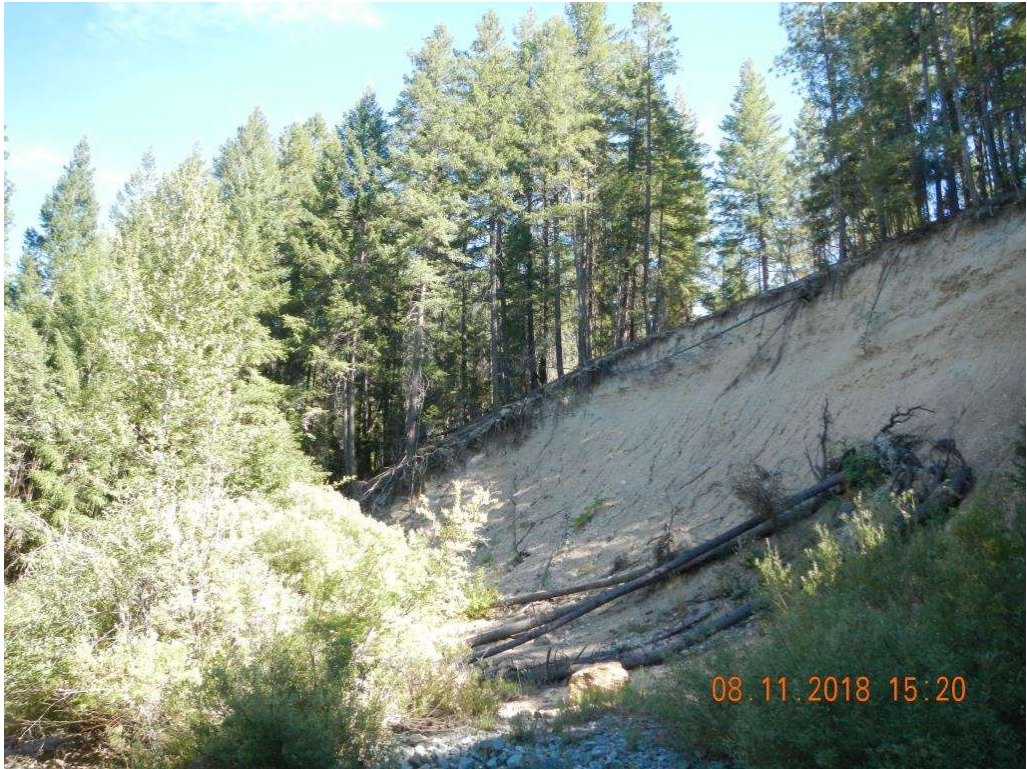
Picture 11 – Actively eroding stream bank in Phase II Reach – looking downstream

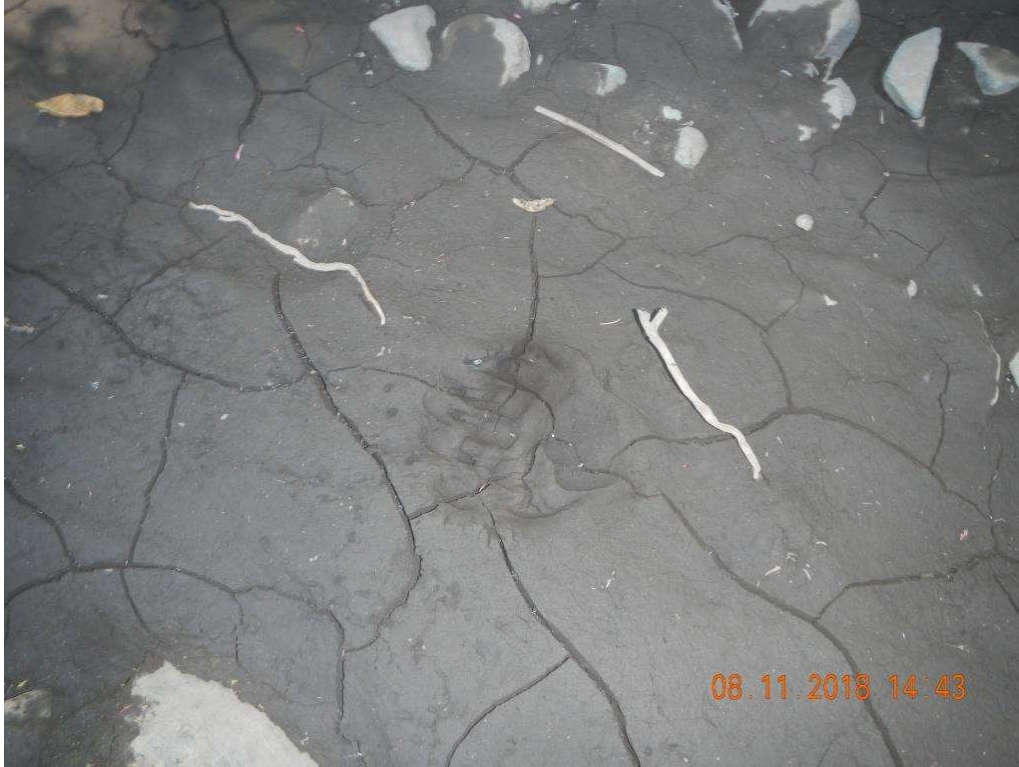
A field tour of the Patterson Creek Accelerated Wood Recruitment Project reach was performed on August 11, 2018 to document current condition and verify the existence of key features identified in the model (Map 3). The field tour was started upstream of the Phase I Treatment Reach and ended at the downstream extent of the proposed Phase II Treatment Reach. A significant thunderstorm driven runoff event occurred in Patterson Creek on July 15th, 2018. Fine sediment (silt) deposits from the runoff event were observed throughout the reach during the field visit (Picture 13).

Picture 13 – Deposit of fine sediment (silt) from July 15th, 2018 thunderstorm runoff event
