Scott River Beaver Dam Analogue Coho Salmon Habitat Restoration Program 2017 Monitoring Report

EXECUTIVE SUMMARY AND KEY FINDINGS

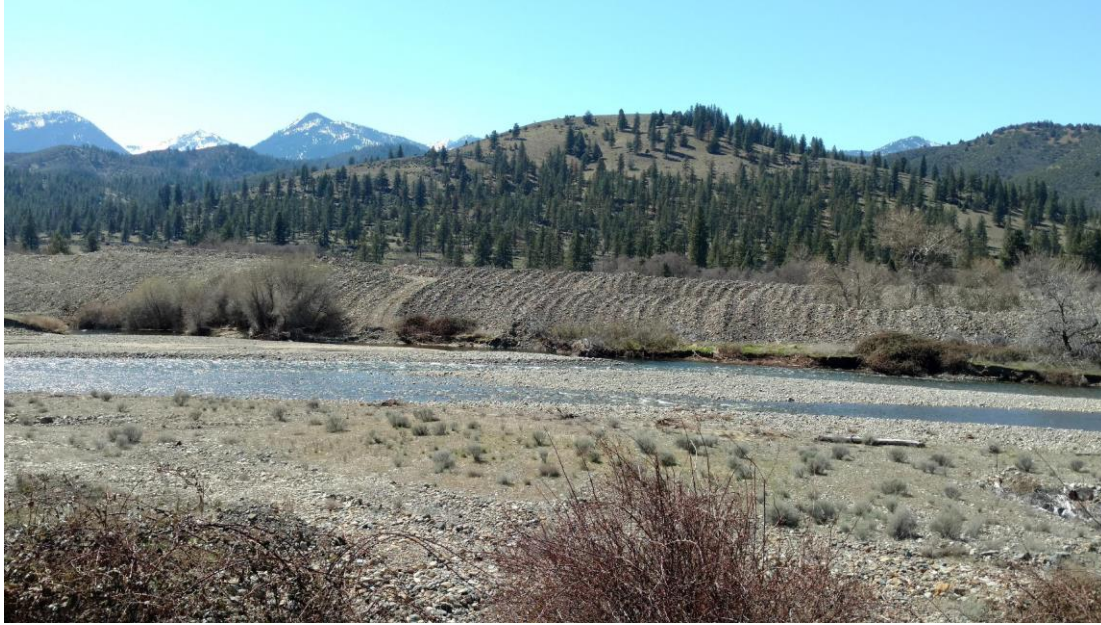
Figure 3. The tailings reach in the upper mainstem of the Scott River, just downstream of the confluence with Sugar Creek, showing the overturned substrate and the lack of riparian vegetation and aquatic habitat simplification. River flow is from left to right. The tailings are the symmetrical mounds of cobble on river left. There is about 6 kilometers of such habitat, most of which dries up during the summer months, though subsurface water persists within 1-2 m of the surface and is occasionally seen in deep scour pools.

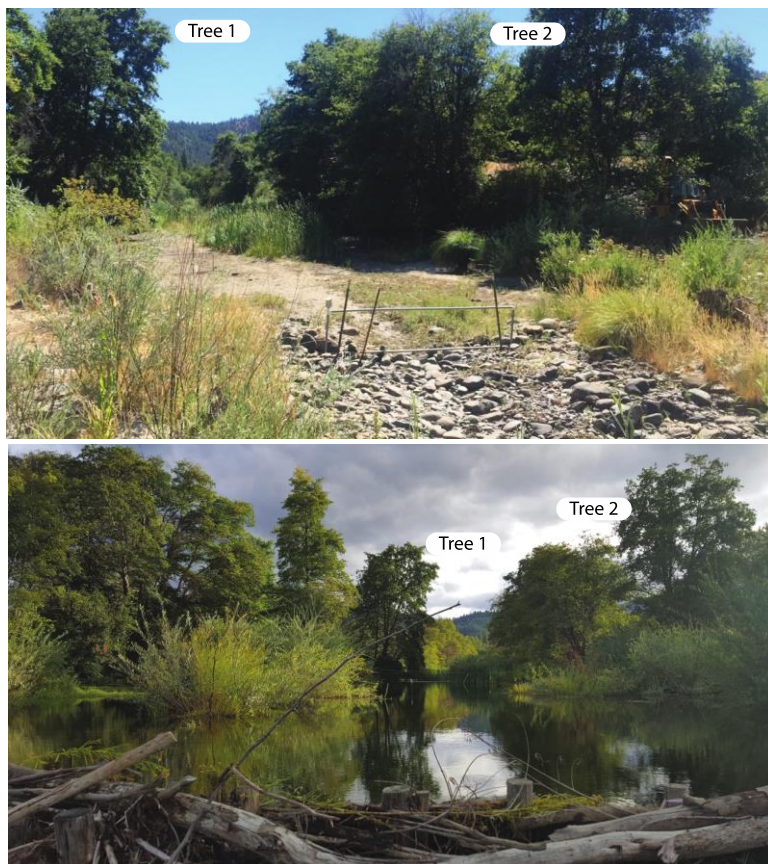
Figure 6. Top: Sugar Creek prior to BDA restoration in July, 2014. Flow is from left to right. At the upstream end of the restoration reach, several hundred meters from where this photograph was taken, a small amount of flow persisted throughout the year, but it ceased flowing where the underlying substrate transitioned from hillside bedrock to the porous alluvial mine tailings of the Scott River floodplain. Bottom: Conditions in September, 2017, as viewed from the top of BDA 1.0, a slightly different vantage point, about 10 m downstream from the top photograph. Two trees labeled in both the photographs provide perspective.

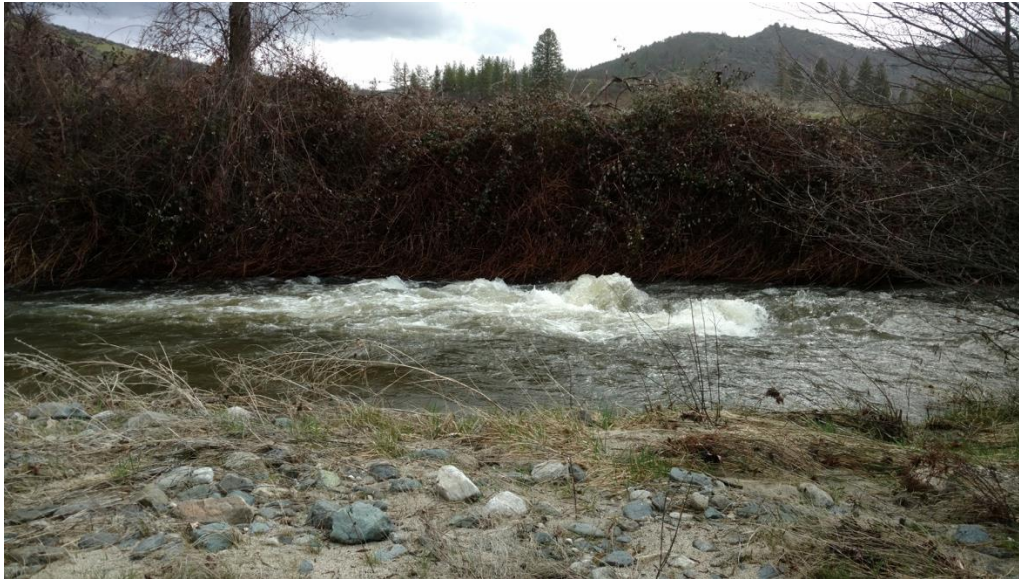
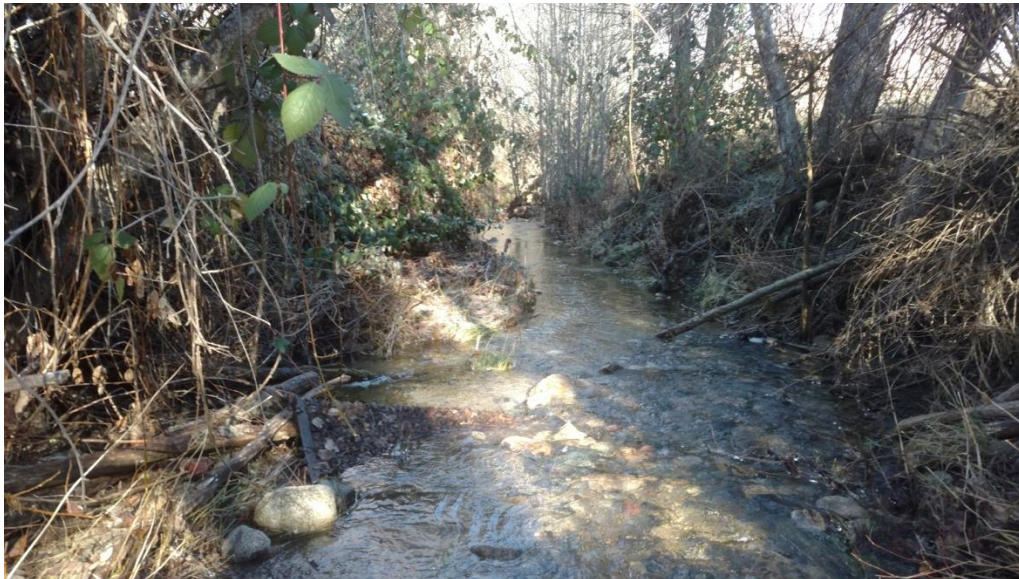
Figure 8. High flows on a typical reach in French Creek, near the control site. The river right side is rip-rap covered with Himalayan blackberry (top). French Creek side channel during winter high flows, prior to installation of BDAs. The channel generally flows through dense riparian vegetation, but is lacking in deep pools (bottom).

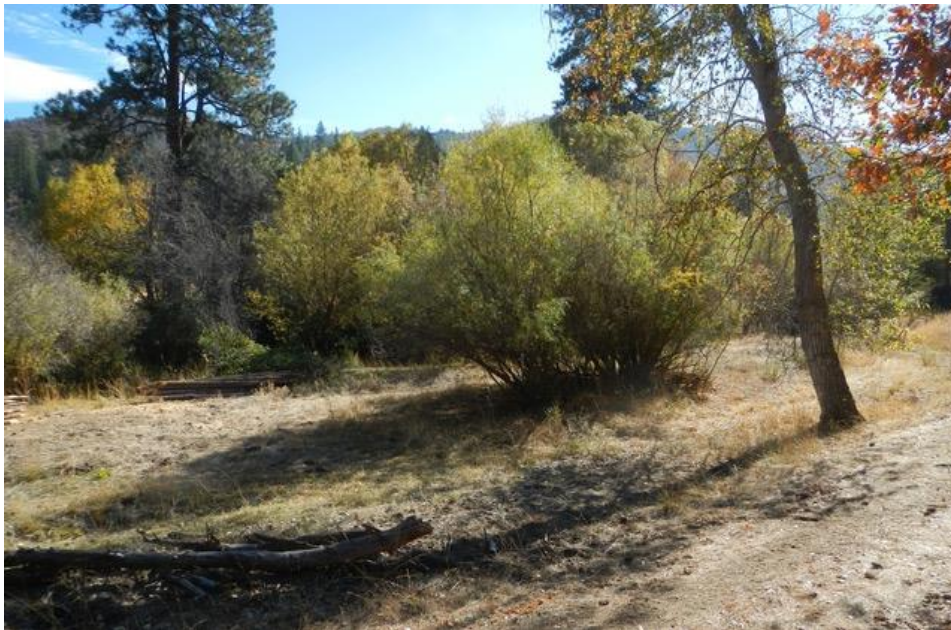
Figure 9. The Miners Creek floodplain near the BDA restoration site showing the sandy, porous alluvium. The small creek flows near the Ponderosa pine in the background

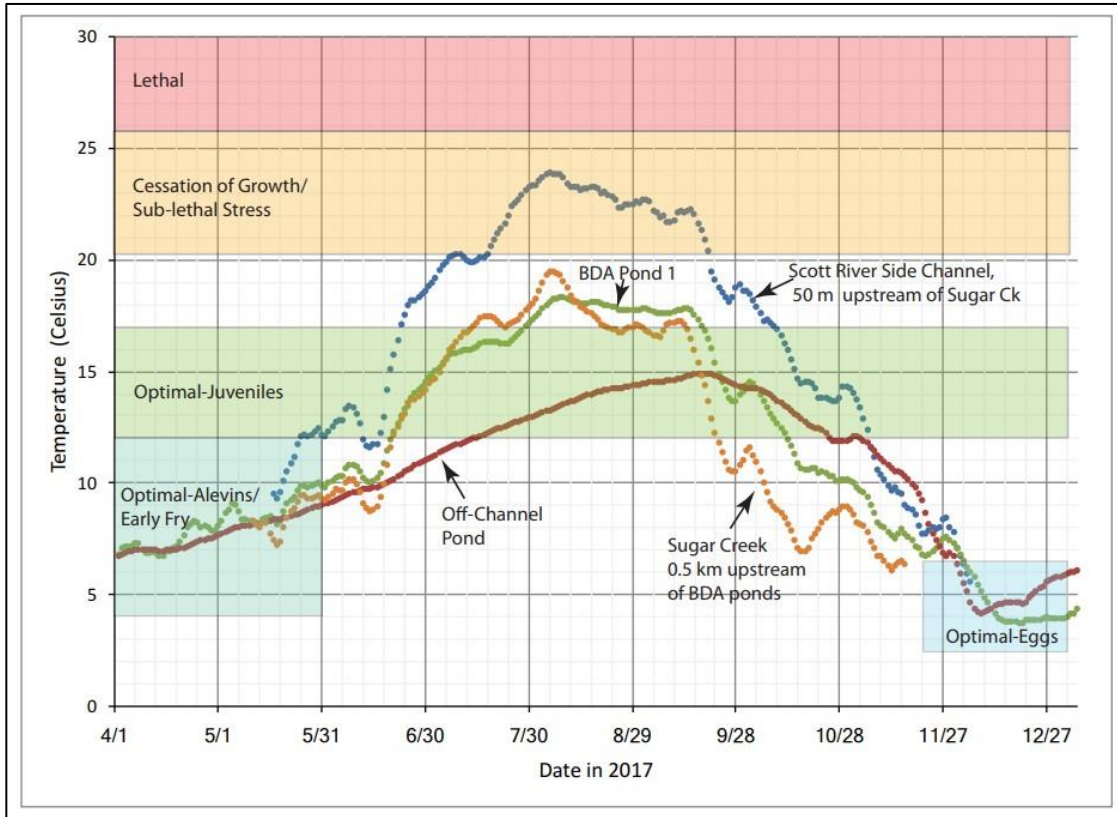
Figure 10. Moving weekly maximum temperature (MWMT) (°C) at Sugar Creek recorded in WY17. Thermal optimum and stressful ranges for coho salmon life stages based on Richter and Kolmes (2005).

Figure 10 shows the moving average weekly maximum temperature (MWMT) (°C) at Sugar Creek in WY17 compared to thermal optima and stressful ranges for coho salmon at various life stages (Richter and Kolmes 2005). The BDA pond provides good growing conditions for juvenile coho from mid-June through mid-October, while the off-channel pond provides good growing conditions from mid-July through early November. Temperatures in the off-channel pond are much more stable, presumably due to the alluvial groundwater influence at that site. Of all the sites, the off-channel pond remains within the thermal optima for coho salmon for the longest period of time. Temperatures in the nearby Scott River are significantly higher than at the restoration site and are in the stressful range for juvenile coho throughout most of the summer. In Sugar Creek at RKM 1.0, upstream of the restoration site and below the gage station, temperatures provide good growing conditions throughout the summer.

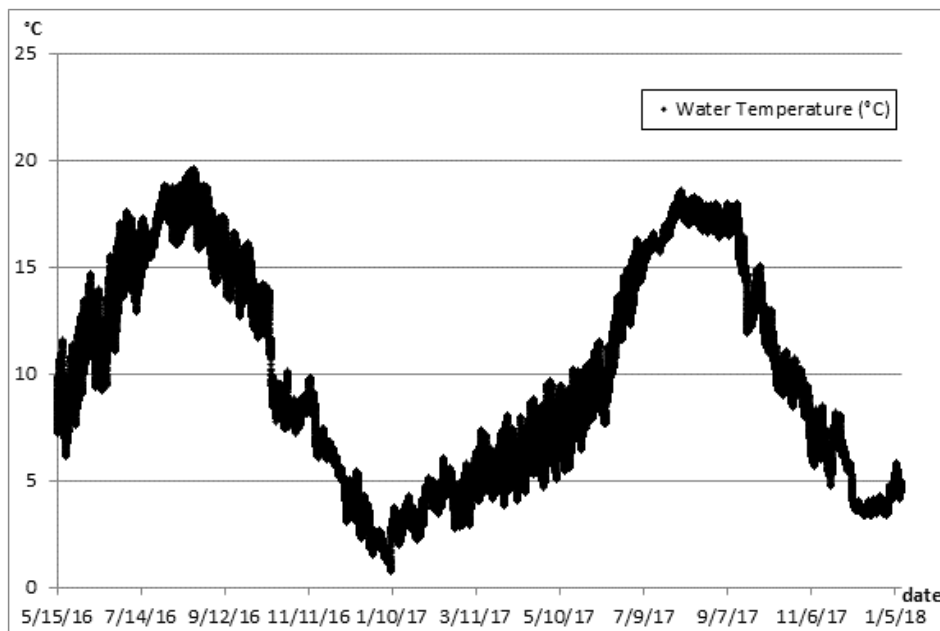
Figure 11. Water temperature (°C) in Sugar Creek BDA Pond 1 from May, 2016 through January, 2018.

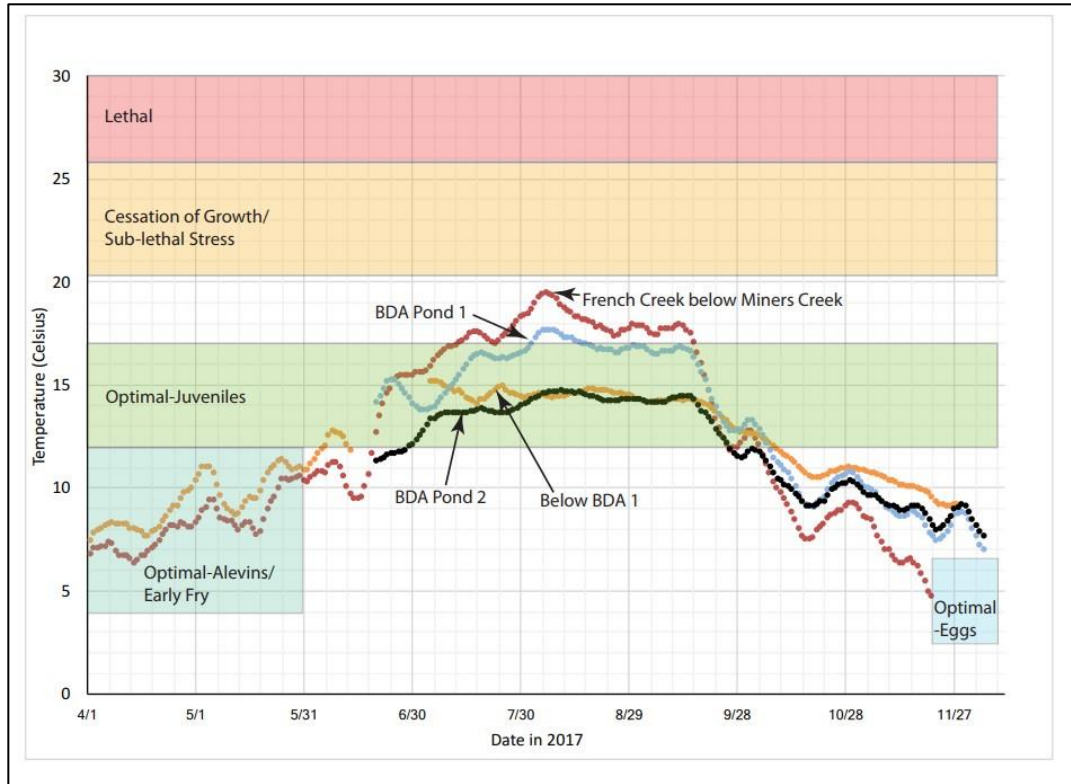
Figure 12. Moving average weekly maximum temperature (°C) in French Creek mainstem and Side Channel BDA Reach April-November, 2017. Thermal optimum and stressful ranges for coho salmon life stages based on Richter and Kolmes (2005).

At French Creek, water temperatures were recorded in the mainstem, downstream of the Miners Creek confluence and throughout the side channel where a series of BDAs were installed in 2017. Figure 12 shows that at all sites, water temperatures remained within or close to the thermal optima for coho salmon, with the exception of the French Creek mainstem, which rose close to stressful levels for a few weeks in early August.

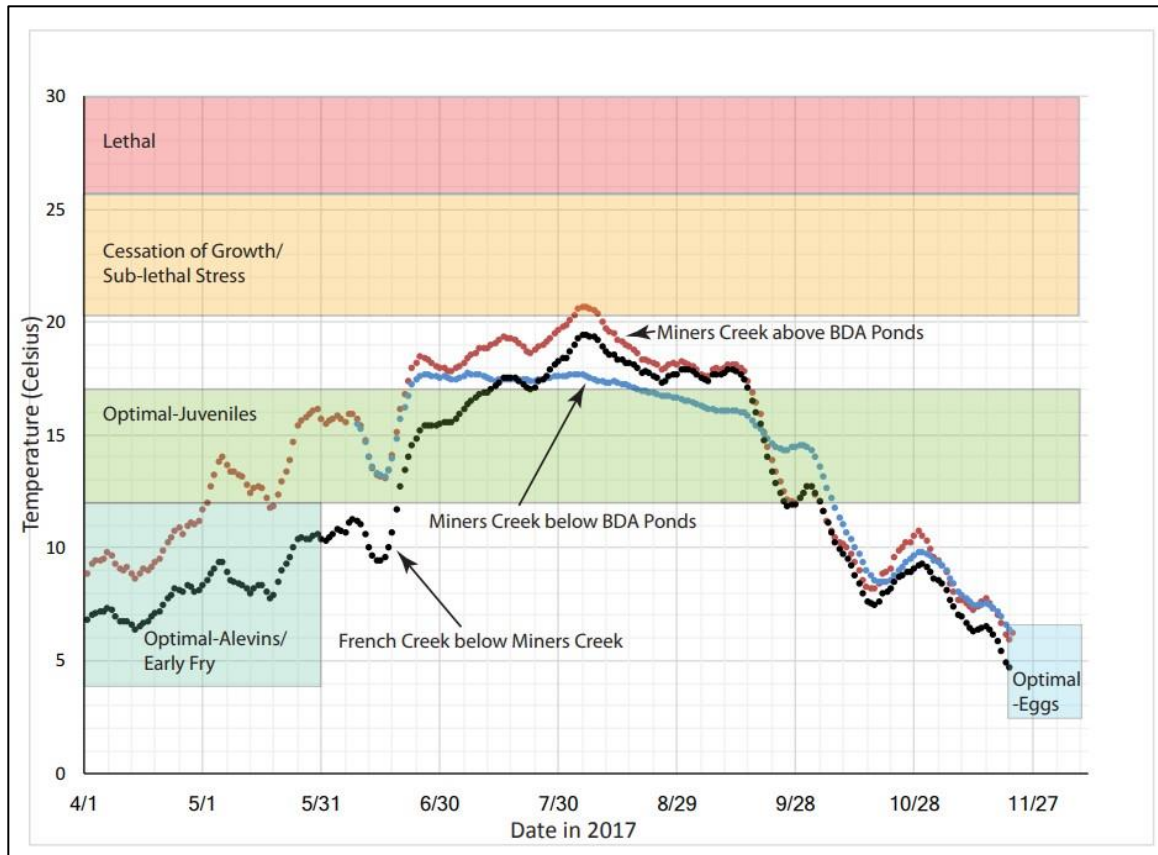
Figure 13. Moving average weekly maximum temperature (°C) in Miners Creek, April-November, 2017. Thermal optimum and stressful ranges for coho salmon life stages based on Richter and Kolmes (2005).

In Miners Creek, water temperature was recorded in four locations - upstream and downstream of the two BDAs. Water temperatures in French Creek, downstream of the Miners Creek confluence were compared in Figure 13. The BDA reach had areas of disconnection during summer and fish presumably moved downstream with receding flows. Above the BDA treatment reach, temperatures in Miners Creek rose to above 20 °C for a brief period in August, a level that can cause stress in coho salmon. Below the BDA ponds temperatures were much cooler, and close to or within the thermal optima for coho salmon throughout the summer. The difference may be due to increased groundwater storage in the alluvial valley that may be partially attributable to the BDAs. The upper BDA did accumulate a considerable amount of alluvium, and the amount and duration of flows in the reach appear to have improved relative to pre-project conditions, when the stream regularly ceased flowing during the summer months. However, interpretation of data is somewhat confounded by water withdrawals upstream of the site.

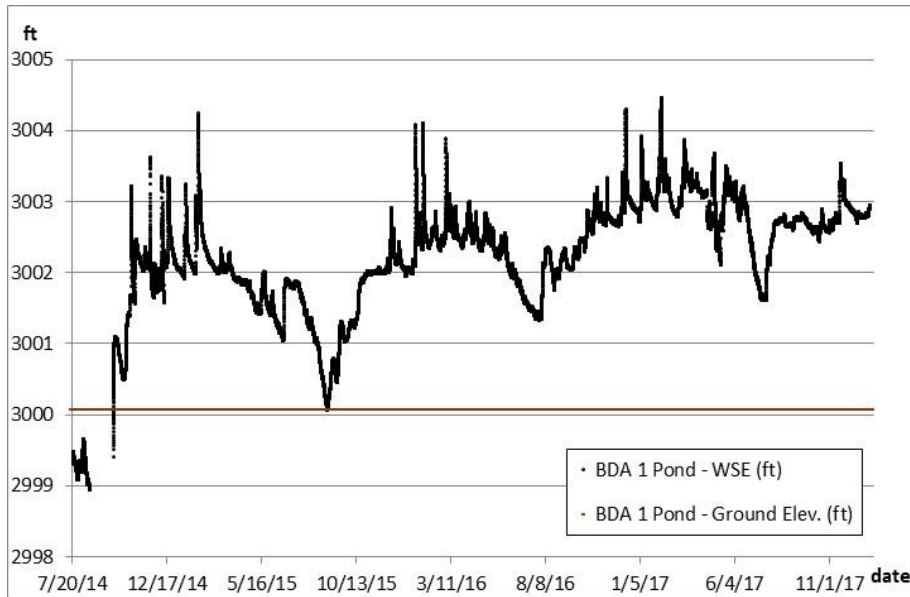
Figure 14. Water surface elevation (ft) as measured in BDA Pond 1 from July of 2014, when flow ceased at the time of installation, to November, 2017. The line just above 3000 ft is the bed surface elevation at the base of BDA 1.0. The low water points in 2015, 2016 and 2017 are from breaches that were repaired later in the year when flows receded.

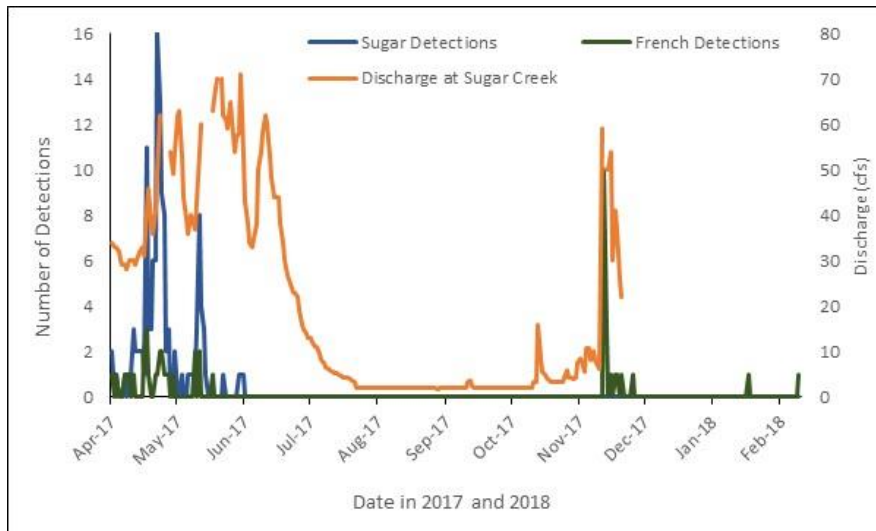
Figure 19. Number of fish detected outmigrating at the Sugar and French Creek arrays between April 10, 2017 and February 22, 2018. Sugar Creek detections include only juvenile coho salmon tagged in the upper BDA Pond 2. Detections in the lower BDA Pond 1 infer outmigration of juvenile coho salmon. Discharge at the Sugar Creek gage shown from April 10, 2017 to November 29, 2017.

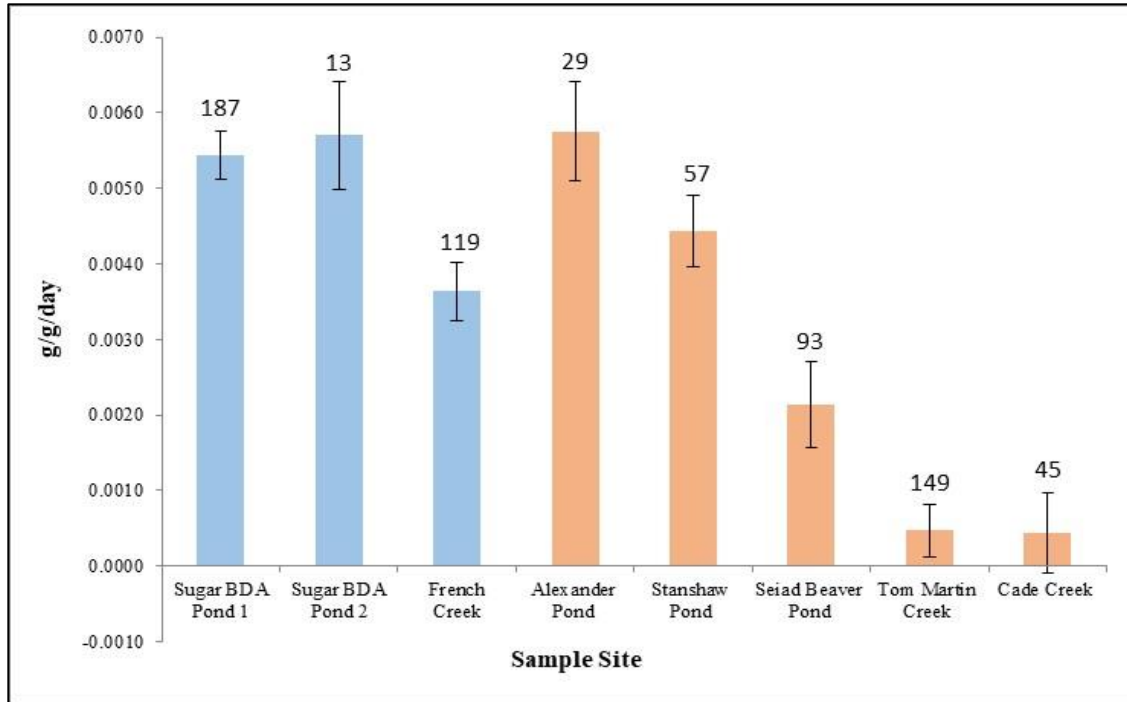
Figure 20. Average summer growth rates of juvenile coho salmon in Klamath River tributaries and Scott River restoration sites. The blue bars indicate growth rates estimated during the 2017 summer season and orange bars indicate growth rates estimated during the 2012 summer season. Numbers shown above the bars represent sample size for the calculation.

Because we did not see significant movement between Sugar Creek’s BDA Pond 1 and BDA Pond 2 (see Table 5), growth rates were estimated separately for these habitats. Figure 20 shows the estimated growth rates and standard error of the juvenile coho salmon in the Sugar and French Creek sites as compared to the estimated growth rates of coho salmon in tributaries of the mid-Klamath, using the same methods for estimation (from Witmore 2014). The BDA ponds showed high rates of growth, among the best of all sites examined (Figure 20). Relative to the other stream sites (Tom Martin and Cade Creeks), which are generally not as productive as ponds, the French Creek site showed good growth.

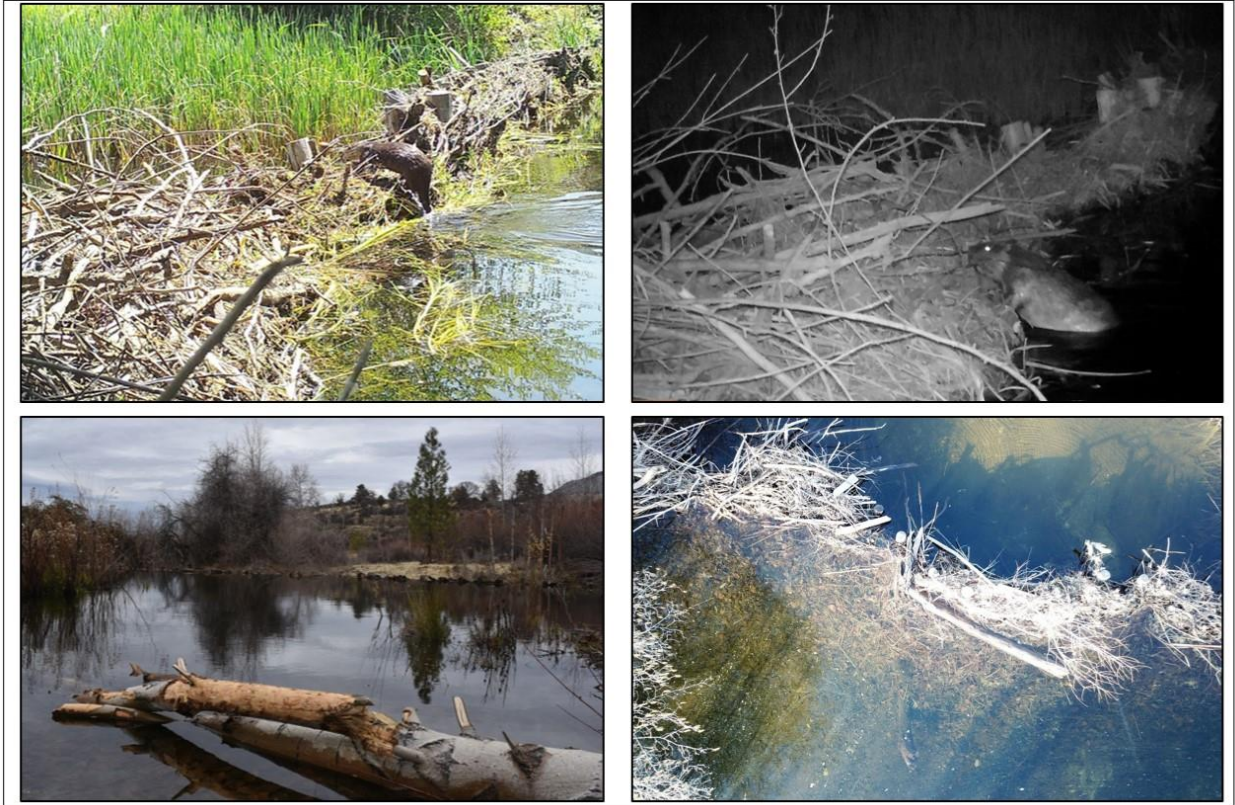
Figure 23. Top left: a river otter crossing a BDA 2.0 in Sugar Creek. Top right: two beaver modifying BDA 2.0 at night in Sugar Creek. Bottom right: aerial view of a section of BDA 2.0 repaired and maintained by beaver. Bottom left: A remains of a cottonwood tree felled and consumed by beaver in BDA Pond 1.

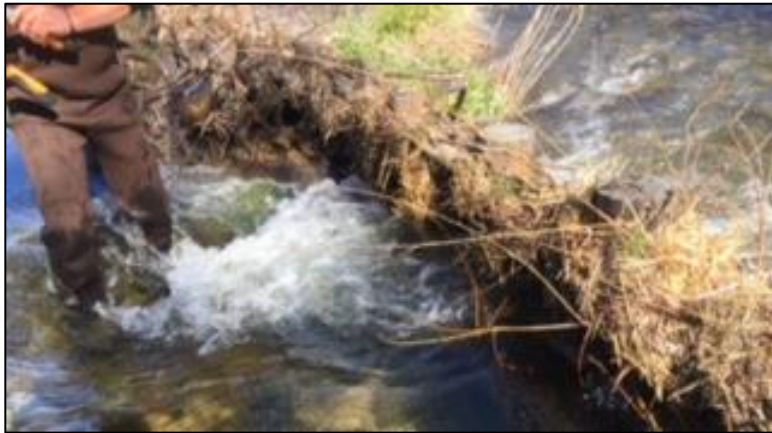
Figure 24. Scour hole undercuts BDA 1.0 at Sugar Creek.

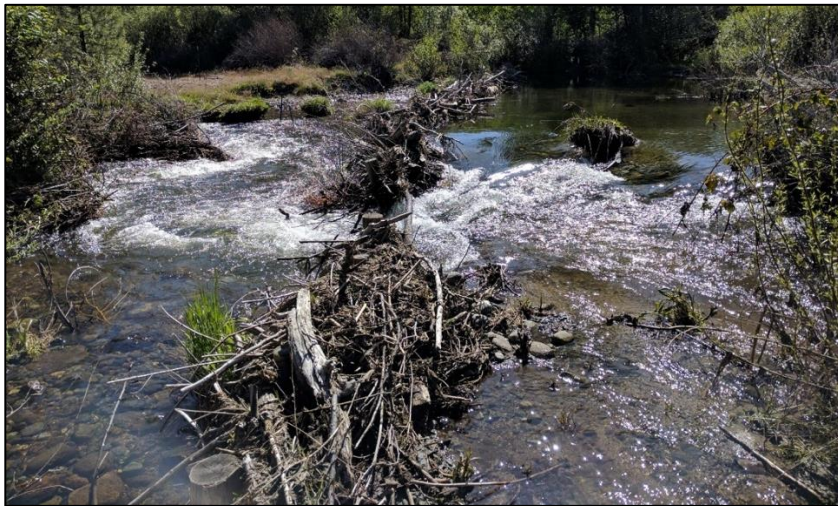
Figure 25. A 20-foot section of BDA 1.0 that was scoured during a February 2017 flood, resulting in the loss of four posts and associated weave.

In general, repairs to BDAs seem to have an almost immediate effect. For example, an increase in WSE resulting from repairs of a 20-foot breach to the BDA 1.0 structure on May 15th raised the WSE by approximately 27 cm (0.9 ft) in less than a day (Figure 15).

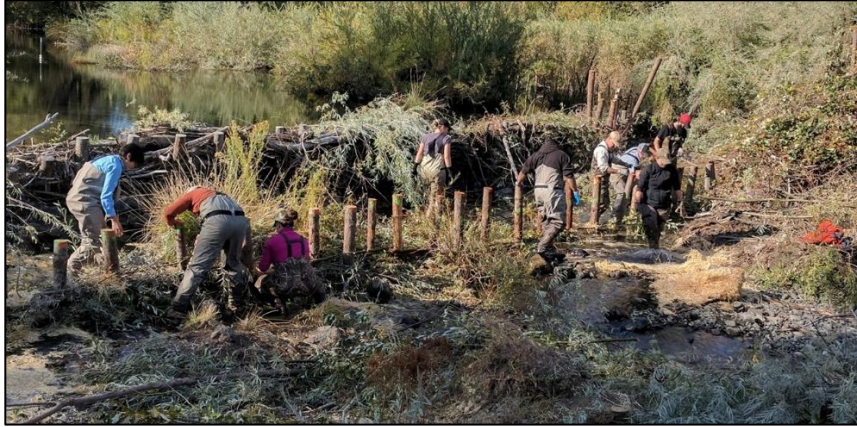
Figure 26. Construction of two step BDAs (BDA 1.1 and BDA 1.2) downstream of BDA 1.0 at Sugar Creek.

monitoring upstream of the BDA suggests that fish passage was not an issue. The new BDA crests were designed to be at one foot water surface elevation differences from upstream to downstream in a stair-step fashion (Figure 26). In the 20-foot section of BDA 1.0 that had previously been repaired with hand tools on May 15th, we installed 6 additional posts, using a backhoe with a plate vibrator, to provide additional stability. Finally, the small gap between the main section and the left wing of BDA 1.0 was filled using 20 posts and willow weave. No filling or berming of the weave occurred in this new section to facilitate passage for juvenile fish through multiple flow pathways.

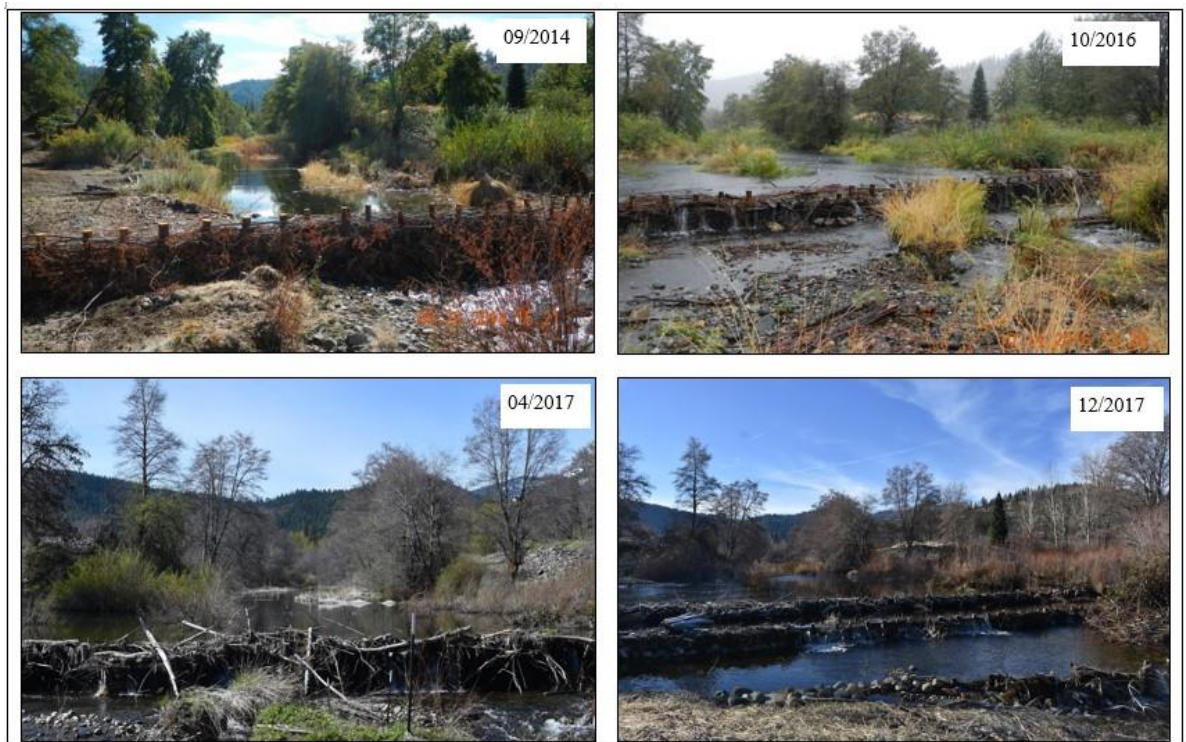
Figure 27. Sugar Creek feature photos. BDA 1.0 from 2014 to 2017.

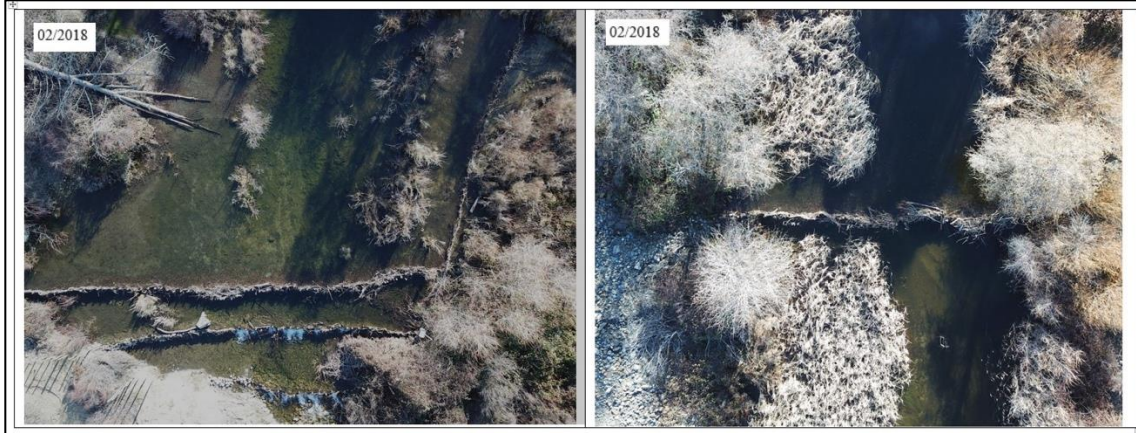
Figure 28. Landscape Photos from Sugar Creek restoration site. Left photo: Sugar BDA 1.0 with step BDAs 1.1 and 1.2, Side Channel 1 to the right and flowing from BDA 1.0 wing, and recent cottonwood fallen by beavers. Right photo: Sugar BDA 2.0

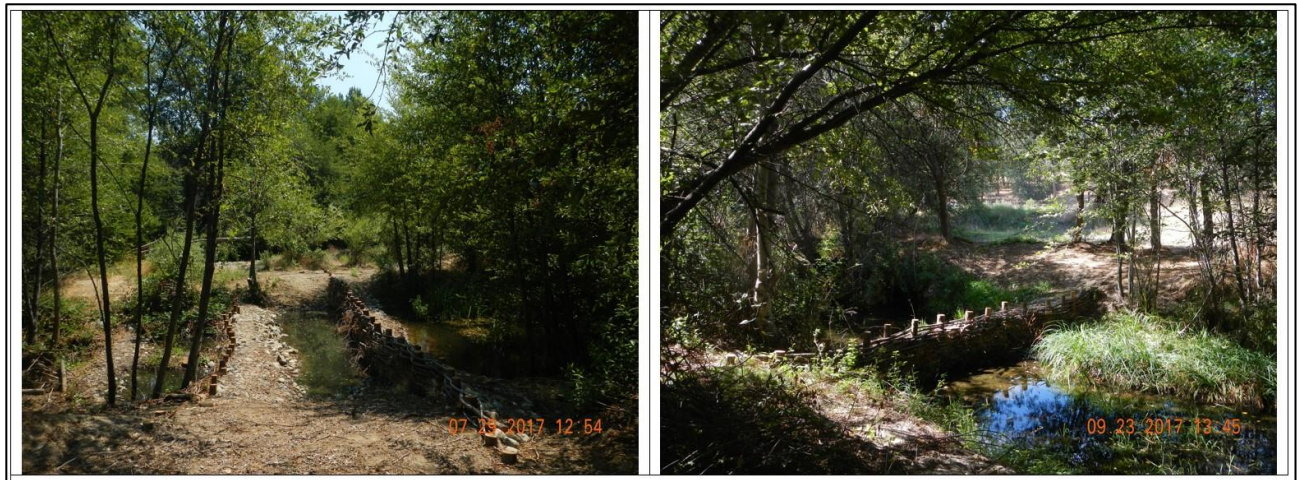
Figure 30. Feature photos. BDA 1 post construction. Photos taken from bank of mainstem French Creek, looking toward the side channel, now containing BDA structures.

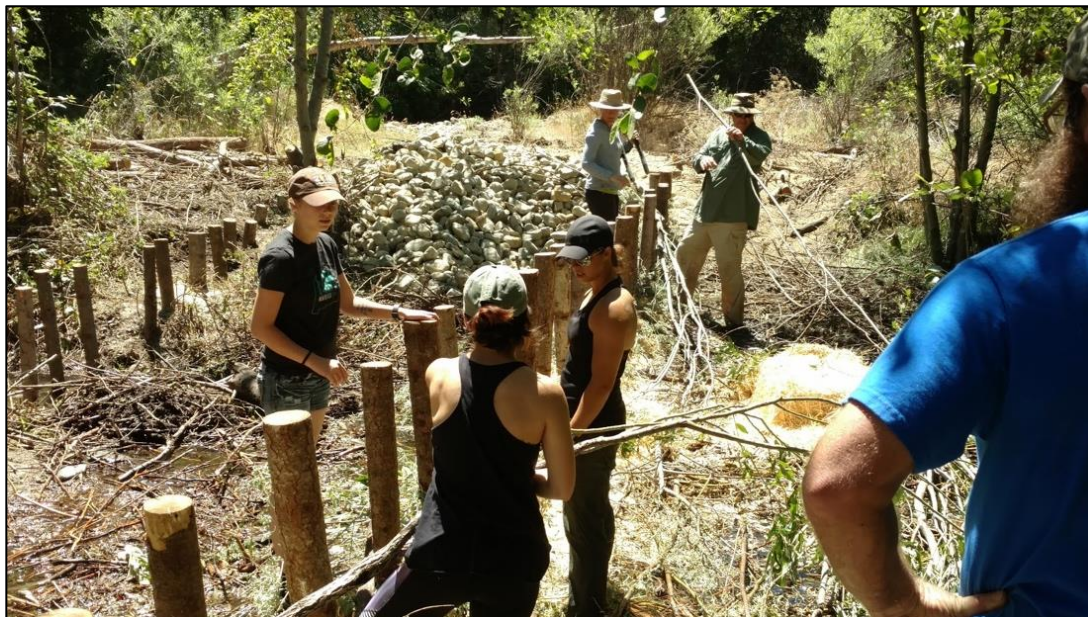
Figure 31. French Creek Beaver Dam Analogue 1 during construction. Photo taken 6-21-2017.

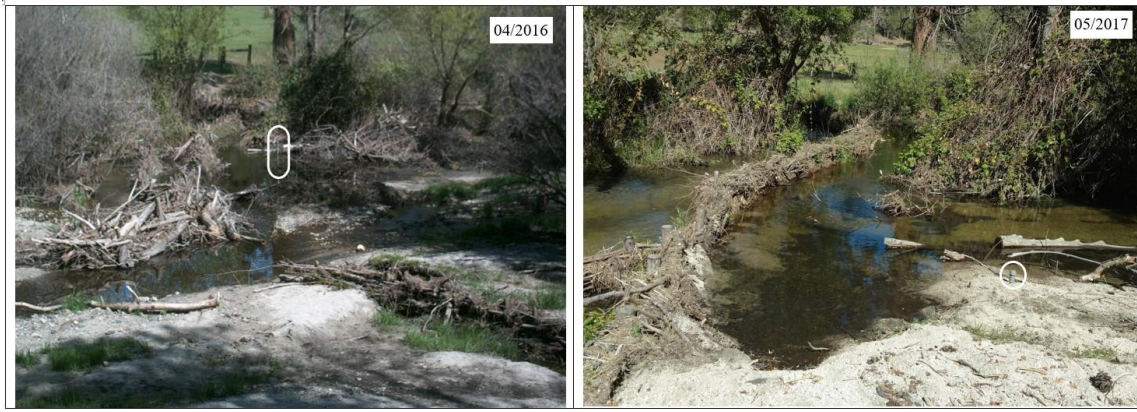
Figure 32. Miners Creek Feature Photos. Left photo: significant breach of BDA and draining of pond. Note location of ground water well with pipe extending approximately 5 feet above channel bed. Right photo: Significant aggradation behind repaired BDA one year later. Note location of same ground water well with pipe extending approximately one foot above channel bed.

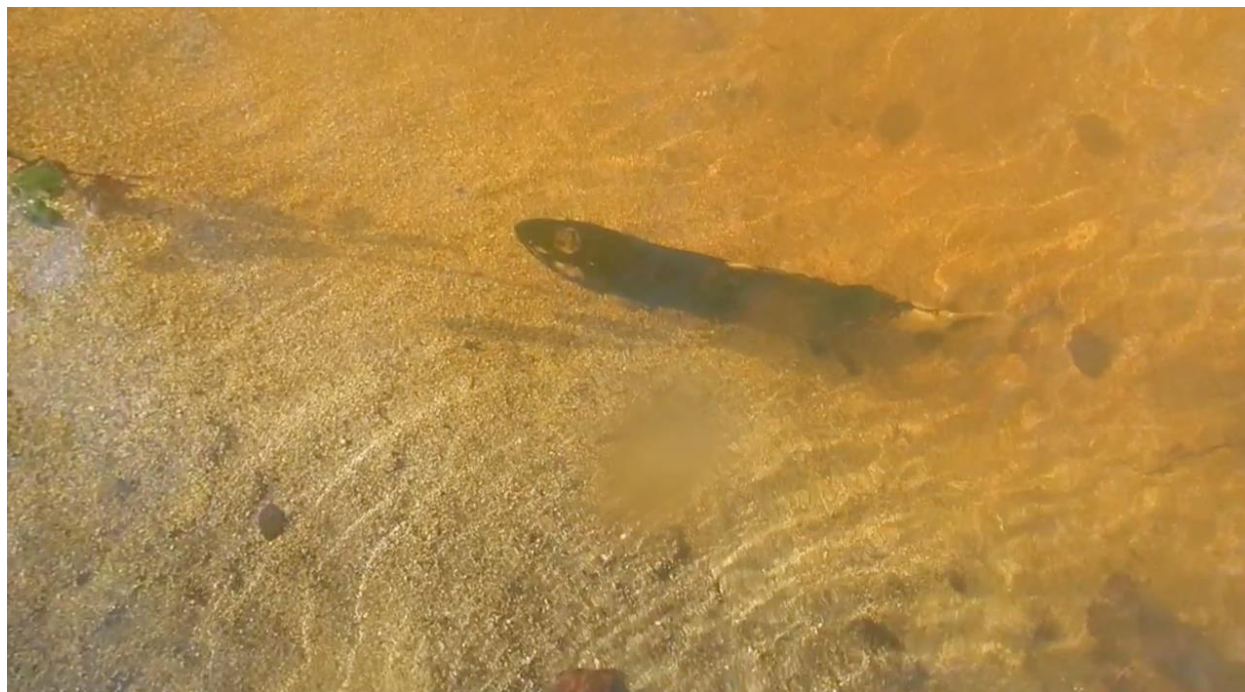
Figure 33. A still from a video of coho salmon spawning in a sand-bedded portion of Miners Creek.

sand (aka decomposed granite) may be reducing the availability of quality spawning habitat in the Scott River basin, and that this may be affecting the production of fry, particularly in years when there are frequent floods during the winter.
