Scott River Tributary Fish Passage and Refugia Enhancement

Introduction

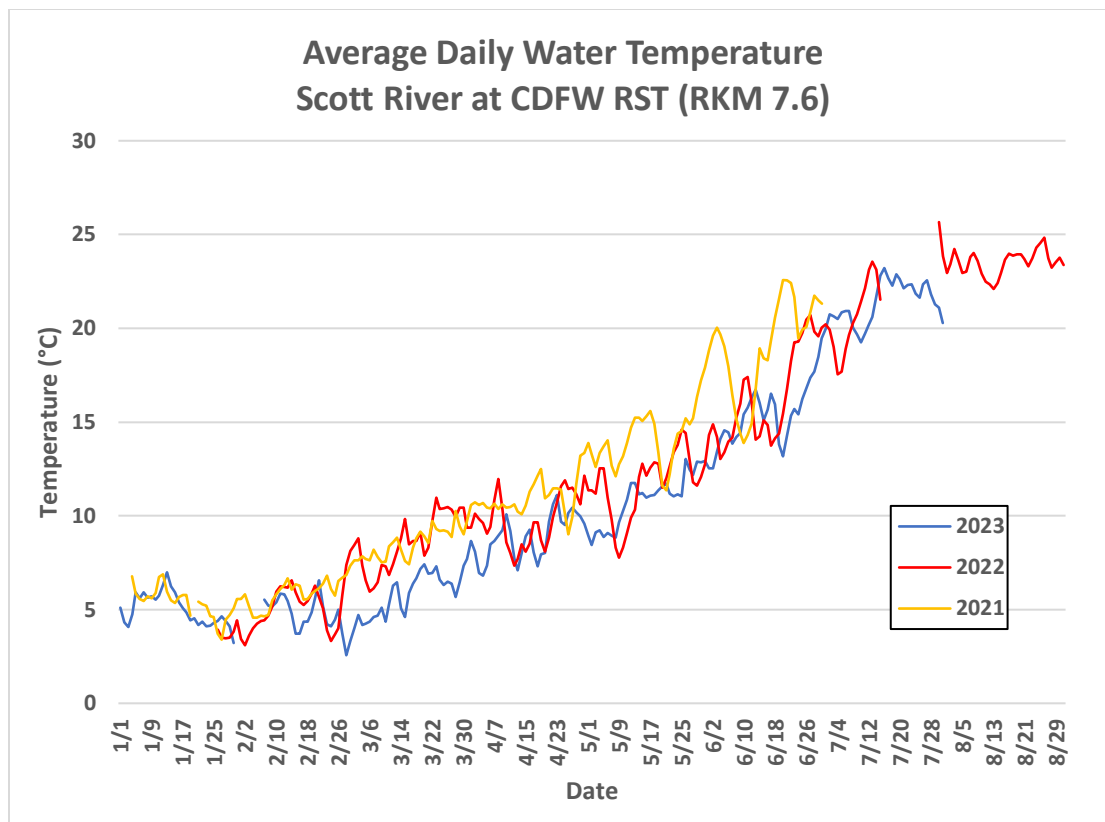
Figure 1. Average daily water temperature recorded on the Scott River at RKM 7.6. 2021-2023. Data provided by the California Department of Fish and Wildlife.

The Scott River watershed is home to three species of native salmonids: Endangered Species Act (ESA)-listed Coho Salmon (*Oncorhynchus kisutch*), Chinook Salmon (*Oncorhynchus tshawytscha*) and rainbow trout/steelhead (*Oncorhynchus mykiss*). During the summer, these fish are faced with harsh conditions as water temperatures in the mainstem Scott River frequently rise to levels that are unsuitable for rearing juveniles. Coho Salmon are particularly sensitive to high temperatures, having been shown to not persist in areas where the maximum weekly average temperature (MWAT) exceeds 16.7 °C (Welsh 2001). Temperature data from the California Department of Fish and Wildlife (CDFW) rotary screw trap site at Scott River kilometer (RKM) 7.6 shows that average daily water temperature has exceeded 20 °C for extended periods of time in each of the last three summers (Figure 1).

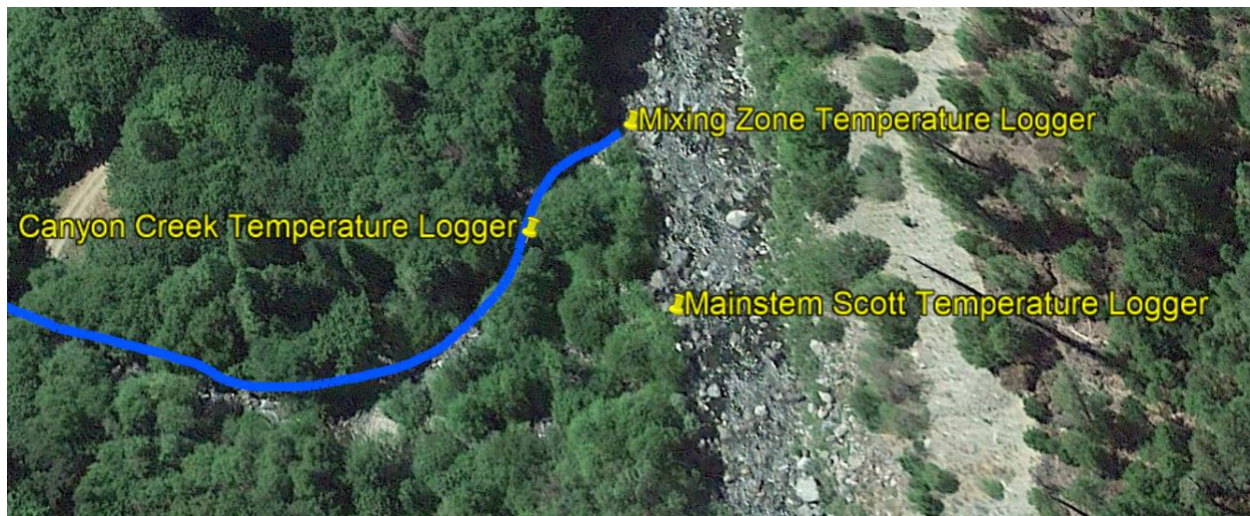
Map 2. Map of temperature logger locations around the Canyon Creek work area. The main channel of Canyon Creek is highlighted in blue.

On August 2, 2023 SRWC staff conducted a pre-treatment assessment of Canyon Creek and its mixing zone. HOBO temperature loggers were installed in the mainstem Scott River upstream of Canyon Creek, in the mixing zone, and in Canyon Creek approximately 100 feet upstream of the mouth (Map 2).

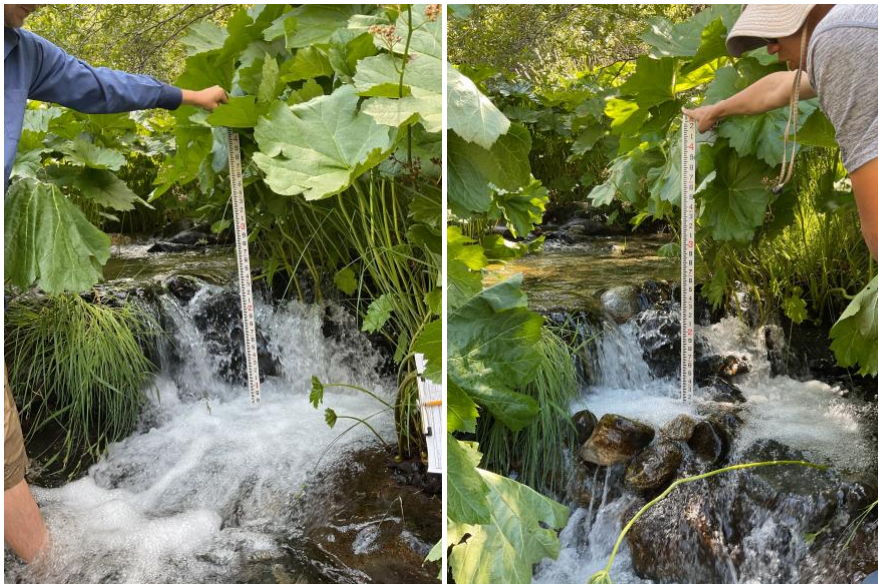
Photos 1 & 2. The mouth of Canyon Creek before (left) and after (right) treatment. August 2, 2023.

Staff conducted work at two barriers near the mouth of Canyon Creek to facilitate upstream passage by salmonids. Using rocks from the stream, a series of step pools were created below barriers and concentrated flow paths were dispersed to reduce resistance. Prior to treatment, the maximum jump height (distance from water surface below barrier to water surface above barrier) at the main barrier was 1.7 feet. The maximum depth in the pool immediately downstream of the barrier was 0.75 feet. Following treatment, the maximum jump height was 1.0 feet, and the maximum pool depth was 1.2 feet. Staff snorkeled the mixing zone and the first 400 feet of Canyon Creek, identifying and counting all salmonids observed. During the post-treatment survey, greater numbers of Coho Salmon and *O. mykiss* were observed than during the pre-treatment survey (Photo 3). However, fewer Chinook Salmon were observed during the post-treatment survey (Table 1).

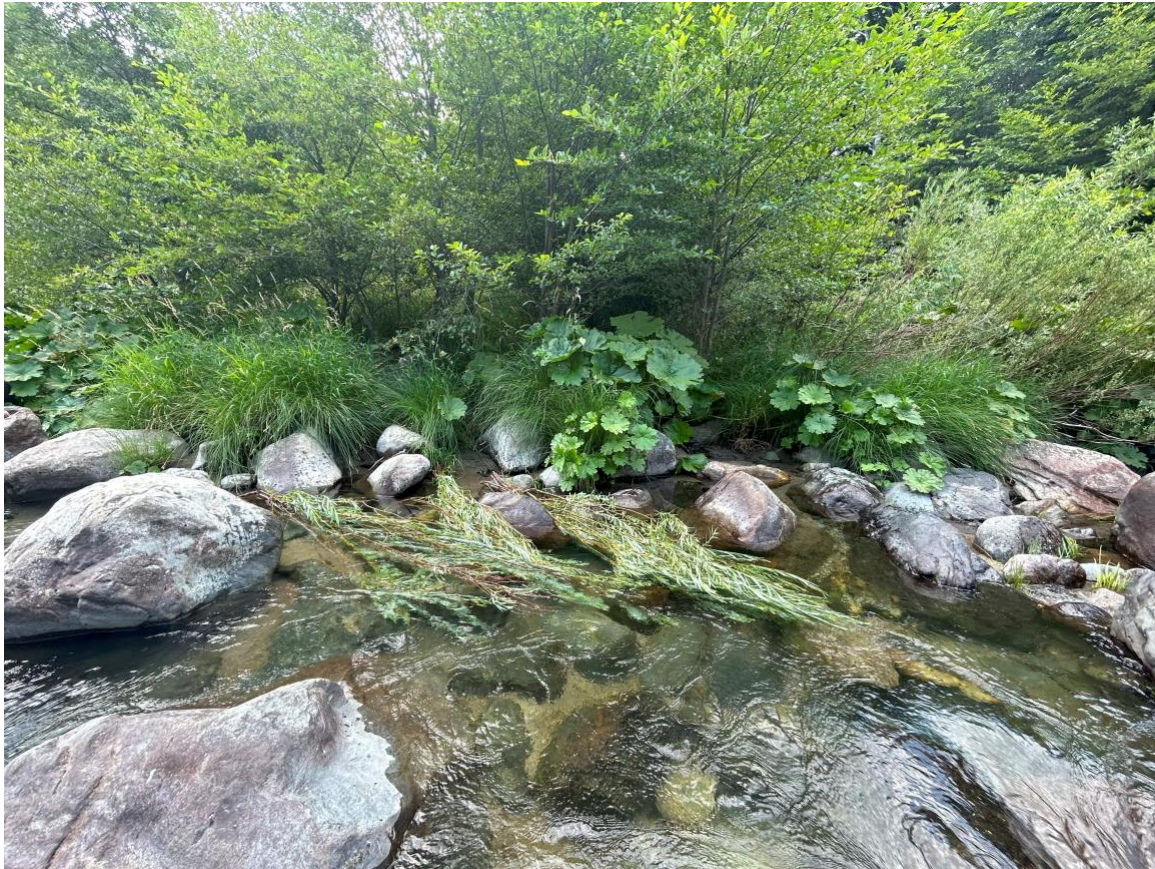
Photo 4. View of brush bundles added to Canyon Creek mixing zone. August 2, 2023.

Staff created “brush bundles” by cutting willow branches and tying them together with twine. These bundles were then placed in refugial areas near the mouth of Canyon Creek to provide juvenile salmonids cover, in which they can hide from predators. In total, eight brush bundles were placed in the Canyon Creek area, adding 160 ft² of habitat. During the post-treatment assessment on October 6th, juvenile salmonids were observed utilizing the new habitat created by the brush bundles (Picture 4-5).

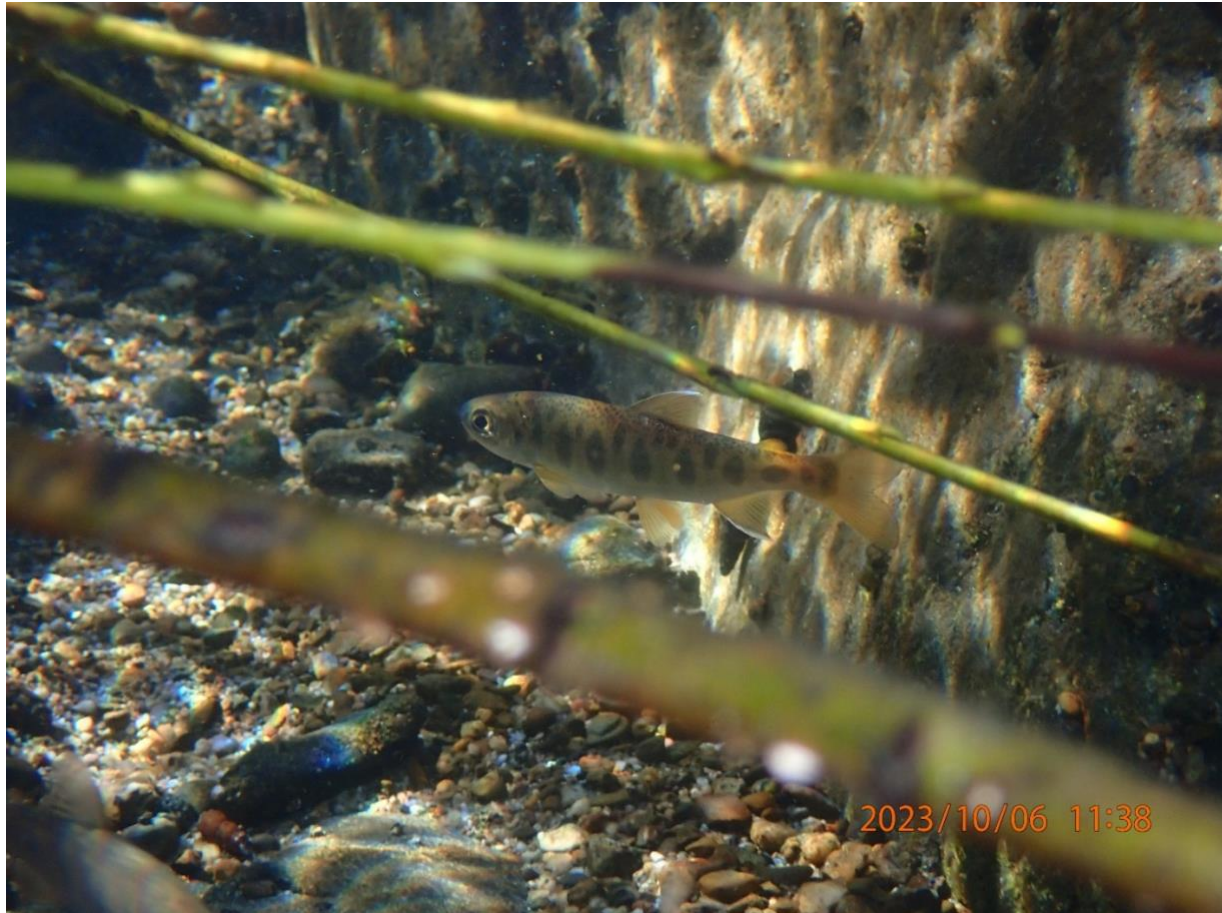
Photo 5. Juvenile Coho Salmon among willow branches added to Canyon Creek mixing zone. October 6, 2023.

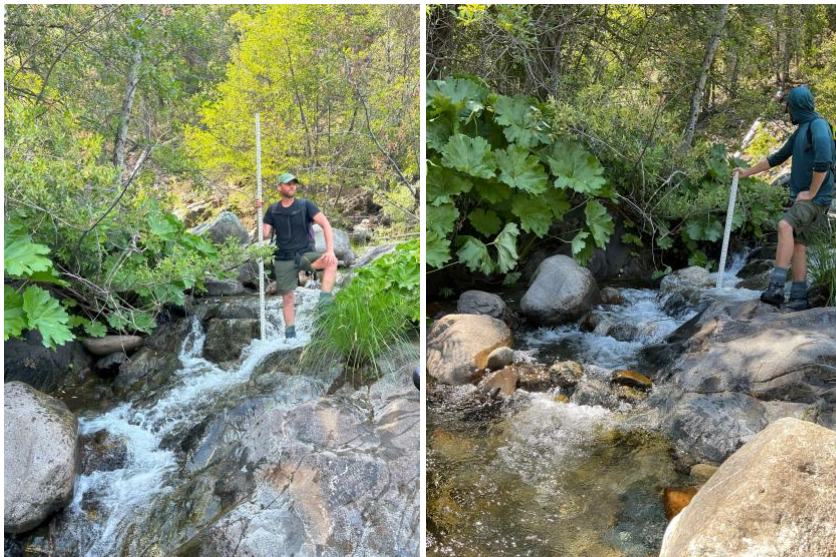
Photos 6 & 7. The mouth of Kelsey Creek before (left) and after (right) treatment. August 3, 2023.

Staff conducted work at four barriers near the mouth of Kelsey Creek to facilitate upstream passage by salmonids. Like at Canyon Creek, rocks were rearranged to create step pools and decrease velocities at crucial areas. Prior to treatment, the maximum jump height at the main barrier was 2.0 feet. The maximum depth in the pool immediately downstream of the barrier was 0.5 feet. Following treatment, the maximum jump height was 1.3 feet and the maximum pool depth was 0.8 feet (Photos 6 & 7). Staff snorkeled the mixing zone and the first 400 feet of Kelsey Creek, identifying and counting all salmonids observed. On both survey dates, Chinook and Coho Salmon were only observed in the mixing zone. Similar numbers of these species were observed at each survey event. Fewer *O. mykiss* were observed during the post-treatment assessment than during the pre-treatment assessment (Table 2).

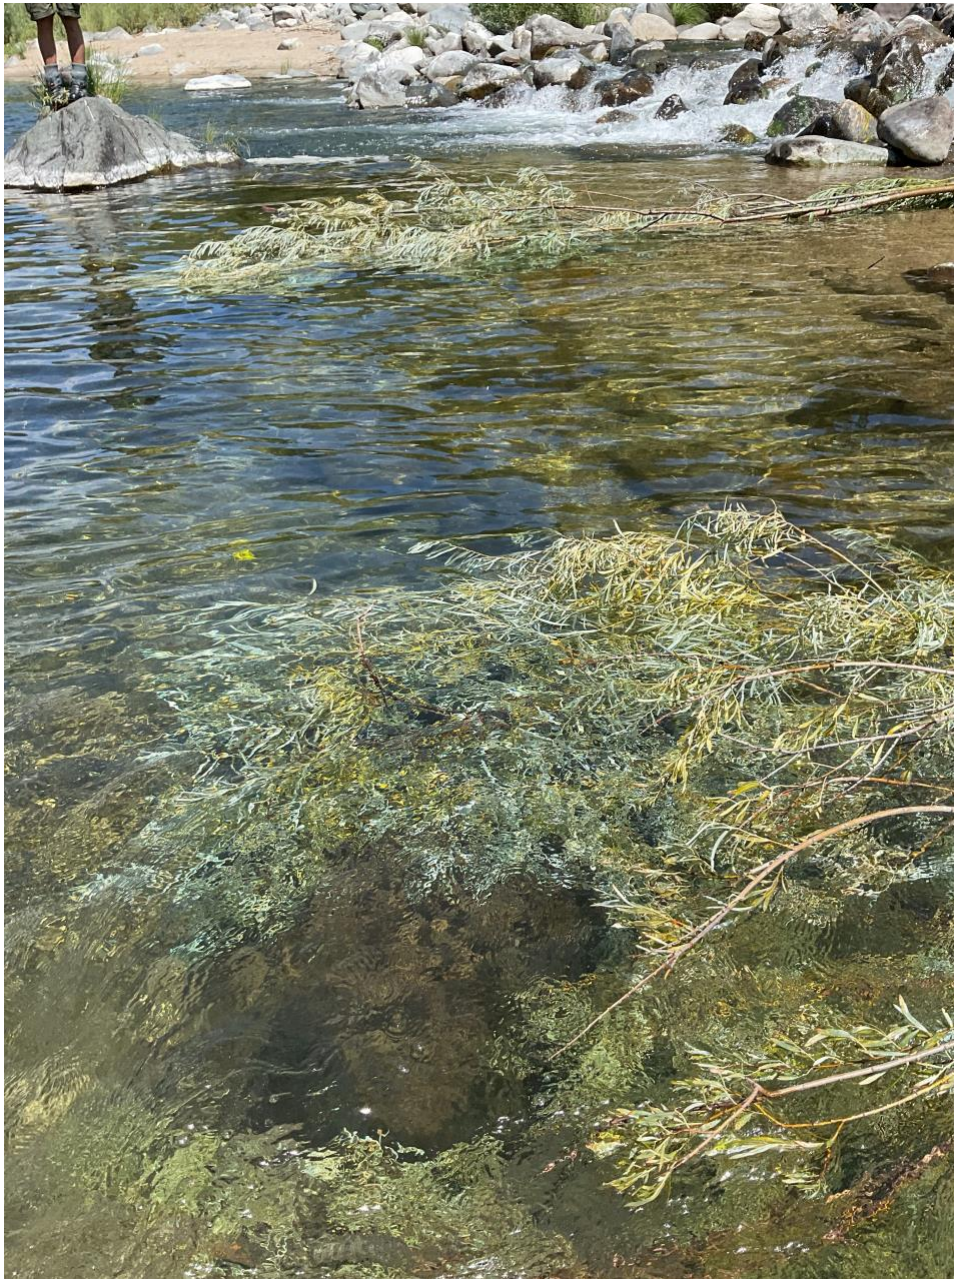
Photo 8. Brush bundles added to the Kelsey/Scott mixing zone. August 3, 2023.

Eight brush bundles were placed in the Kelsey Creek mixing zone, adding 240 ft² of cover to the rearing area. During the post-treatment assessment on October 6th, juvenile salmonids were observed utilizing the new habitat created by the brush bundles (Photos 8 & 9).

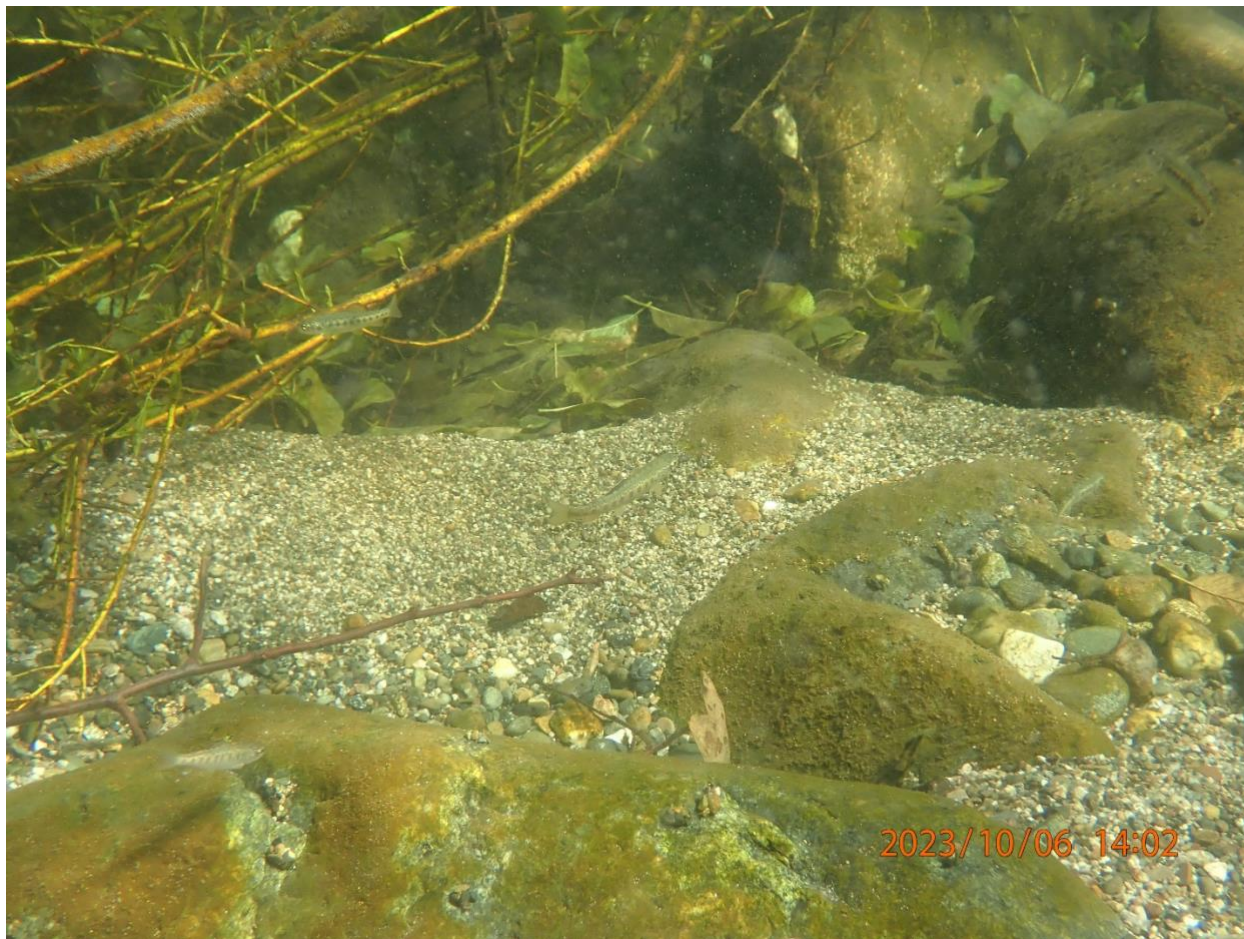
Photo 9. Juvenile rainbow trout/steelhead utilizing brush bundle habitat in the Kelsey/Scott mixing zone. October 6, 2023.
