Scott River Watershed Trip Report
A Field Review of Selected Sites of the Eastside Watershed
April 12-15, 2004
Etna, CA

Final Report Date: September 29, 2004

**Scott River Watershed Trip Report
National Riparian Service Team
April 12-15, 2004**

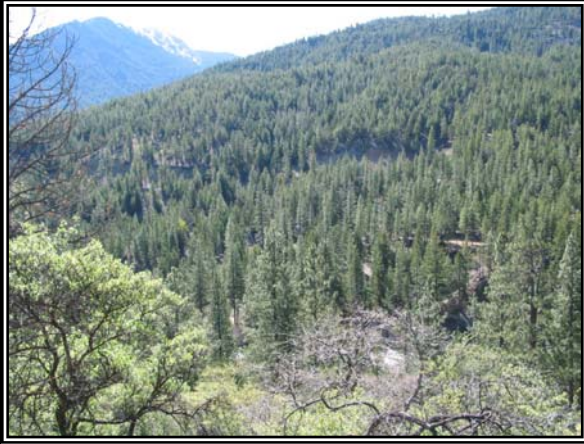
Photo 1. SF Scott River, scars of hydraulic mining are still visible.

The upper watershed of the Scott River in the vicinity of the South Fork is well vegetated with conifers. The South Fork and its tributaries have been impacted by gold mining, and a number of streambanks the team viewed in passing, are composed of unvegetated cobble and fines that have minimal stability. The stream's channels are heavily loaded with coarse and fine sediment. Mid-channel bars are signatures of sediment overloading. The scars of hydraulic mining are still visible (Photo 1). It is probable that some of the waste material from these operations may still be in the channel where it is mobilized during high flow events. Numerous roads contribute to the sediment supply, and efforts are being made by natural resource agencies and land managers to stabilize or decommission them.

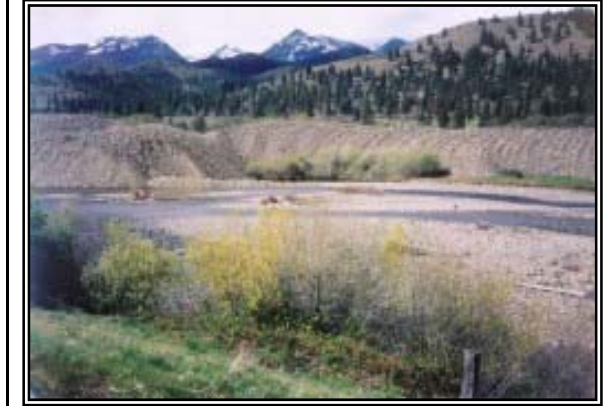
In the mainstem Scott River below the confluence of South Fork and East Fork, a massive gold dredge tailings area occupies the former floodplain of the river (Photo 2). The Scott River is mostly confined to the eastern side of the valley by these tailings. It is probable that the loss of the original floodplain that once dissipated flood energy results in an energy transference to the open floodplain immediately downstream. The stream in this reach is braided and very little riparian vegetation was observed along the banks. This condition is an indication of instability. Braiding is also influenced by Young's Dam which traps sediment above it.

Photo 2. Gold dredge tailings area.

The dredge tailings in upper Scott Valley crowd the river against the eastern flank of the valley. These tailings also obstruct the river from spreading onto the original floodplain. The restrictions of the historic floodplain, coupled with high levels of bedload material

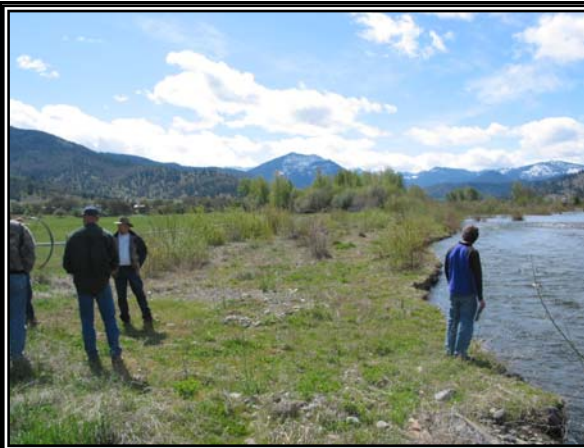
Photo 3. Area that eroded, was filled back in, and planted.

Two riparian planting projects were visited. On-site discussions included topics such as native vs exotic stocks, bare root vs cuttings, lethal water table levels in August, irrigation systems, drilling and large (>4" dbh) pole plantings, site potential, rodents, large mammals, and insects. At the site near the fish screen, the floods of 1997 washed away some streambank and floodplain above the screen. After the flood, the erosion area was filled back in and planted with young shrubs and trees (Photo 3). Just below the fish screen, other young shrubs and trees were planted on a riprapped streambank which acts much like a dryer terrace since it is several feet above the low water level (Photo 4). The second planting site had a sandy streambank that is eroding with each high flow event (Photo 5). Plantings across the frequent floodplain died when drip irrigation was turned off. Core drilling to the depth of late summer water tables for deep pole plantings of willow or cottonwood was suggested. Established plantings of rhizomatous willow species such as coyote (*Salix exigua*) and streambank (*Salix melanopsis*) could spread by rhizomes into dryer sites. This would require maintenance along ditch banks, but would have the effect of widening the riparian area faster than waiting for natural regeneration from seed. Revegetation project monitoring is documented in CalForest Nursery 1998 (Feb) and 1998 (Mar). Across the river on the west bank, cottonwood were planted in baffles and from our far away vantage point, appeared to be doing well.

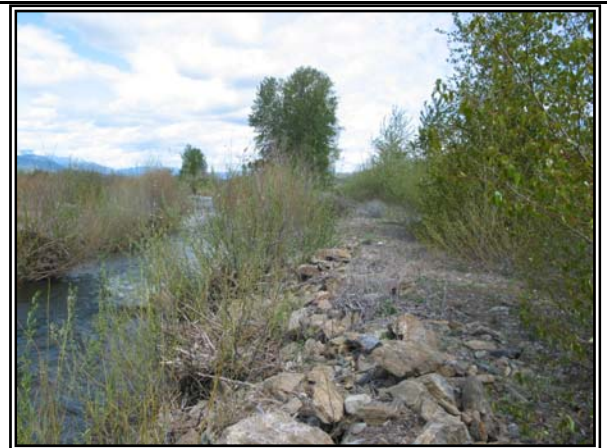
Photo 4. Plantings on high streambank.

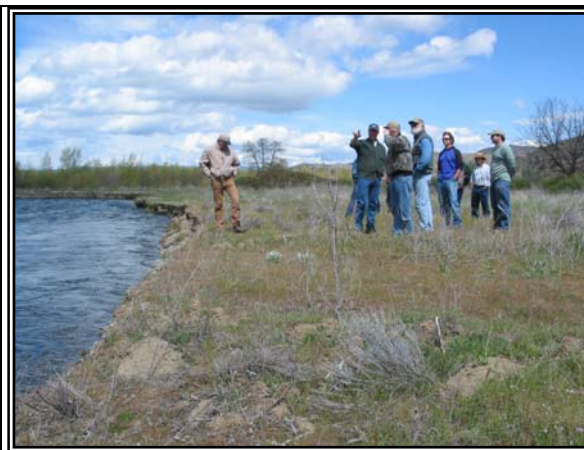
Photo 5. Eroding sandy streambank in need of riparian-wetland vegetation's stabilizing influence.

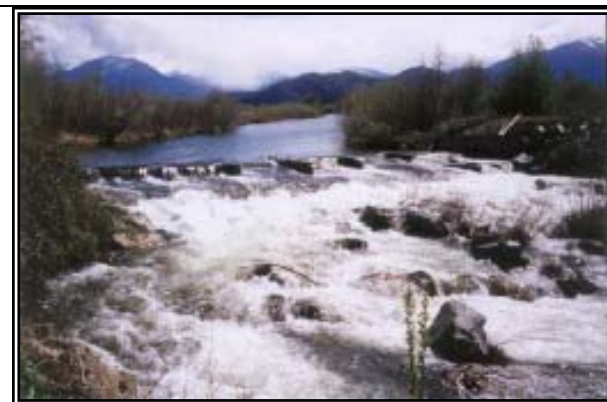
The next site visit was Young's Dam irrigation diversion. River straightening in portions of Scott River below Young's Dam may have caused downcutting and lowering of the channel bed. There is about an eight feet difference in the bed level above and below Young's Dam (Photo 6). The lowering of the river bed level below Young's Dam is believed to be responsible for a drop in the valley's ground water storage capacity. Once the high spring river flows drop, the water in the valley rapidly drains into the lower channel and is lost. Historically the higher bed level prevented the rapid drainage of the soils in the valley.

Photo 6. Young's Dam.

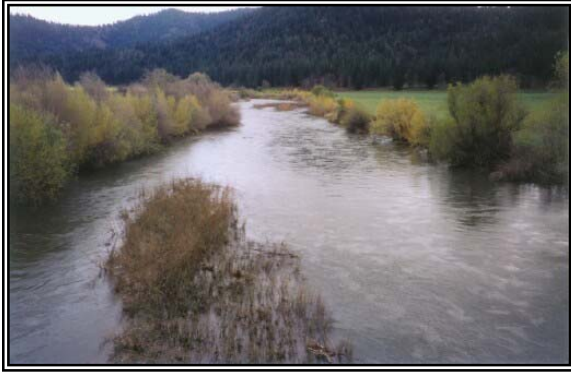
For a few miles above the entrance to the outflow canyon from Scott River valley, the Scott River is not entrenched, and can access its floodplain. The riparian zone is very narrow and has numerous planted golden willows lining the banks (Photo 7).

Photo 7. Scott River above the entrance to the outflow canyon from Scott Valley. The riparian zone is very narrow and has numerous planted golden willow lining the banks.

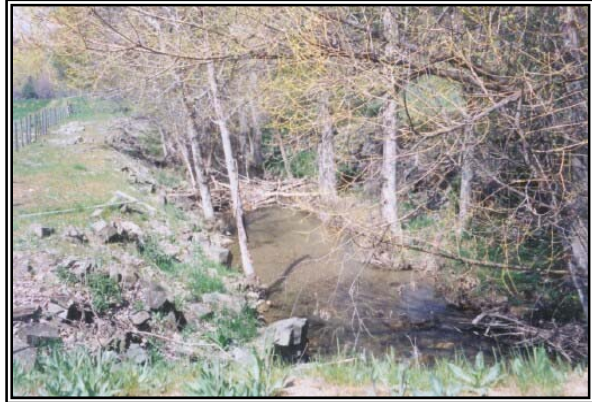
Moffett Creek carries a high bedload and the channel has been extensively modified by land management practices. Some reaches of the stream have been channelized, and on others the riparian plant community has been nearly eliminated. Much of the stream along agricultural lands above Highway 3 has been channelized and rip-rapped. Some reaches of the stream in the upstream agricultural areas are bordered by willows and alders. Some of the tree willows were planted when the rip-rap was placed, and are now mature (Photo 8). The tributaries of Moffett Creek are used for grazing and timber production. Over time, grazing impacts have reduced the riparian plant community or caused it to be replaced by annual non-native grasses.

Photo 8. Portions of Moffett Creek has been channelized, riprapped. Willows planted during construction are now mature.

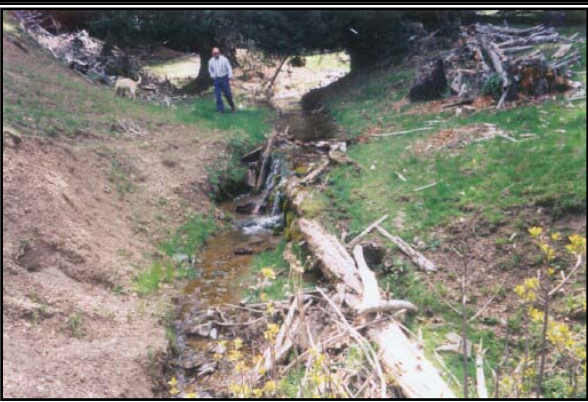
Past timber harvest and road construction has modified the mainstem and tributaries of Moffett Creek. Trees grow large enough to act as hydrologic modifiers based on the size of Moffett Creek and its tributaries. LWM was once an important component of the stream system by dissipating energy and providing sediment storage. Most of the wood has been lost over the last 150 years of human activities, and has contributed to the channel head-cutting and downcutting. A small number of logs and small wood jams were observed in portions of the channel where they were trapping significant quantities of sediment (Photo 9).

Photo 9. An example of one of the few logs and small wood jams observed which are trapping sediment.

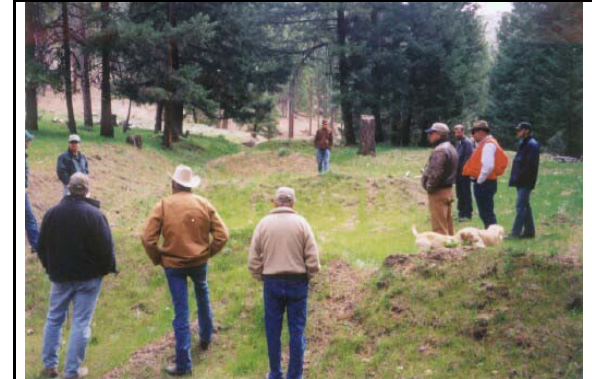
Photo 10. Group viewing road closure work near Moffett Creek.

Local land managers have been working to improve road locations by establishing them away from streams. They are also planning to change some of the grazing practices on some streams to improve riparian vegetation. The team visited a road relocation and decommissioning site in upper Moffett Creek. The decommissioned road was ripped and cells created to capture and infiltrate water (Photo 10). The new road was located and constructed to prevent erosion and to benefit stream/riparian recovery (Photo 11). Improved grazing management will be needed to realize riparian recovery in the reach with the decommissioned road (Photo 12).

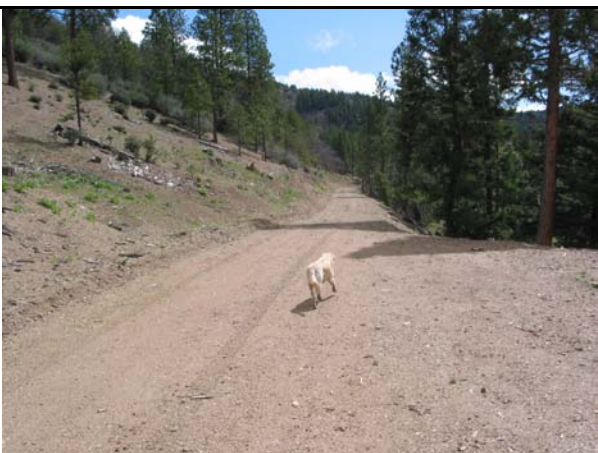
Photo 11. New road located and constructed to prevent erosion and to benefit stream/riparian recovery.

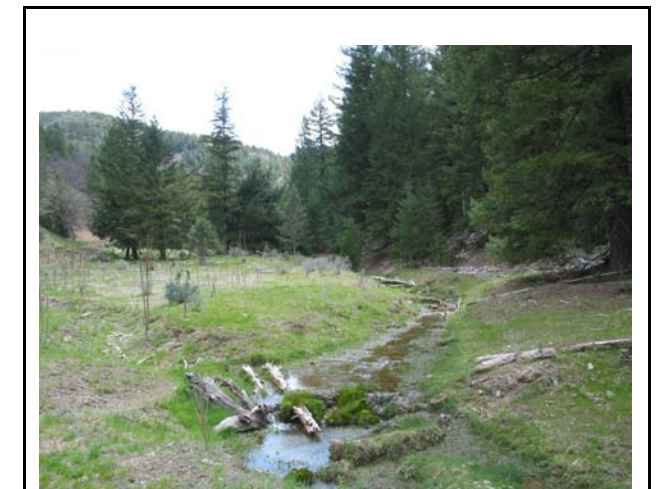
Photo 12. Improved grazing management needed for improvement of riparian-wetland vegetation and physical function on Moffett Creek.

Grazing management in riparian areas needs to focus on recovery of riparian vegetation. Grazing impacts include use of the plants as well as mechanical disturbance (hoof damage). Techniques are currently available that will allow livestock grazing to continue while putting riparian vegetation in a recovery mode. Use creativity and explore all options to determine appropriate grazing management systems tailored to the conditions, problems, potential, objectives and livestock management considerations on a site-specific basis.
