A GLIMPSE THROUGH TIME: FROM A RIVER TO ROCKS TO RECOVERY

Erich Yokel
Scott River Watershed Council

- Scott River Tailings dominate the landscape of the Southern Scott Valley
- Approximately 4.2 miles of the Scott River Impacted by Legacy Dredge Tailings
- Scott River becomes disconnected through a portion of the Tailings Reach during every Water Year Type
- Approximately 23% of the watershed and 20% of the Coho distribution above the Tailings Reach

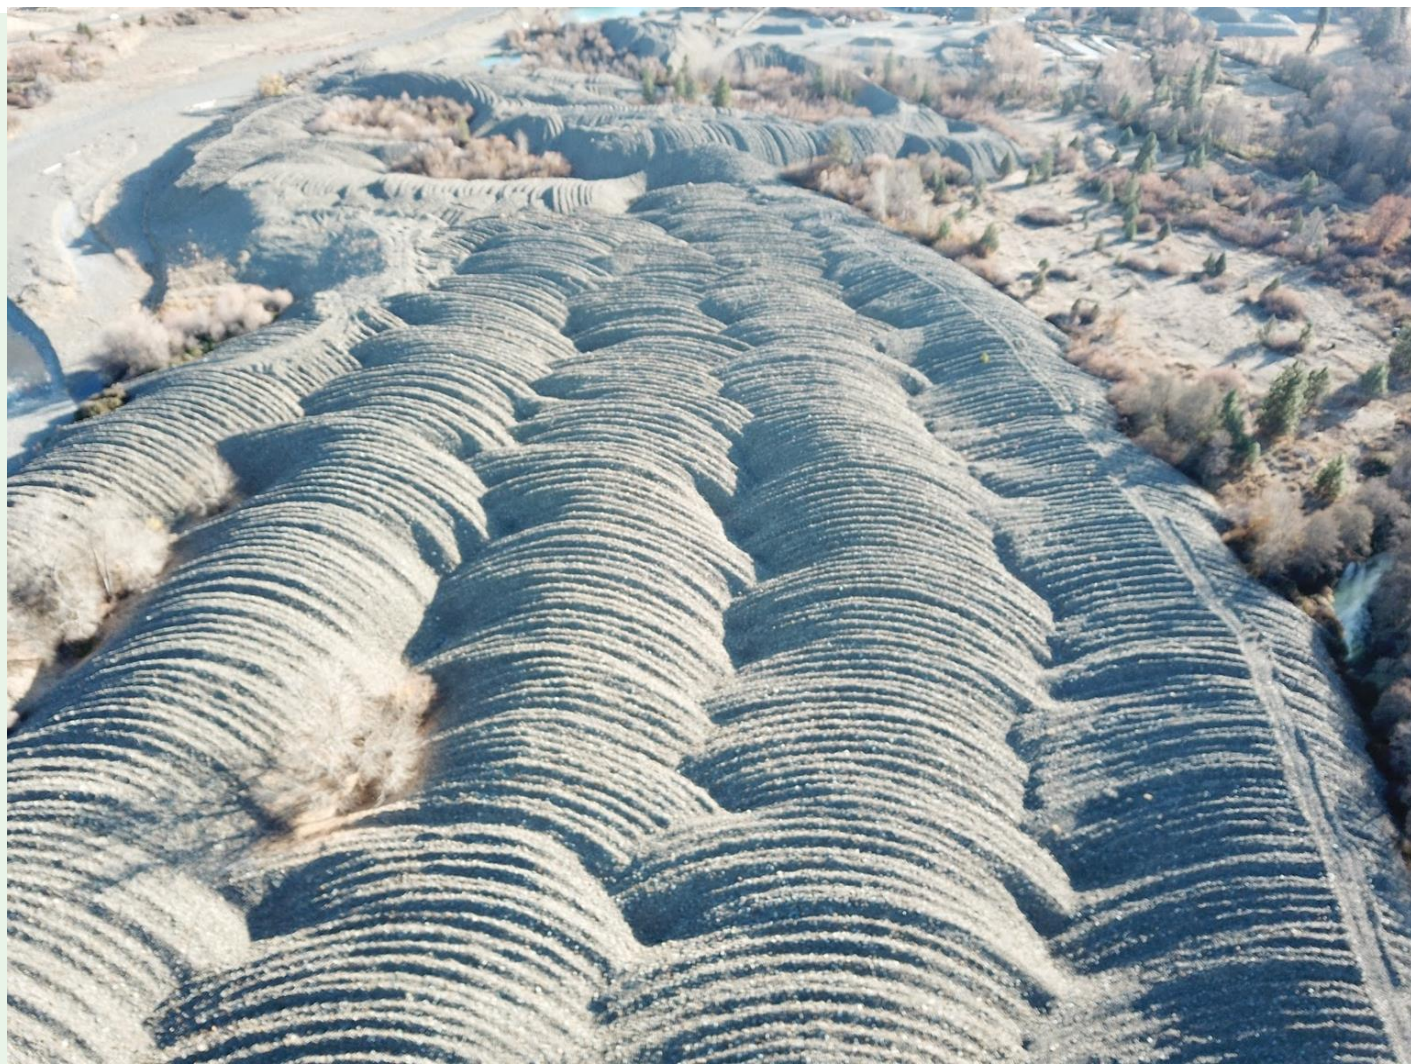
- | | | |

| 1 - BEDROCK | 5 - SLUICE | 9 - SLICKINGS |
| 2 - PAY-DIRT | 6 - TAILINGS STACKER | 10 - SLURRY |
| 3 - OVERBURDEN | 7 - FLOATING BARGE | 11 - STACKER TAILINGS |
| 4 - TROMMEL | 8 - DREDGE POND | 12 - BUCKET LINE |

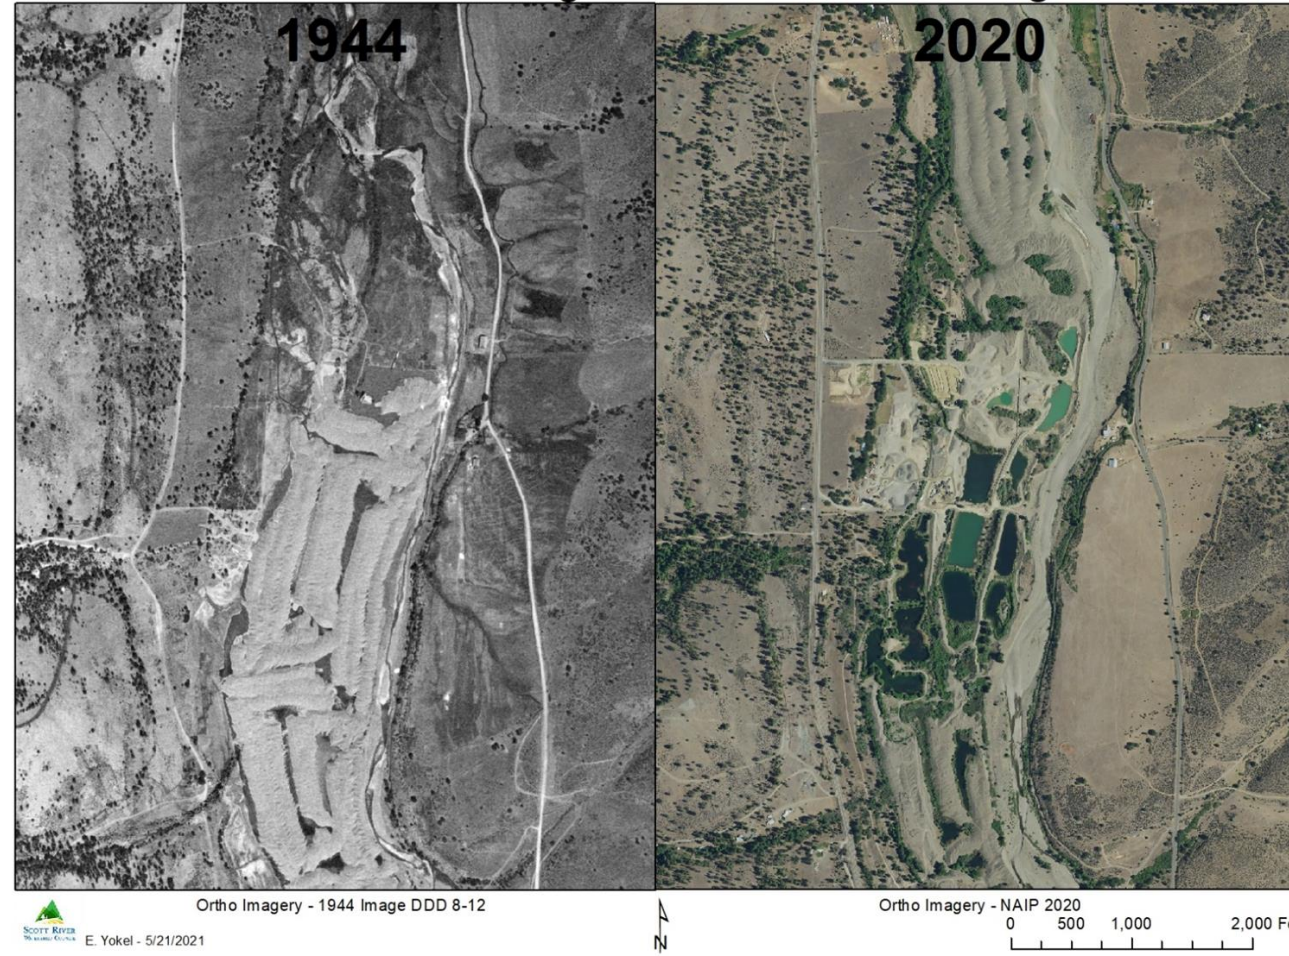
Scott River Tailings - Historic Ortho Images

Georeference
Dredger Logs
&
Historic Aerial
Photos

- 1944
- 1955
- 1965
- 1974
- 1980
- 1994
- 1999
- 2005
- 2010
- 2012
- 2014
- 2016
- 2018
- 2020

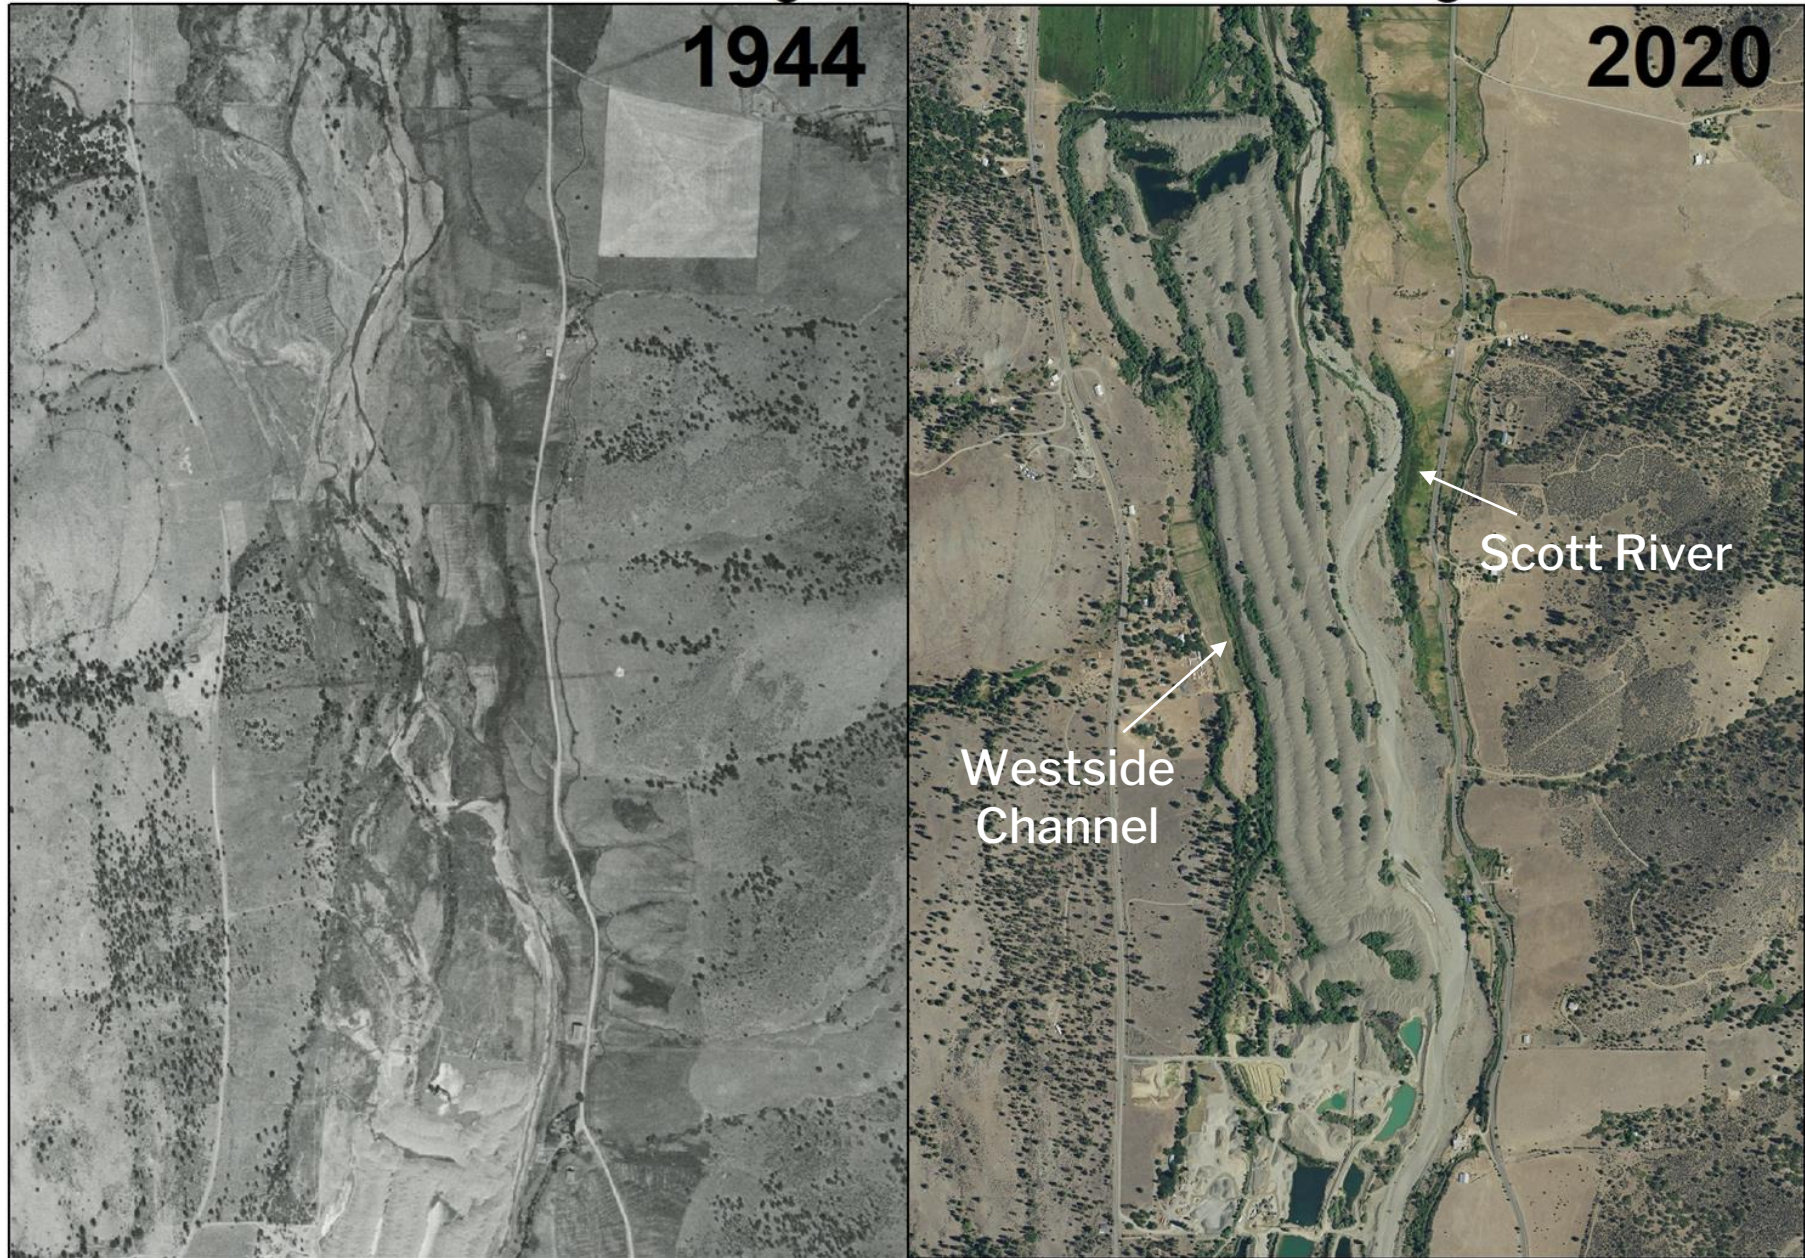
Scott River Tailings - Historic Ortho Images

Ortho Imagery - 1944 DDD 08-11

Ortho Imagery - NAIP 2020

Dredging Moved Channel from West to East side of Valley

Pre dredging - Scott River meandered through Valley
350 - 420 m wide

Post dredging - Scott River constrained by Tailing Piles on West and Bedrock on East
50 - 190 m wide

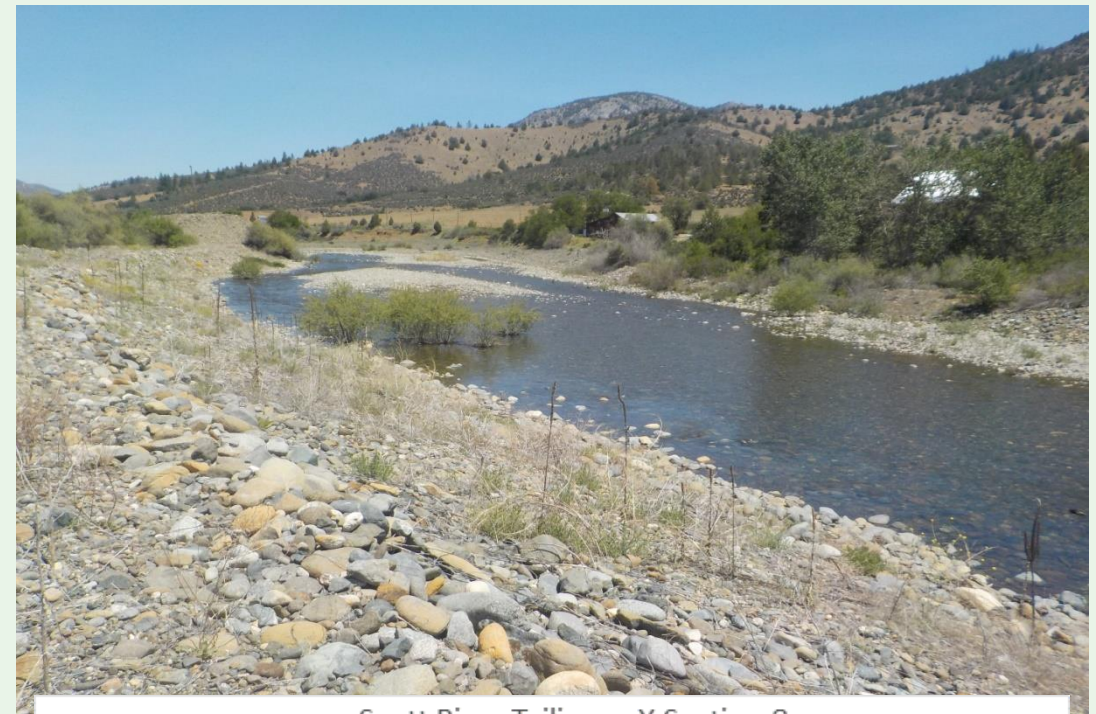
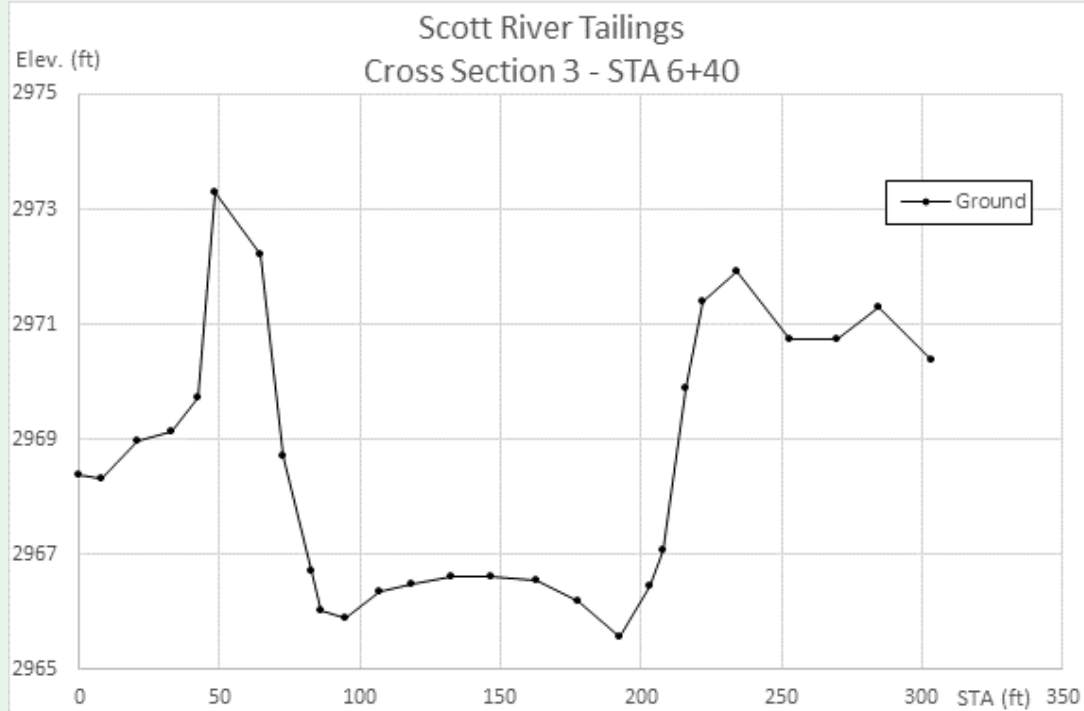
- Cross section of Constrained Channel in area of minimal channel migration
- Comparison of 2010 & 2018 DEMs and 2021 topographic survey documents channel alteration - February 2015 Flood

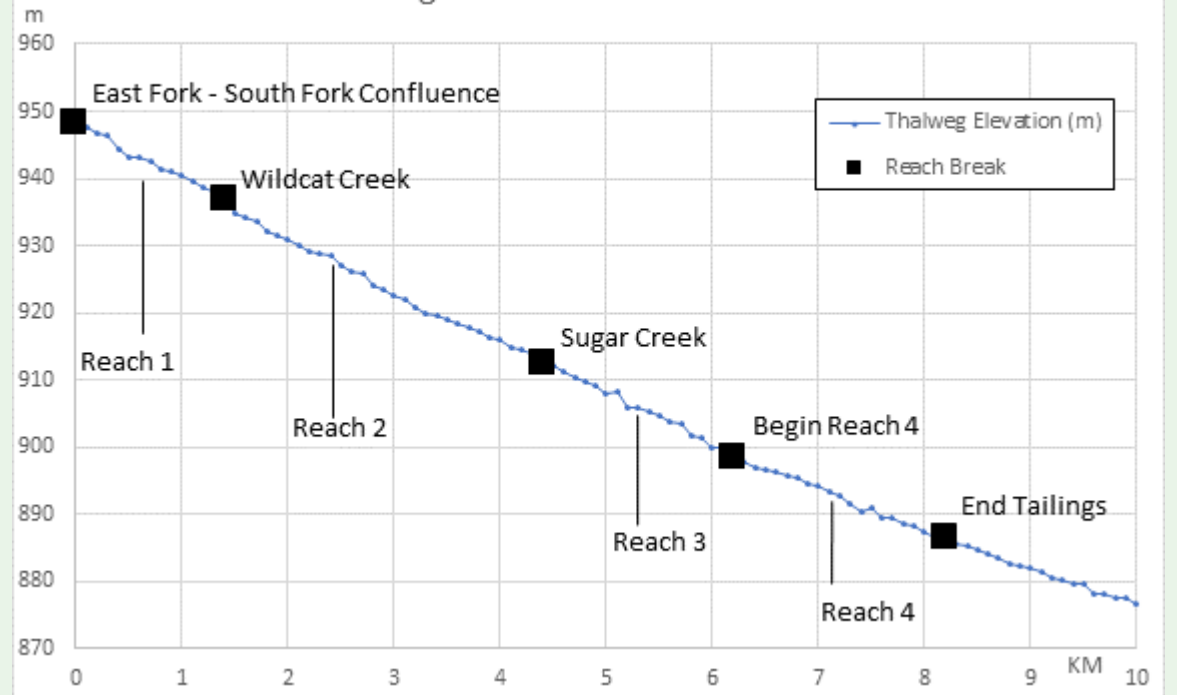
Scott River - Longitudinal Profile from 2010 Lidar DEM

RKM From	RKM To	Gradient	Sinuosity
Reach 1	92	90.6	0.8%	1.2
Reach 2	90.6	87.6	0.8%	1.1
Reach 3	87.6	85.8	0.8%	1.1
Reach 4	85.8	83.8	0.6%	1.2

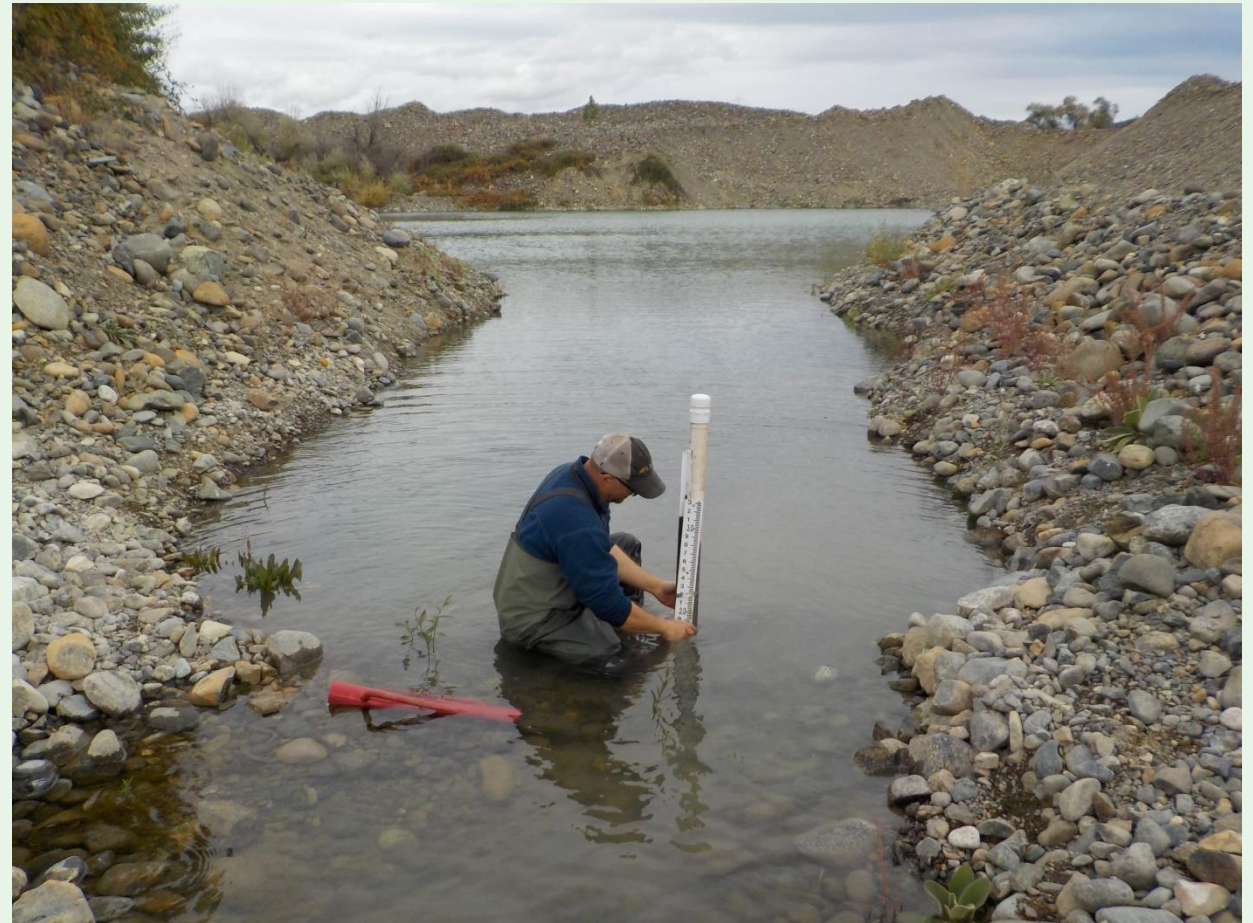
Existing Restoration and Design Projects and Environmental Monitoring

Existing Projects

- Sugar Creek BDAs
- 2014 - Present

- Long Pond existing conditions and Design 2017 - Present

- Scott River Tailings Oasis Restoration Project
- 2019 - Present

- Sugar Creek Floodplain Restoration Project
- 2020 - Present

- Scott River Tailings Restoration Planning & Design
- 2020 - Present

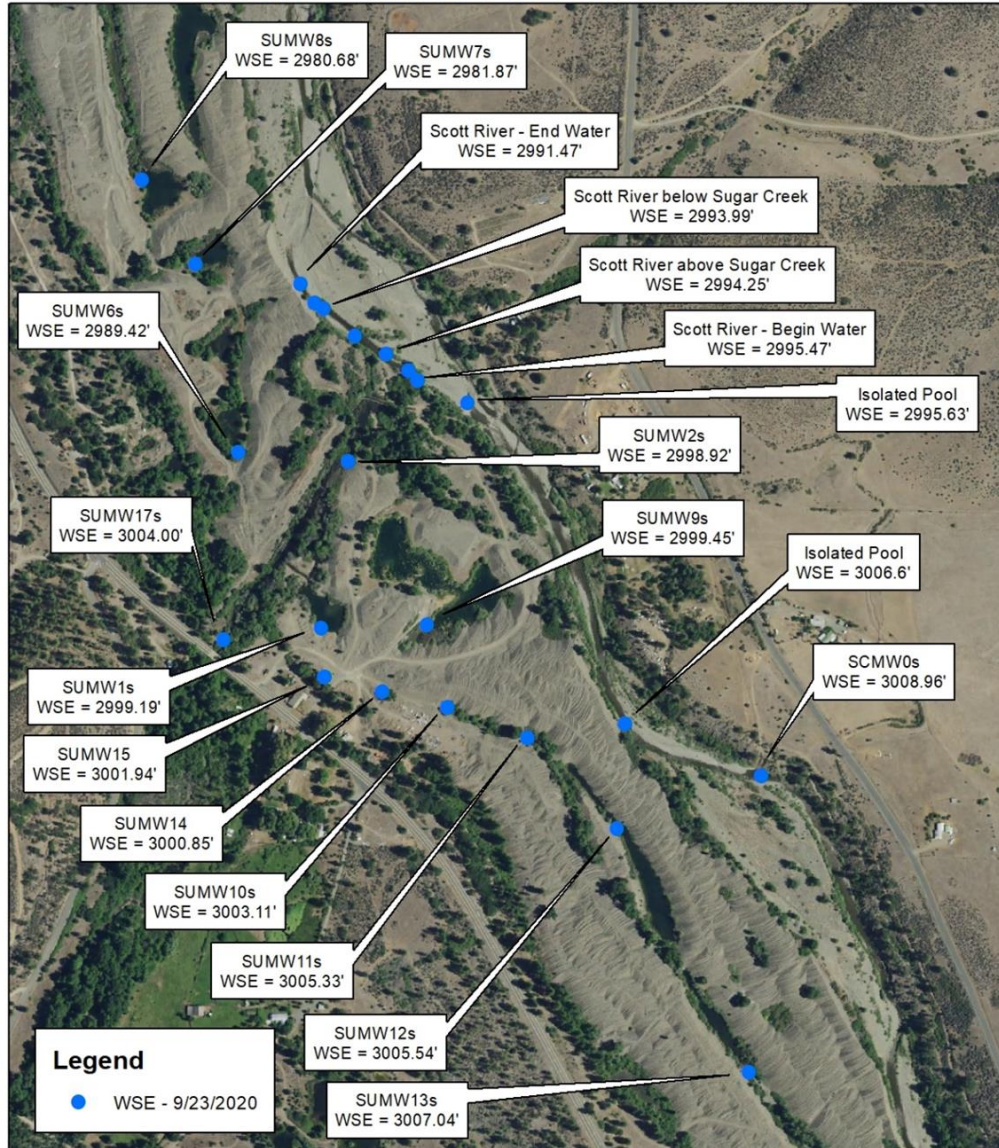
Scott River - Sugar Creek Tailings Reach Water Surface Elevation - 9/23/2020

Sugar BDA Maintenance Sealing generates an increase in BDA Pond WSE and the WSE in adjacent surface water and groundwater

Loss of surface water discharge and dewatering occurs in BDA Pond during drought years (2018, 2020 and 2021)

Periodic RTK surveys during summer base flow performed to document WSE and stream connectivity performed in the Scott River - Sugar Creek - Long Pond Project Area

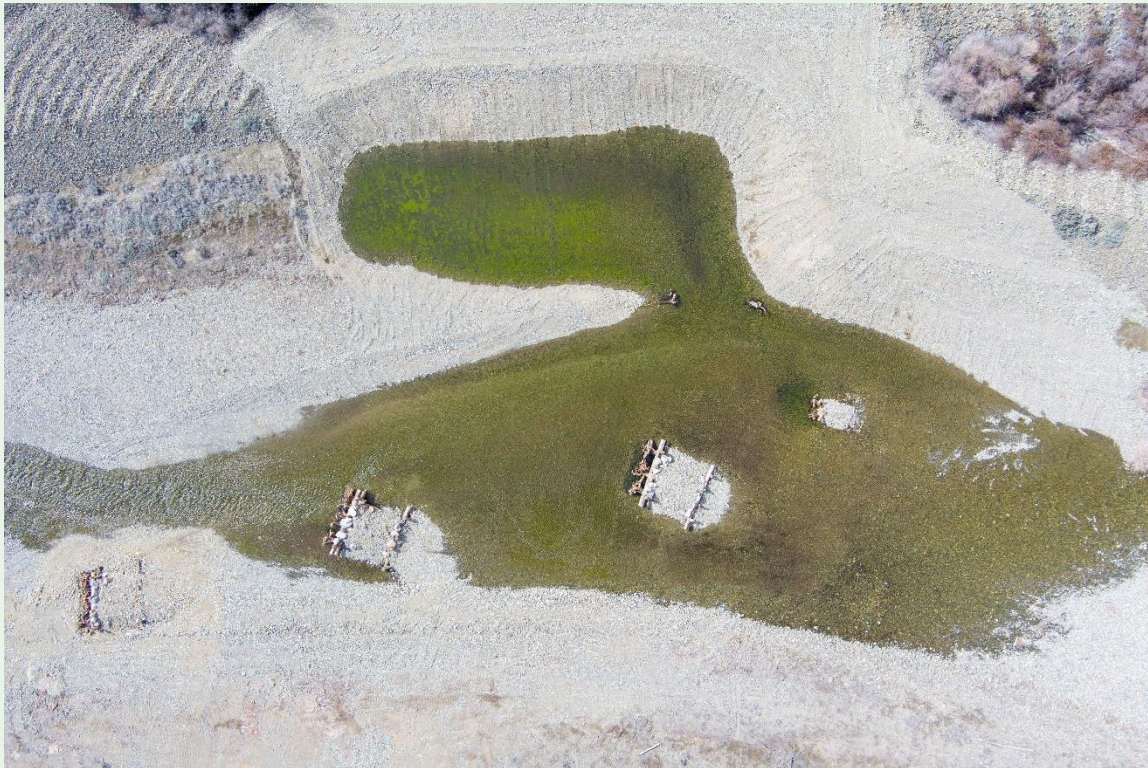
Scott River Oasis Restoration Project Water Surface Elevation (WSE) - April 20, 2021

Installed Scott Tailings “Oasis” Restoration project in 2020

Significant flow losses were observed at the alcove during the reconnection of the channel in 2020 – 2021

Survey of water surface elevation in Scott River and adjacent tailings indicate gradient towards the Northwest

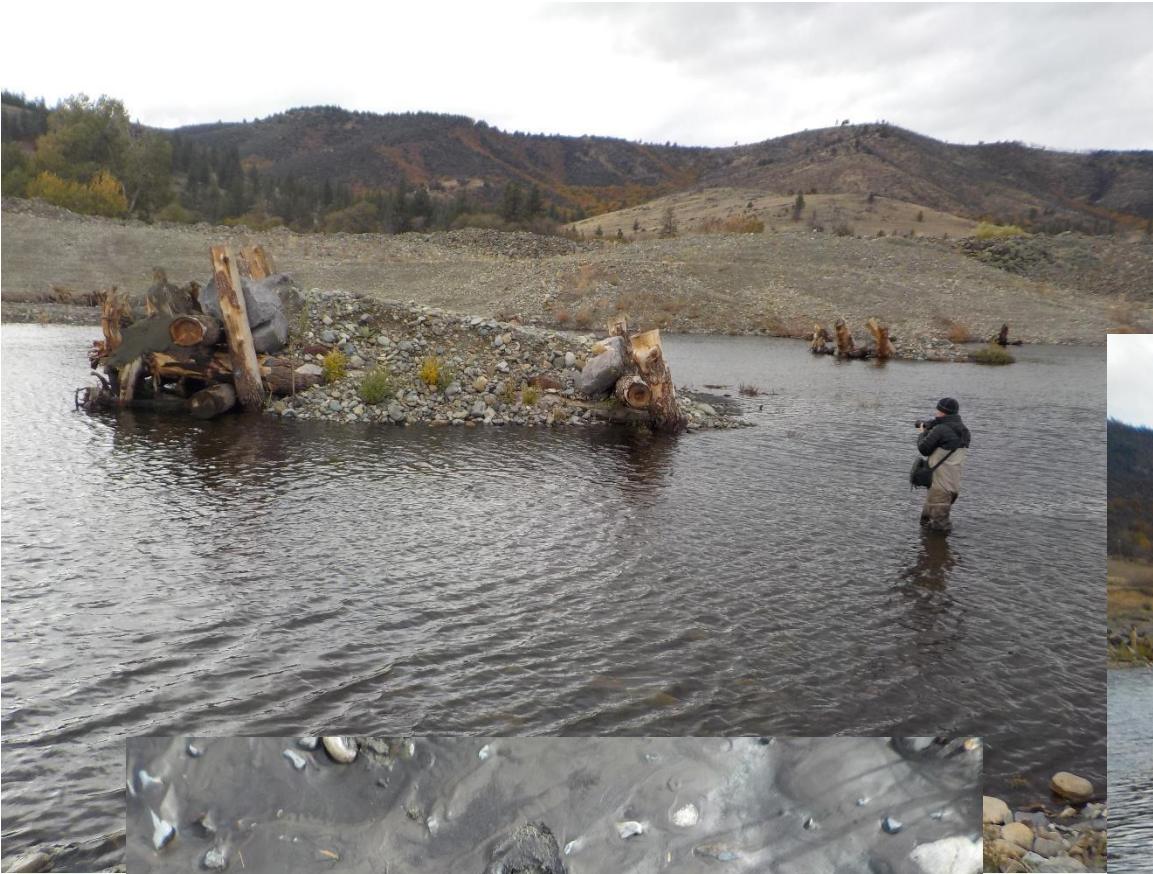
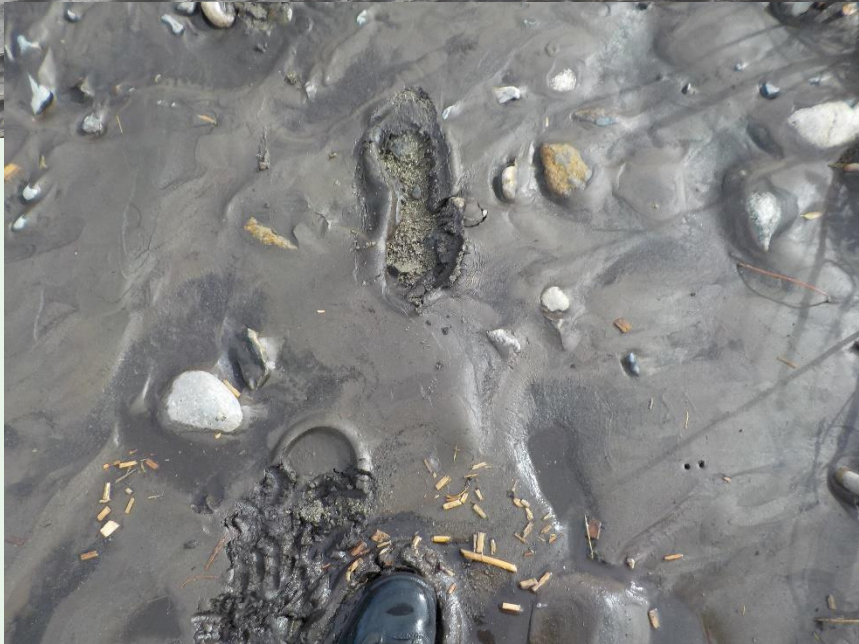
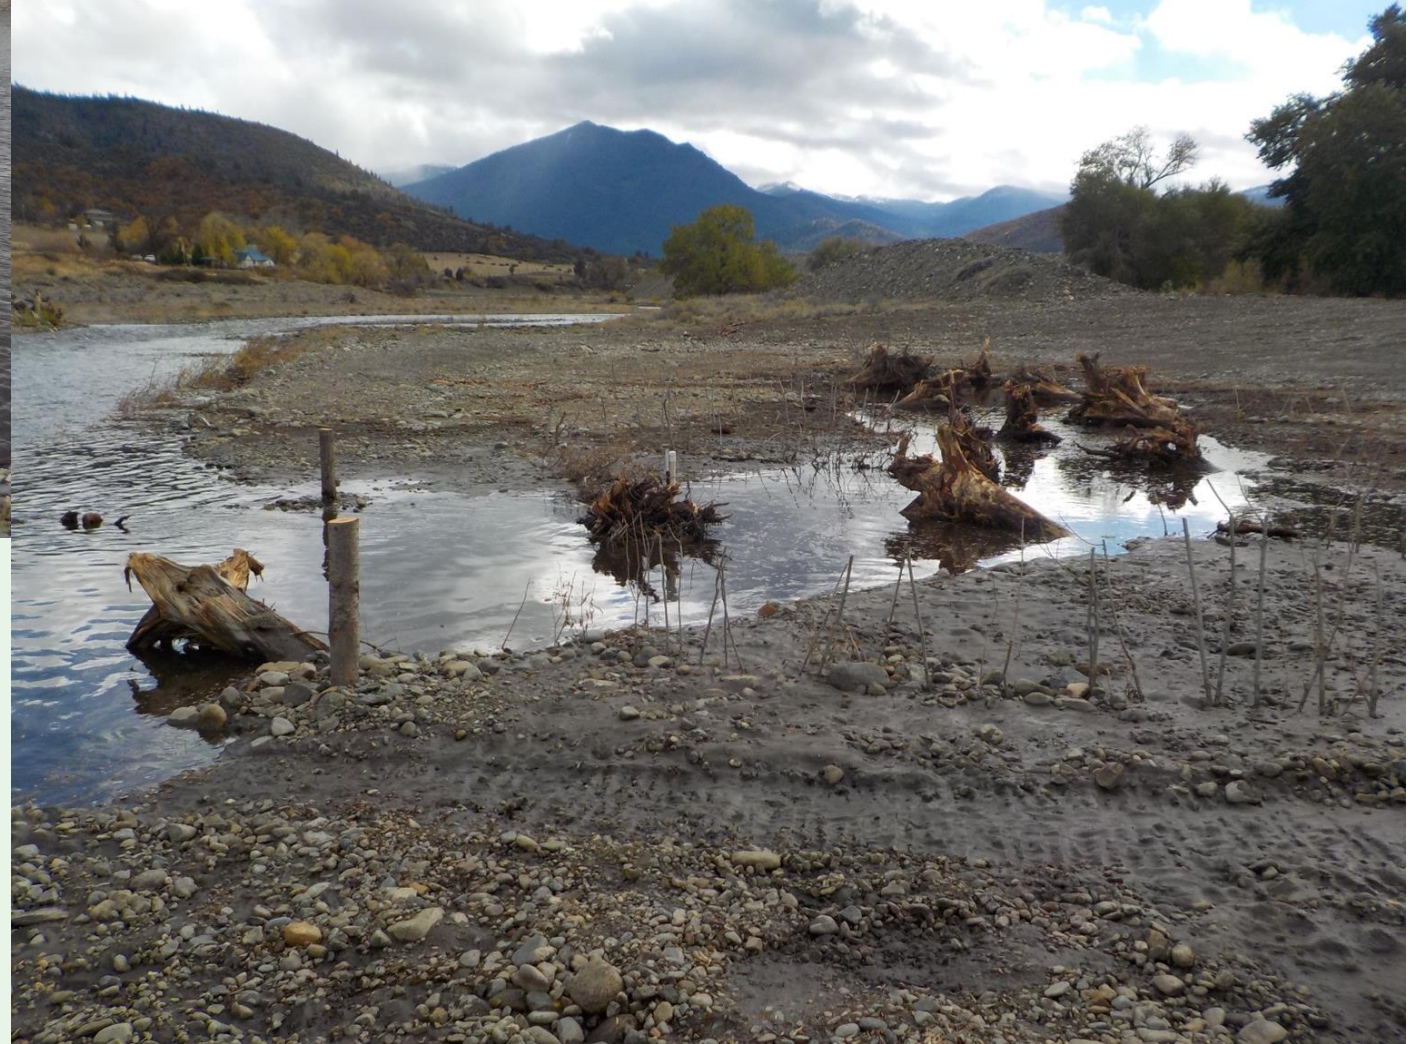
Sediment deposition after initial runoff event –
WY2022

Capture and storage of fire derived sediment
