# ***Beaver Valley Headwaters Preserve: SRWC Final Report***

A Compendium of Natural Resource Information  
Collected to Inform Management Decisions  
Related to Riparian Habitat, Stream Channel  
Restoration and Enhancement & Forest Health  
Resiliency

*Prepared by Scott River Watershed Council  
May 1, 2024*

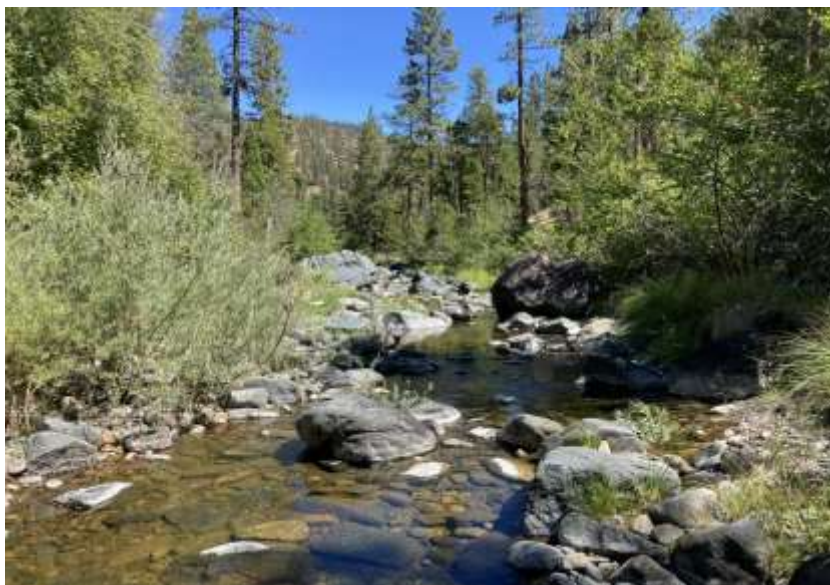
Photo 1.1: Transect EF-04 looking upstream at a healthy and diverse riparian understory along the banks of the East Fork. August 24, 2022.

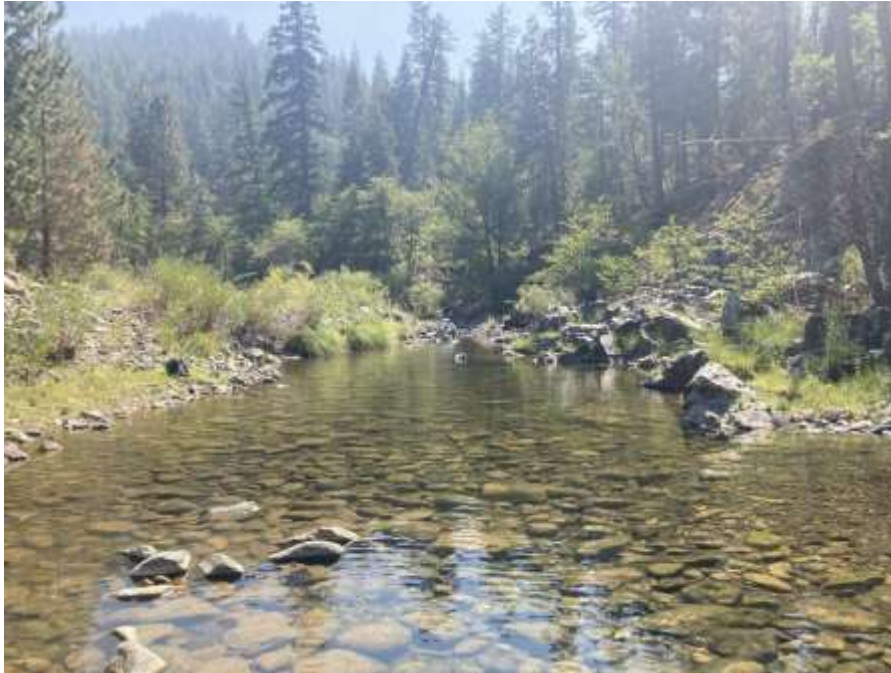
*Photo 1.3: Photo taken at EF-11 looking upstream illustrates how the East Fork channel widens significantly as the topography changes. In addition, the riparian species diversity is more limited. September 1, 2022.*

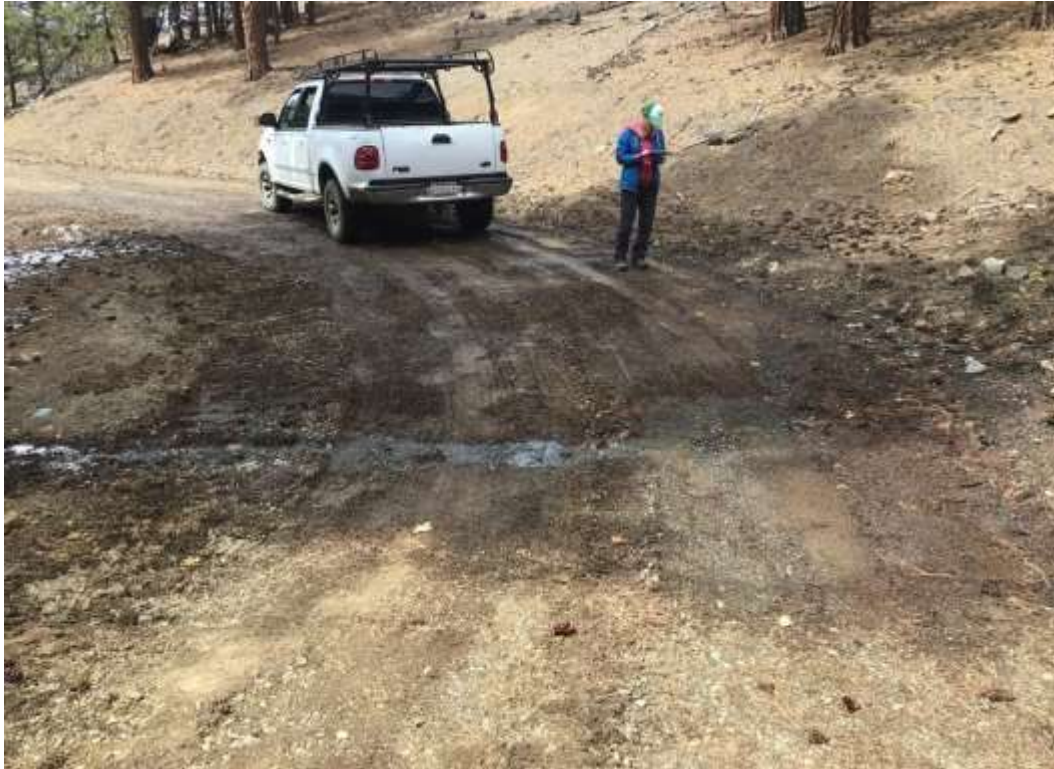
Photo 2.1: Example of mild erosion point. HRR20, April 18, 2023.

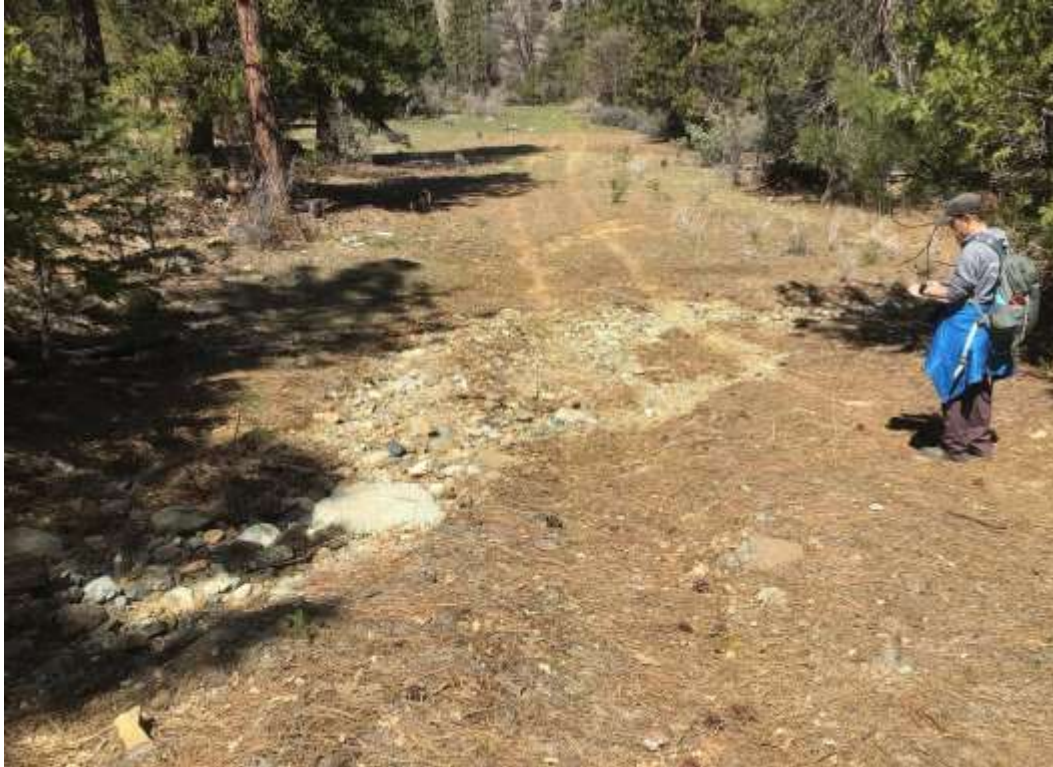
*Photo 2.3: Example of extreme erosion point, EFR13.1; April 13, 2023.*

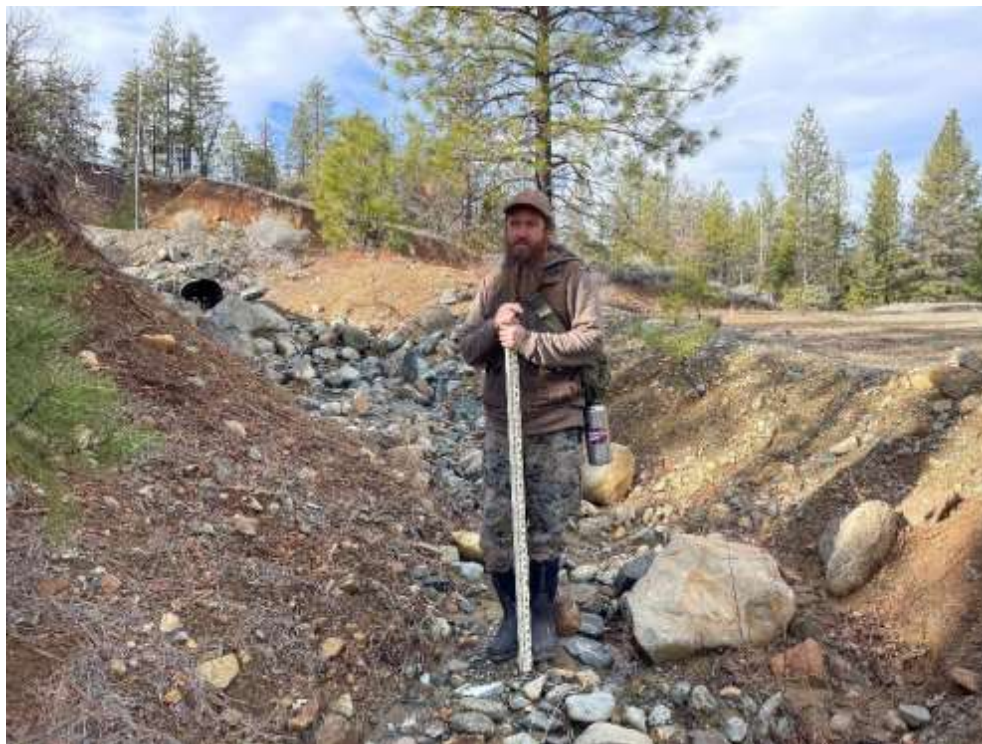
Gully Complex 2 begins at a culvert under Highway 3. It flows downstream as an inboard ditch on an old county road. The ditch is eroding and has no engineered outlet (Photo 2.6). This gully has four associated road erosion features. At two of the road points, the water flows down the road, causing extreme erosion (Photo 2.7). It terminates at the East Fork Scott River, discharging sediment into the river (Photo 2.8).

*Photo 2.6: Outlet of Highway 3 culvert and ditch, looking upslope. EFG2a. January 19, 2024.*

Water management related to Highway 3 causes, or exacerbates, erosion in almost all the high severity gullies and gully complexes. While it may not be feasible to improve water handling on Highway 3, methods to slow the flow--and hence decrease erosion--could reduce sediment delivery to the East Fork Scott River and protect the private roads from further damage.

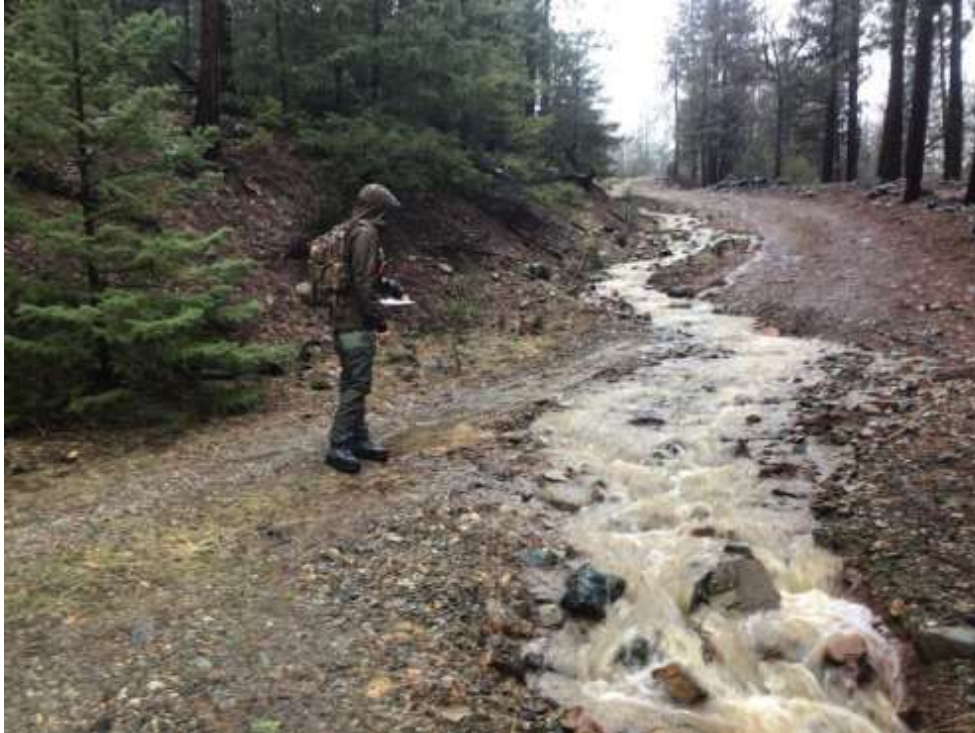
Photo 2.7: Water during runoff event crossing road. EFR2. January 13, 2023.

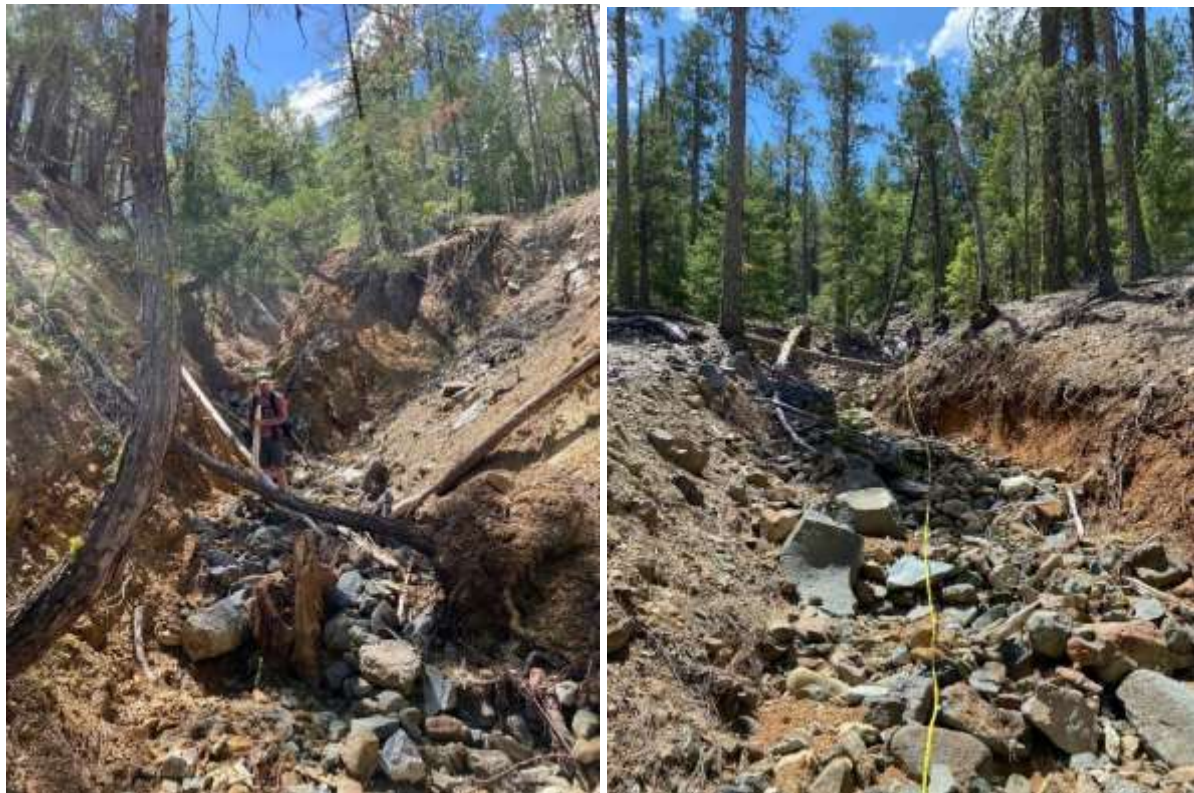
Gully Complex 8 (Table 2.6) begins above Highway 3, collects the discharge from the inboard ditch on Highway 3, passes under Highway 3 through a culvert, and then almost immediately reaches its maximum cross section area of 63 feet wide and 26 feet deep (Photo 2.9 and Photo 2.10). Below that it bifurcates four times, into five gully segments that cross the road at four road points (three with extreme erosion, one with moderate erosion (Photo 2.11), before discharging into the East Fork Scott River (Photo 2.12).

Photos 2.9 and 2.10: Maximum cross-section of Gully Complex 8 is 800ft<sup>2</sup>. EFG8f and EFG8g; May 29, 2023.

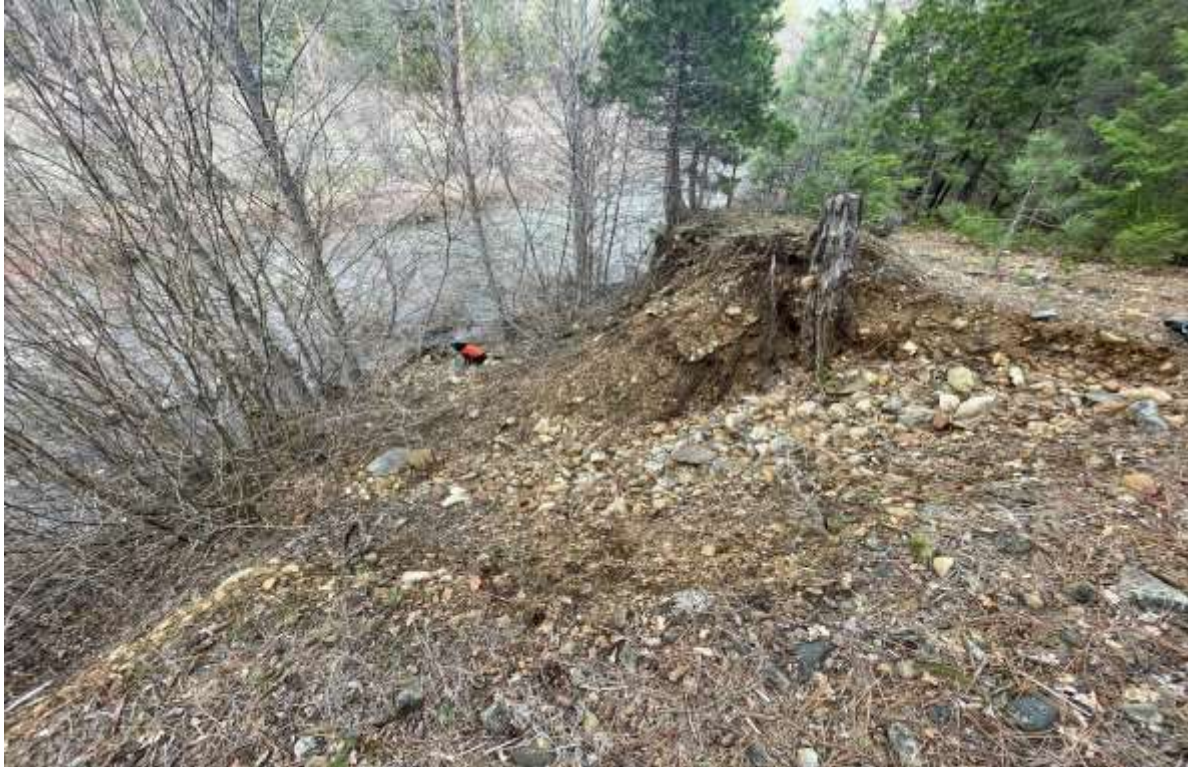
Photo 2.11: Discharge of Gully 8.3 into the East Fork Scott. EFG9e; April 5, 2024.

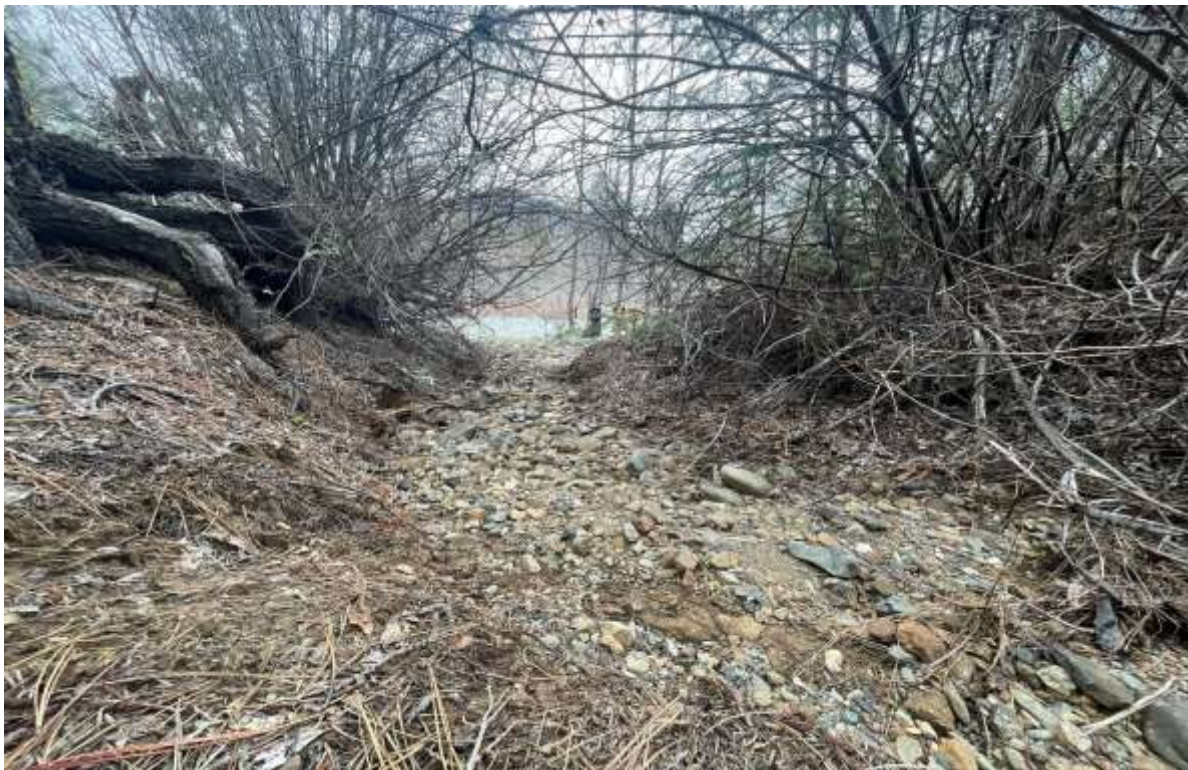
Photo 2.12: Gully 8.4 discharges into the East Fork Scott River. EFG10e; April 5, 2024.

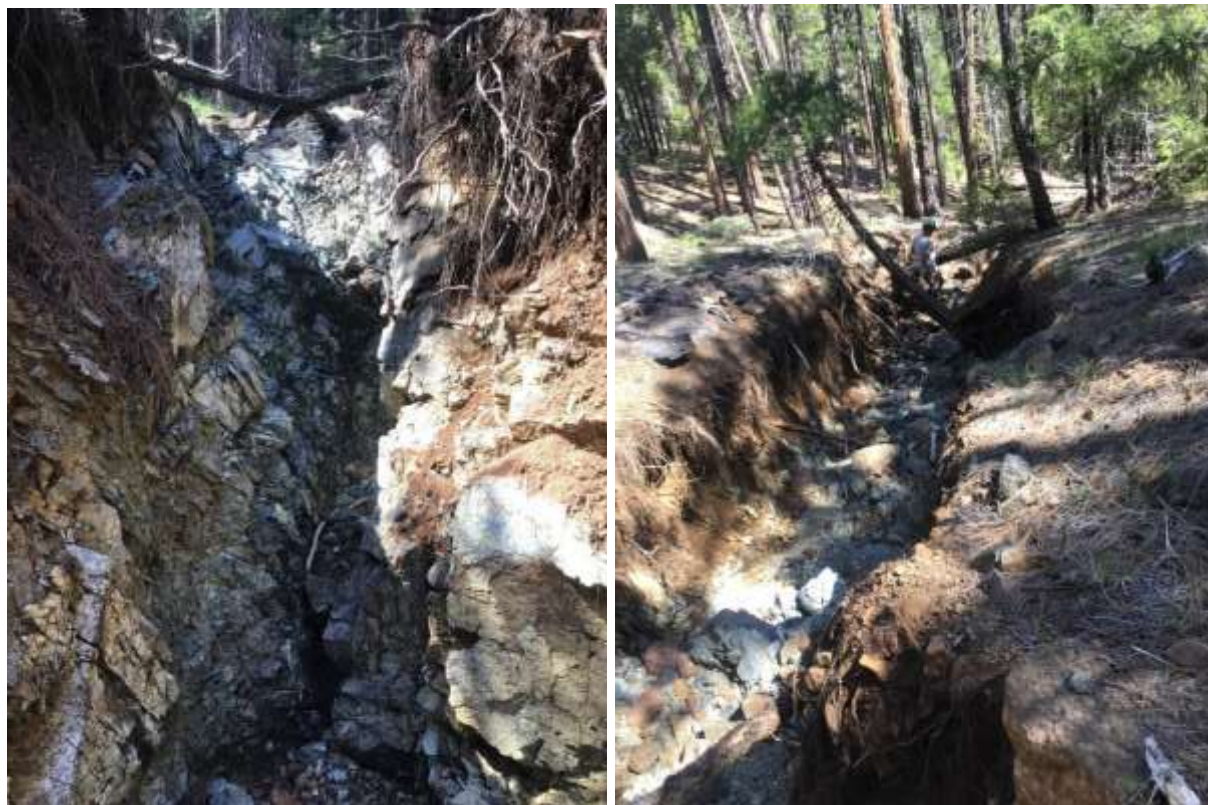
Gully Complex 12 (Table 2.7) begins where a culvert under Highway 3 and an outboard ditch discharge water into the same area. It bifurcates once and the two segments discharge at roughly the same place into Mule Creek, which converges with the East Fork Scott River, approximately 160 feet downstream. Gully Complex 12 only crosses a road once, at the confluence of the two segments, but erosion at that point was rated extreme (Photos 2.13 and 2.14).

*Photos 2.13 and 2.14: Greatest cross-section of Gully Complex 12 is 32 ft<sup>2</sup>; looking up and down the gully at that point. EFG12b; May 23, 2023.*

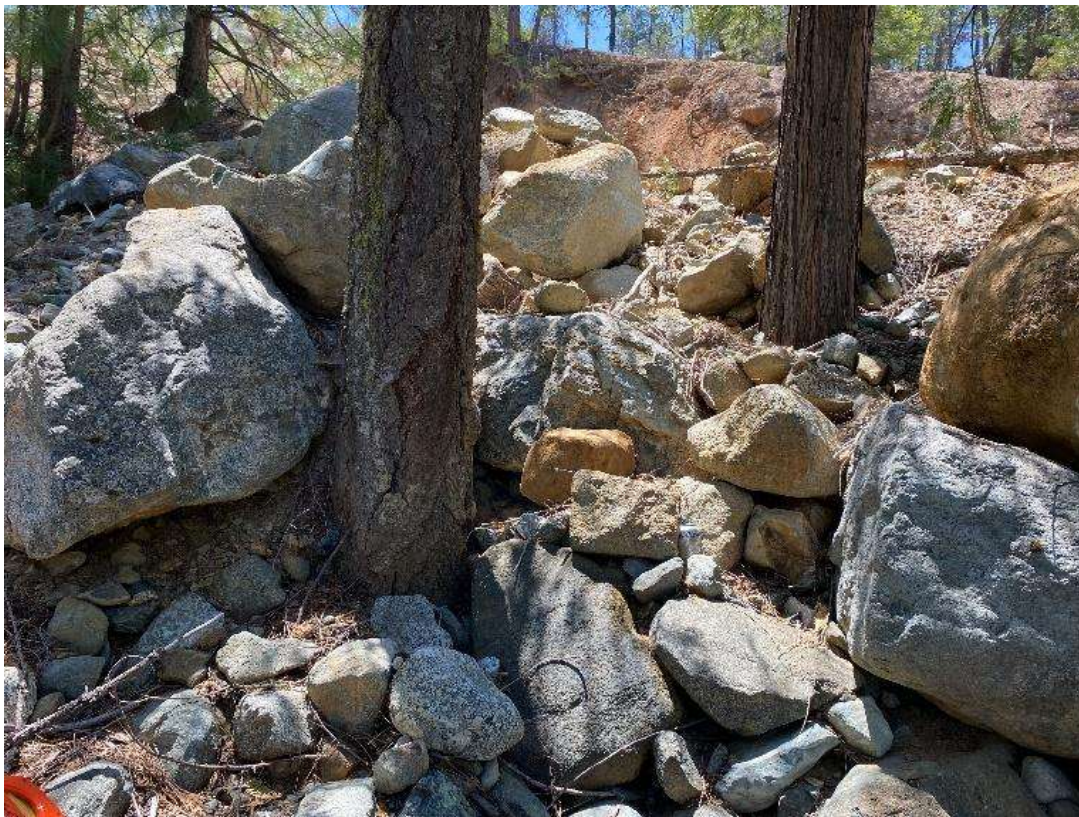
Gully Complex 5 (Table 2.8) originates at two points: a culvert and an outboard ditch, both associated with Highway 3 (Photo 2.15). It consists of three segments that converge as they cross the private road (Photo 2.16), at a point with extreme erosion, and then discharges into the East Fork of the Scott River.

Photo 2.15: Below Highway 3 outboard ditch. EFG6.5.2c; June 2, 2023.

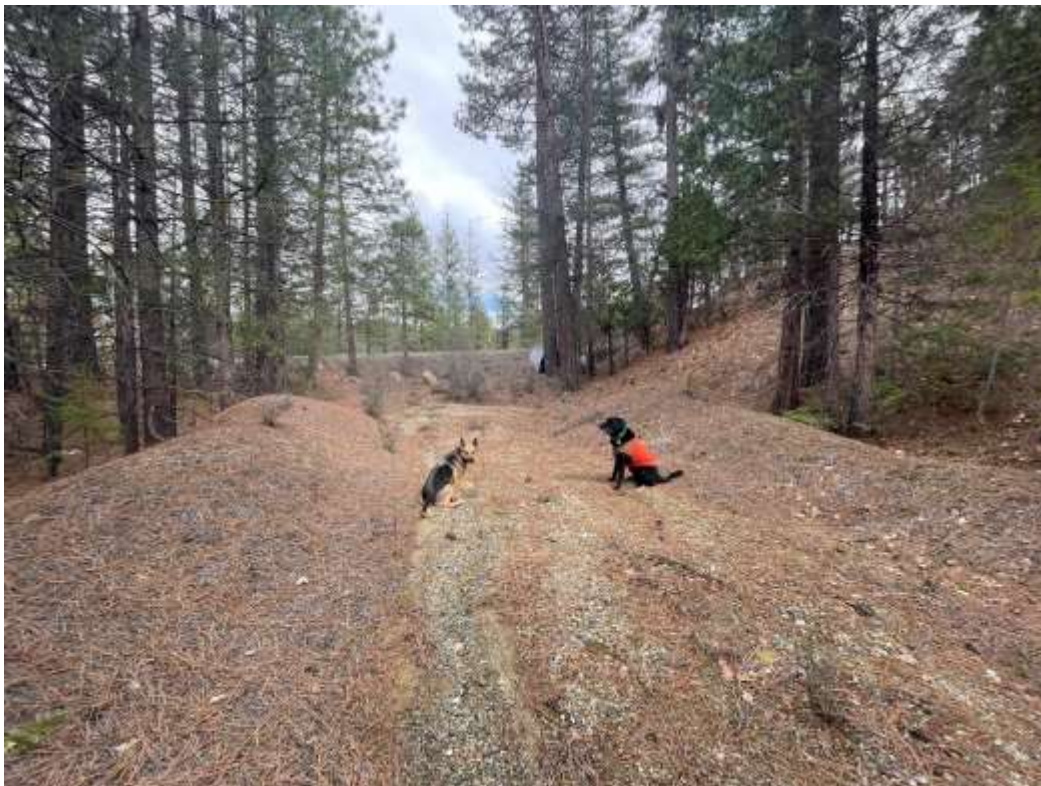
Gully 24 (Table 2.9) begins where the inboard ditch on Highway 3 flows past the mouth of a culvert instead of being directed into the culvert (Photo 2.17). Gully 24 continues on the inboard side of the highway, crosses the private road dirt road (extreme erosion) (Photo 2.18) and cuts down the bank to discharge in Big Mill Creek (Photos 2.19 and 2.20). Big Mill Creek joins the East Fork Scott River about 90 feet downstream.

Photo 2.18: EFG 24 downstream of bypassed culvert. April 5, 2024.

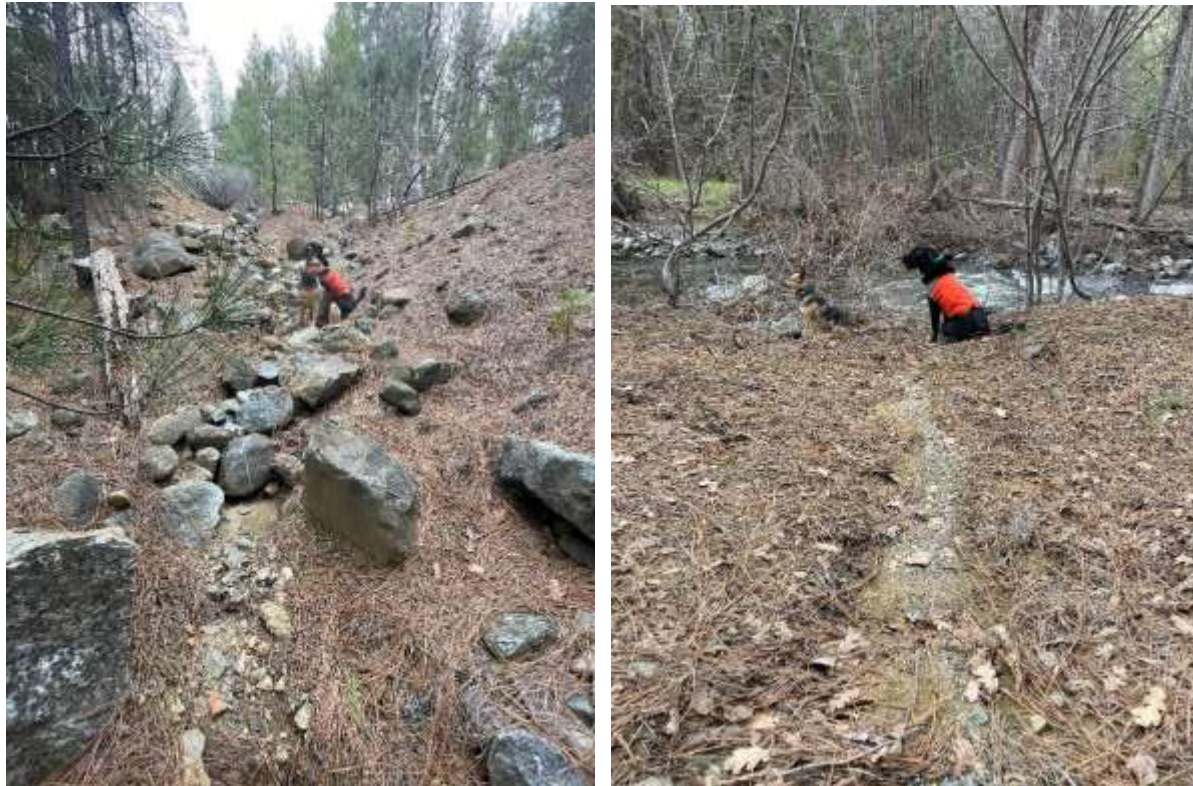
Photos 2.19 and 2.20: EFG 24 below private road. EFG24b (left photo); EFG 24 discharges into Big Mill Creek. EFG24e (right photo). April 5, 2024.

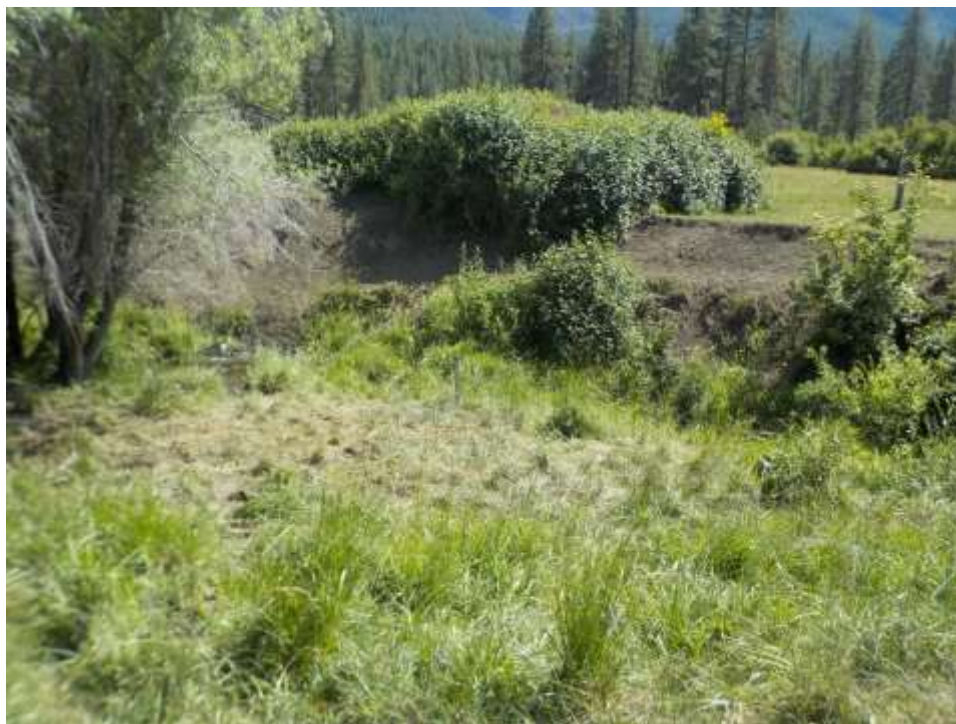
*Photo 6.6: Limited riparian vegetation with blackberry encroachment and actively eroding stream bank. June 21, 2023.*

The SRWC installed cattle exclusion fencing along the East Fork Scott River and two stock water systems in the fall of 2022. Cattle exclusion fencing along Noyes Valley Creek is proposed (Map 6.15). Restoration designs are being developed for Lower Noyes Valley Creek with a potential realignment of the downstream section and confluence with the East Fork Scott River.

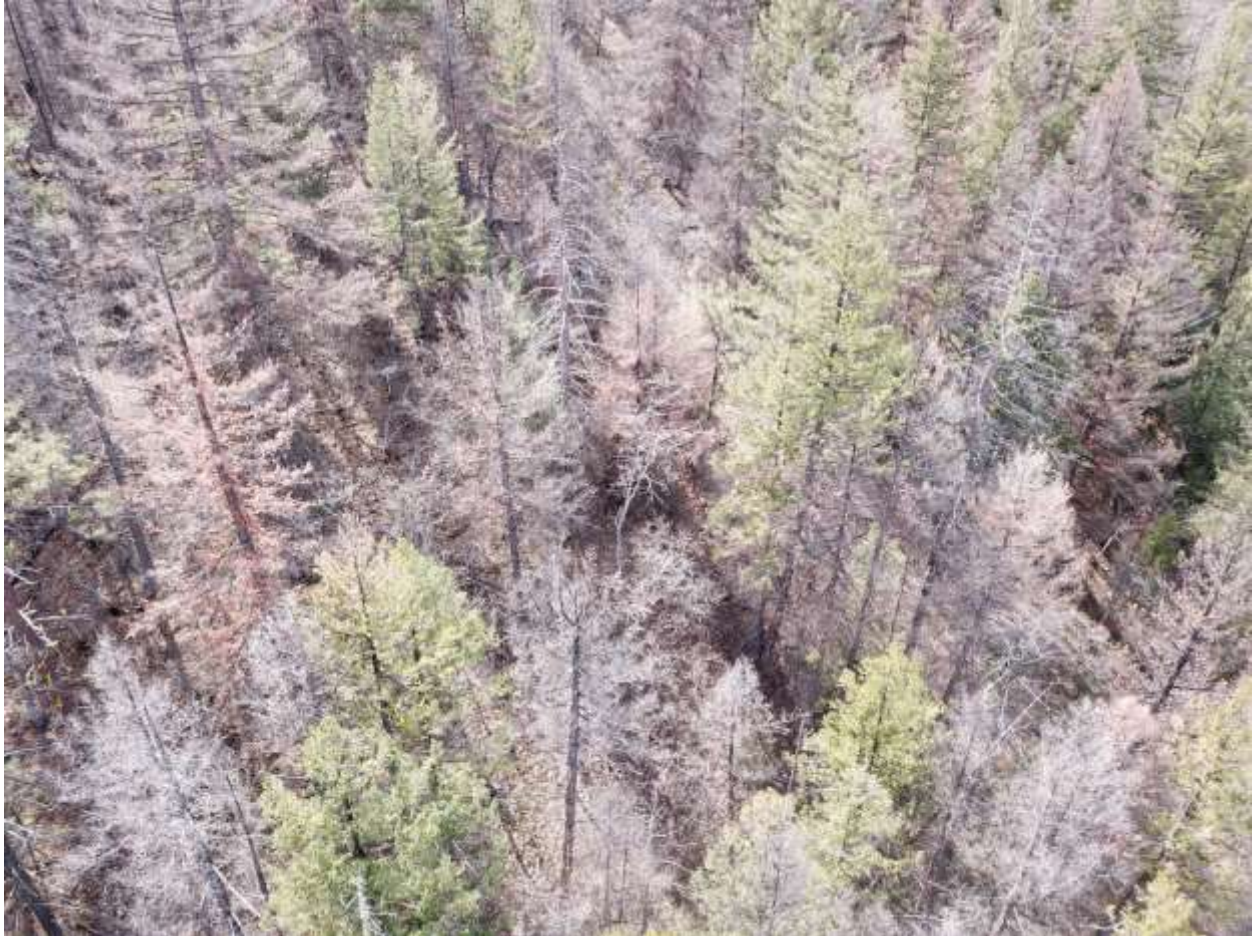
*Photo 7.1: Dead and dying Douglas fir in proposed drought mortality treatment unit. March 25, 2024.*

Current proposed drought mortality treatments should be implemented as soon as possible to reduce hazardous fuel loading and to utilize trees while they are still economical to remove. By removing the dead and dying trees using a combination of commercial harvest and the production of chips, this allows for a large quantity of the bulk material to be removed, eliminating excess mastication and/or burning methods. There is also the ability to couple instream restoration activities with the need for large wood. Using material from TWC can also aid in the goals of removal of the excess biomass and put it to work in instream habitat restoration projects, both on TWC and other areas of the Scott River watershed. Post-treatment monitoring should be conducted to limit the spread of invasive species and ensure that erosion control measures are succeeding.

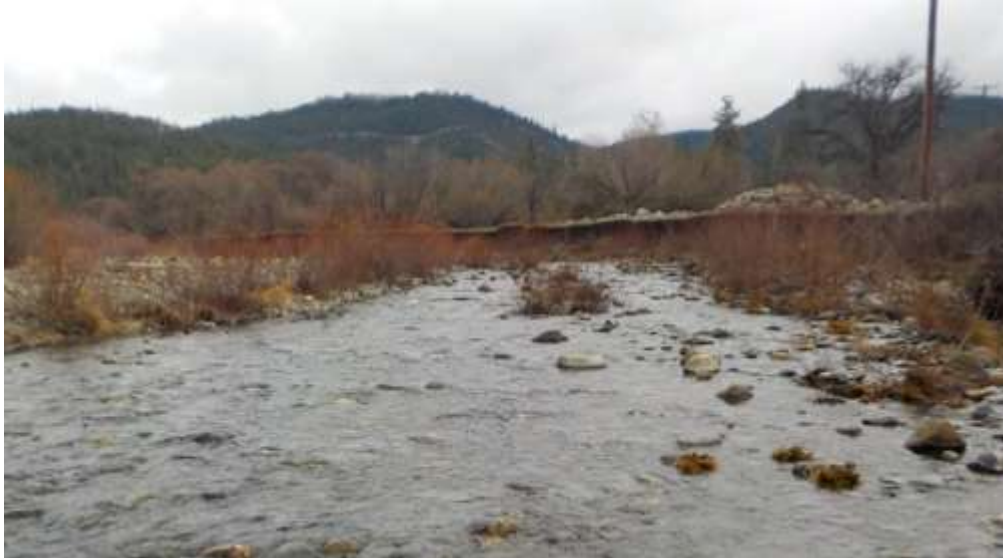
Cutbank at RKM 4.2 - looking upstream - December 2022

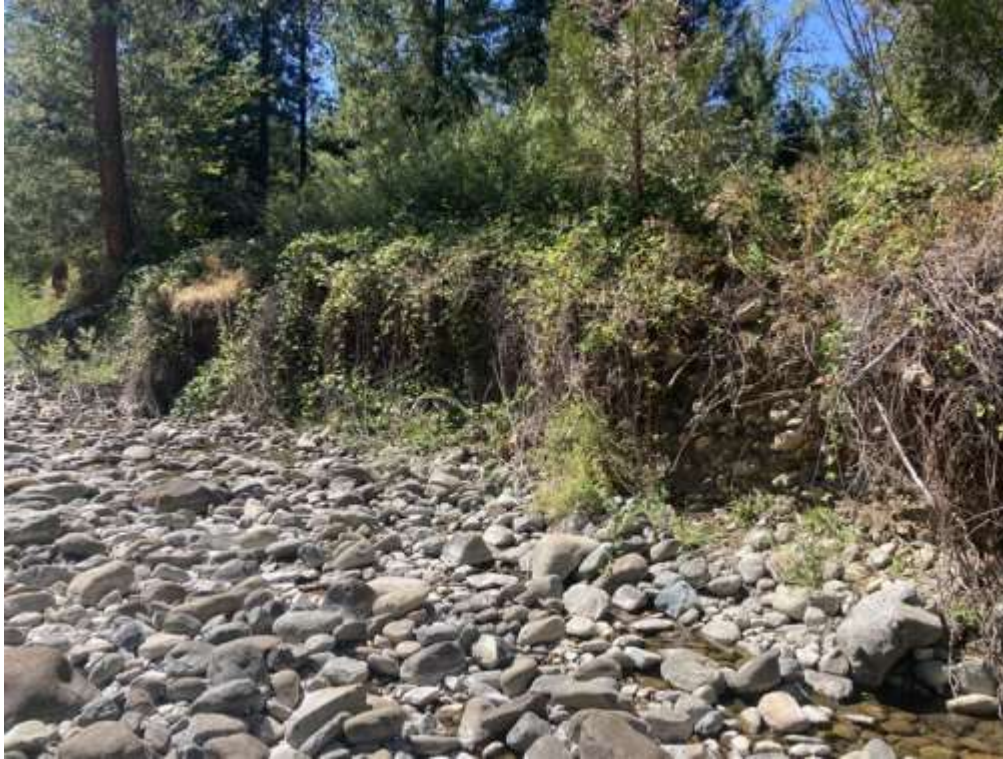
Upstream end of RKM 5.0 cutbank

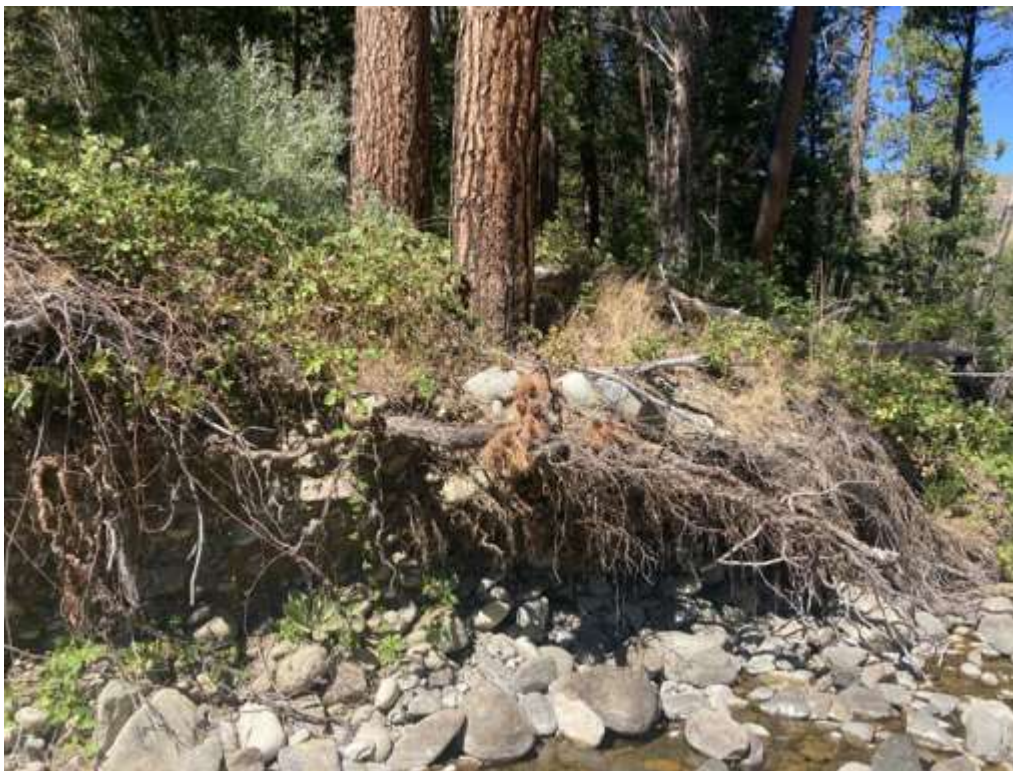
Undercut roots of ponderosa pine at RKM 5 cutbank

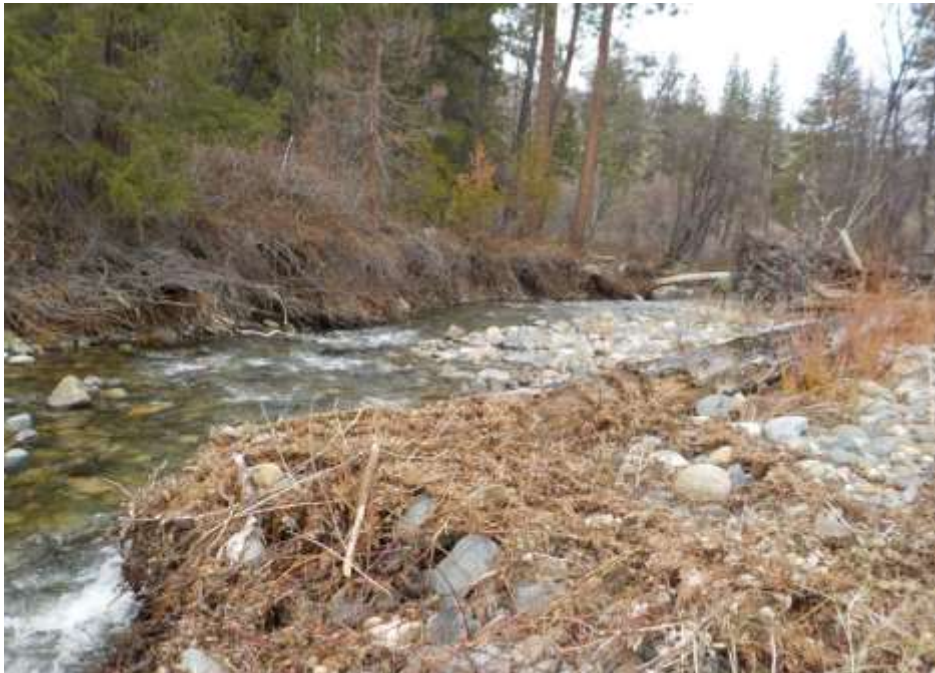
Incised channel at RKM 5.0 - 4.9 - looking downstream

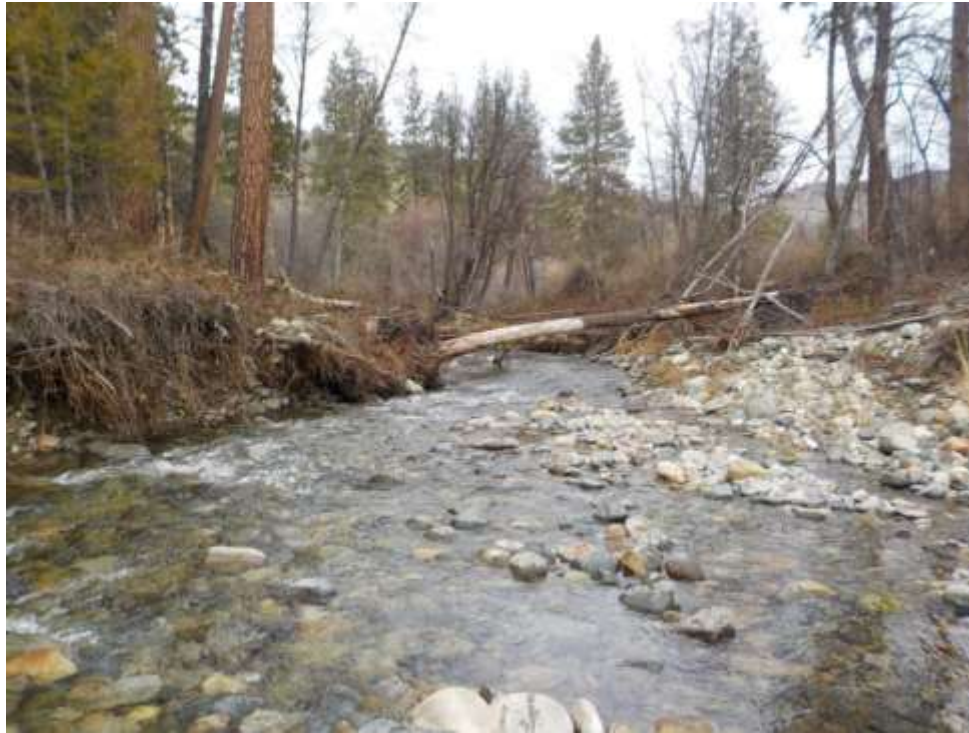
Large woody debris at the downstream extent of the incised channel

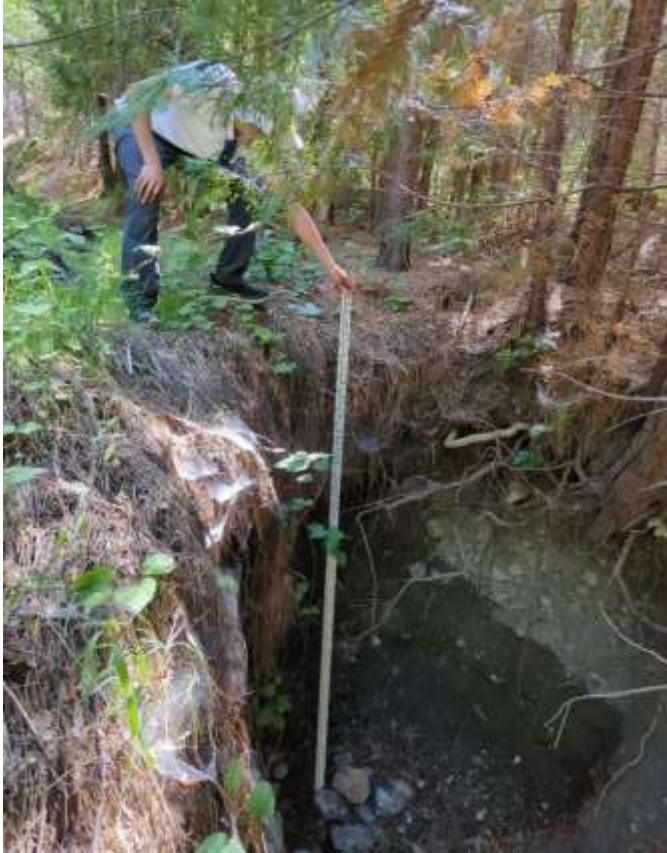
*Photo 2.1: Gully Complex 49, upslope reach. EFG49g. July 25, 2023.*

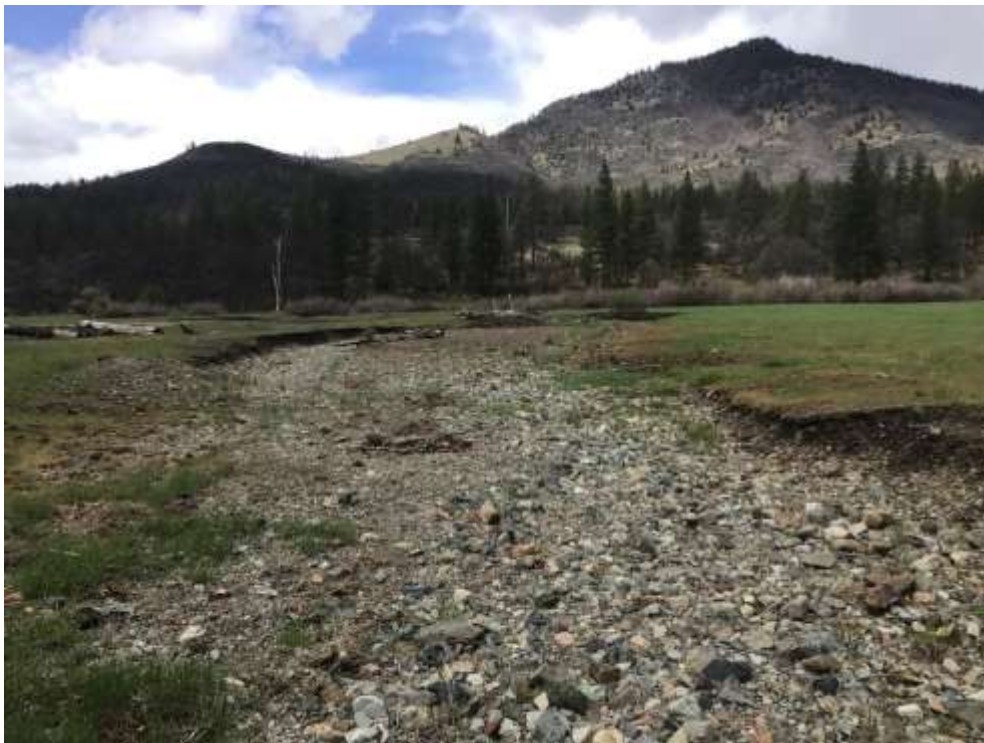
*Photo 2.3: Gully Complex 49 (stream) Downstream of road crossing, looking downstream. Note incision. EFR49. August 5, 2023.*

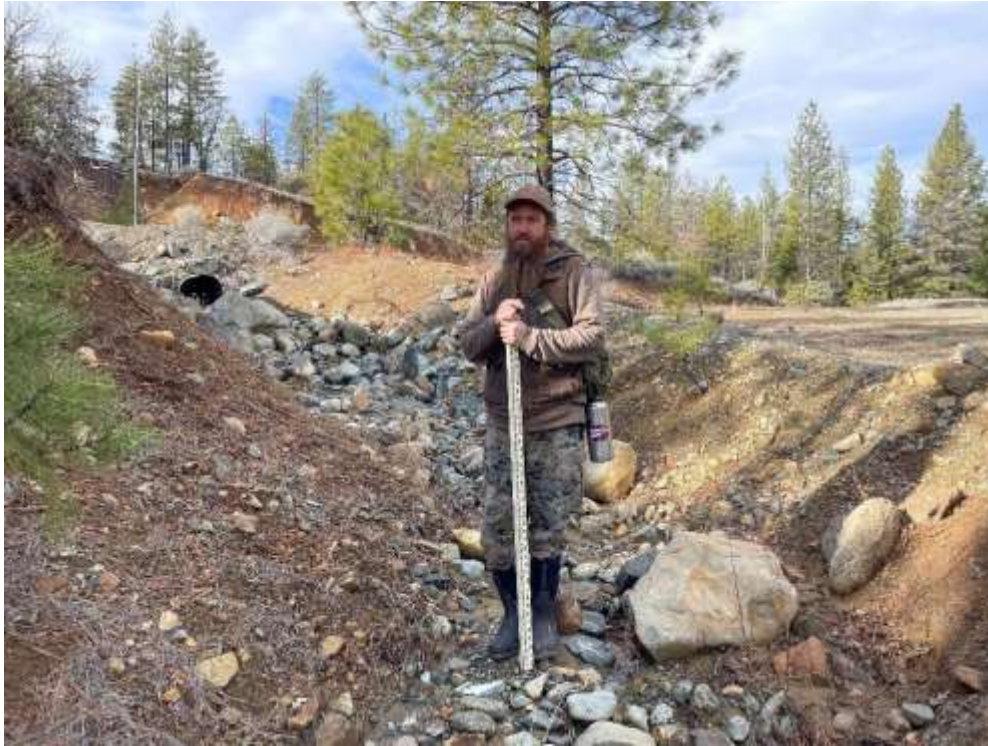
*Photo 2.4: Outlet of Highway 3 culvert, looking upslope. EFG2a. January 19, 2024.*

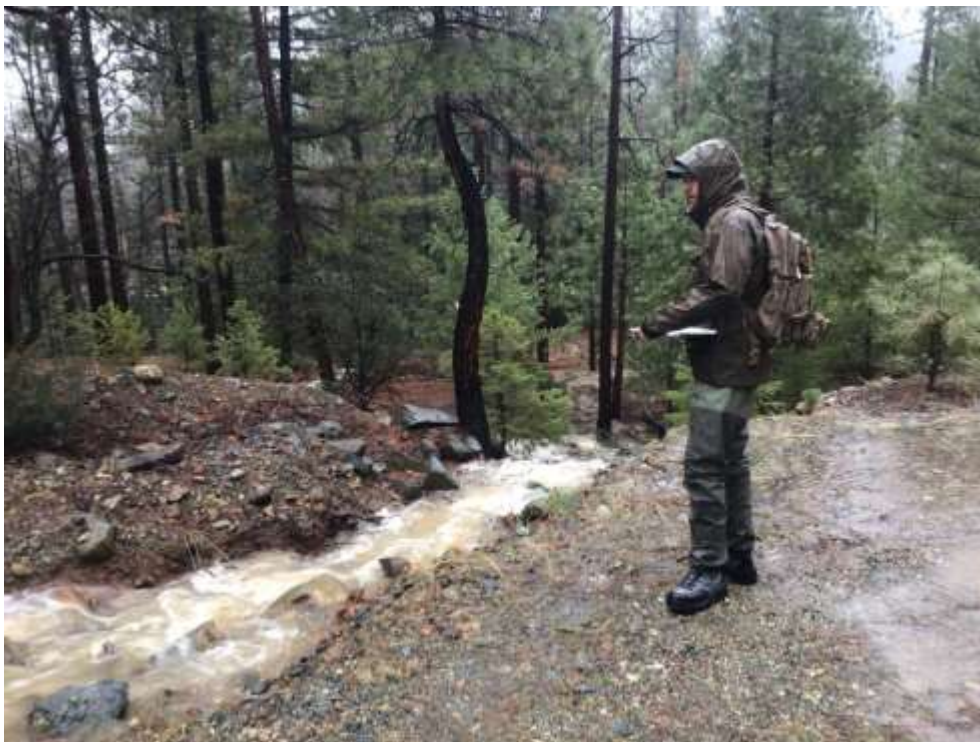
*Photo 2.6: Erosion of road fill. EFR2. January 13, 2023.*

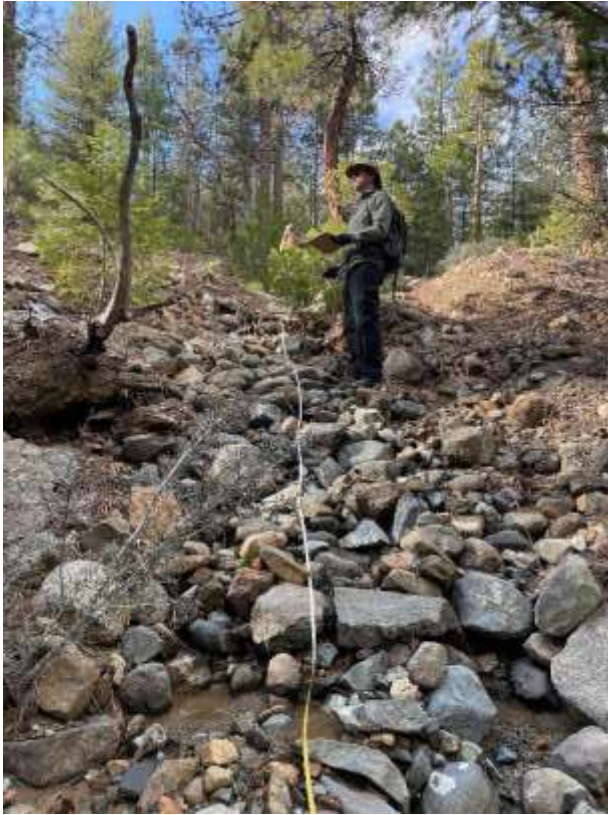
*Photo 2.7: Looking upslope towards site of Figure 2.6, on a day without runoff. EFG2c. January 19, 2024.*

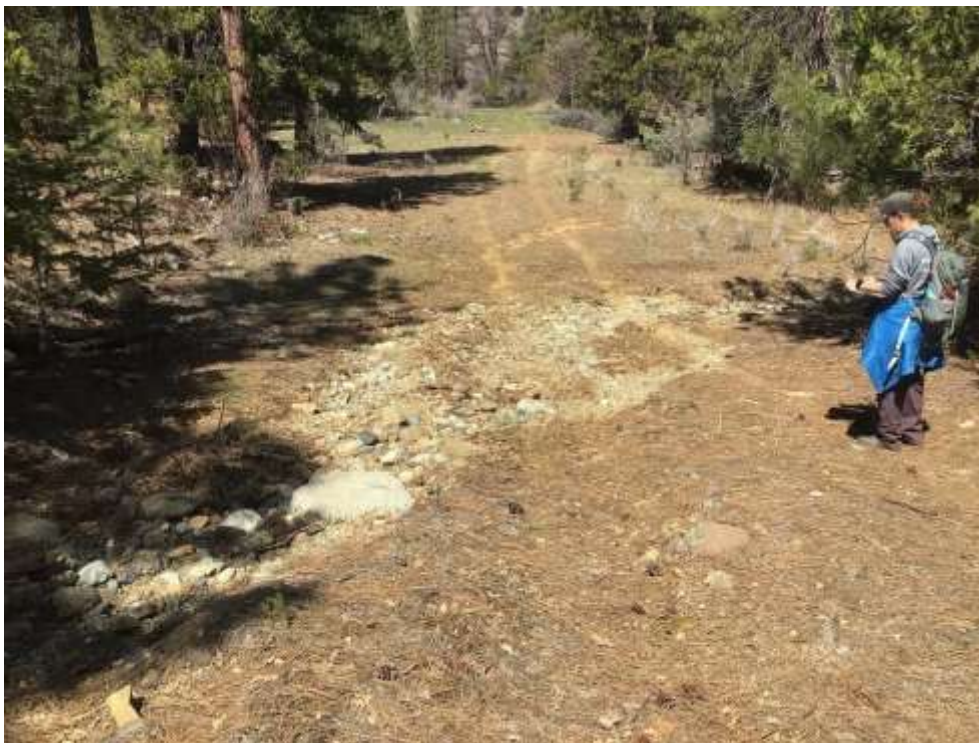
*Photo 2.11: Gully 2 crosses road again. EFR13.1. April 13, 2023.*

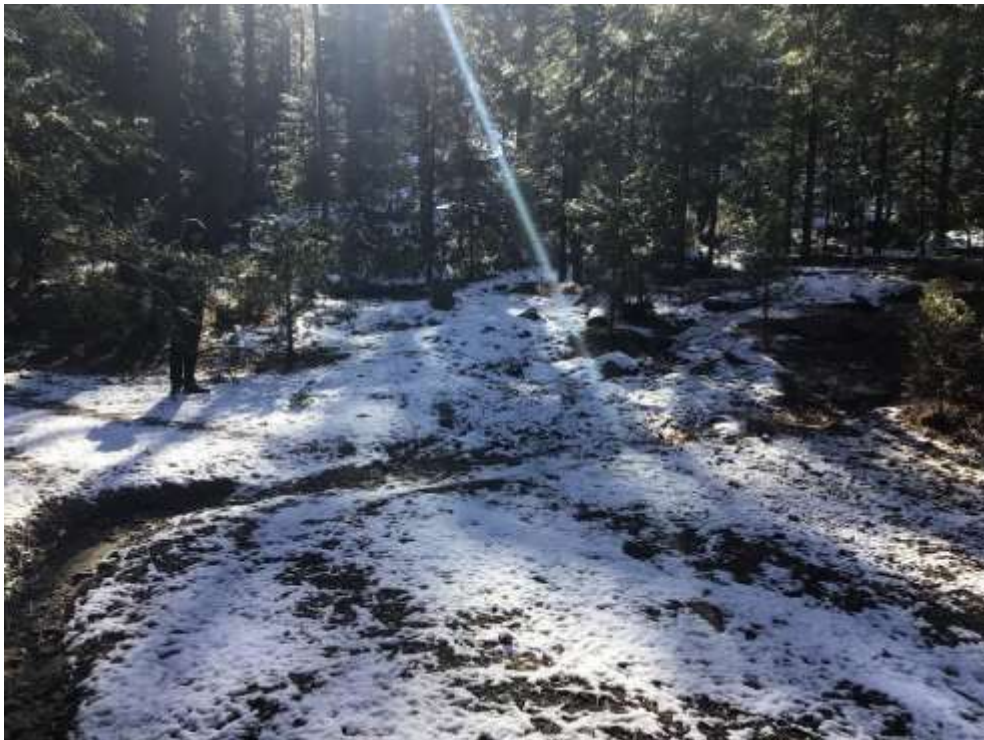
Gully 2.1 (photos below) is a smaller gully that leaves and returns to Gully 2

*Photos 2.17 & 2.18: Gully Complex 2 crossing lower road. EFR13. January 20, 2023.*
