# ***Beaver Valley Headwaters Preserve: SRWC Final Report***

A Compendium of Natural Resource Information  
Collected to Inform Management Decisions  
Related to Riparian Habitat, Stream Channel  
Restoration and Enhancement & Forest Health  
Resiliency

*Prepared by Scott River Watershed Council  
May 1, 2024*

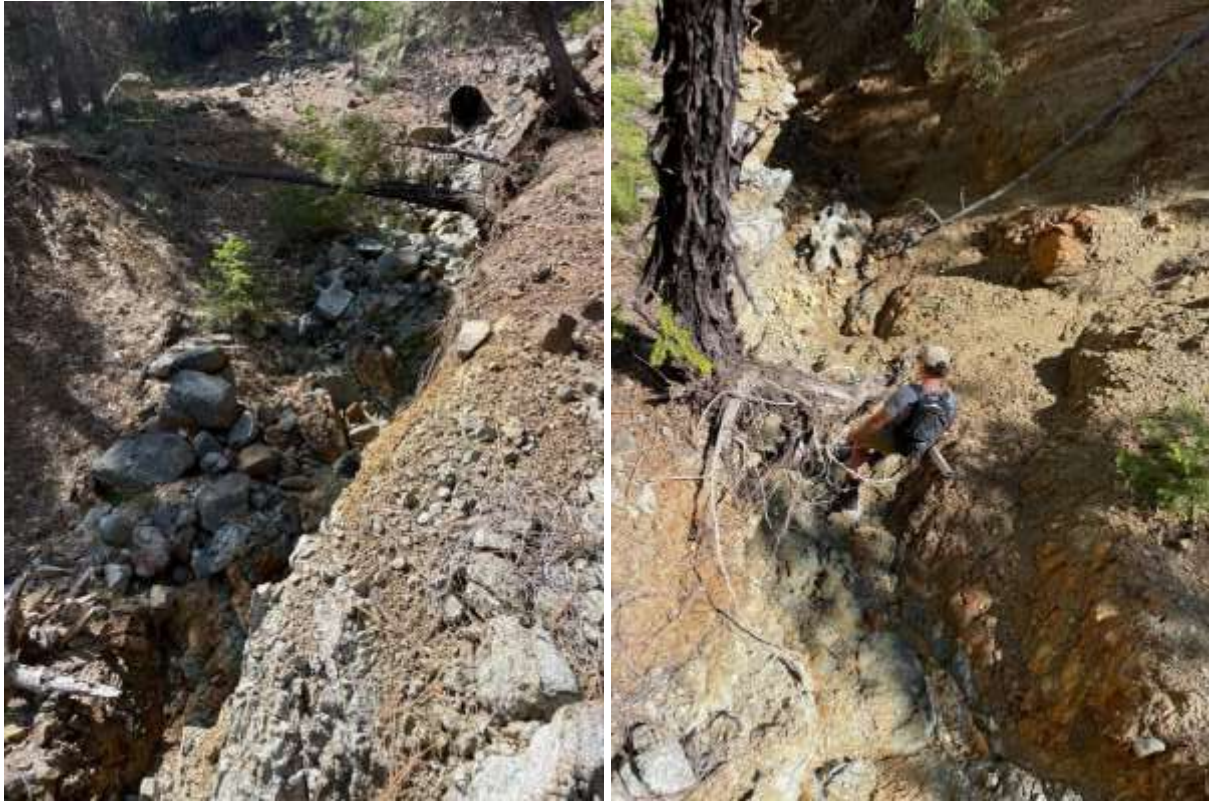
Photos 2.22 and 2.23: Left, culvert discharging in Gully 8. EFG8f. Right, Beginning of deep incision. EFG8f. May 29, 2023.

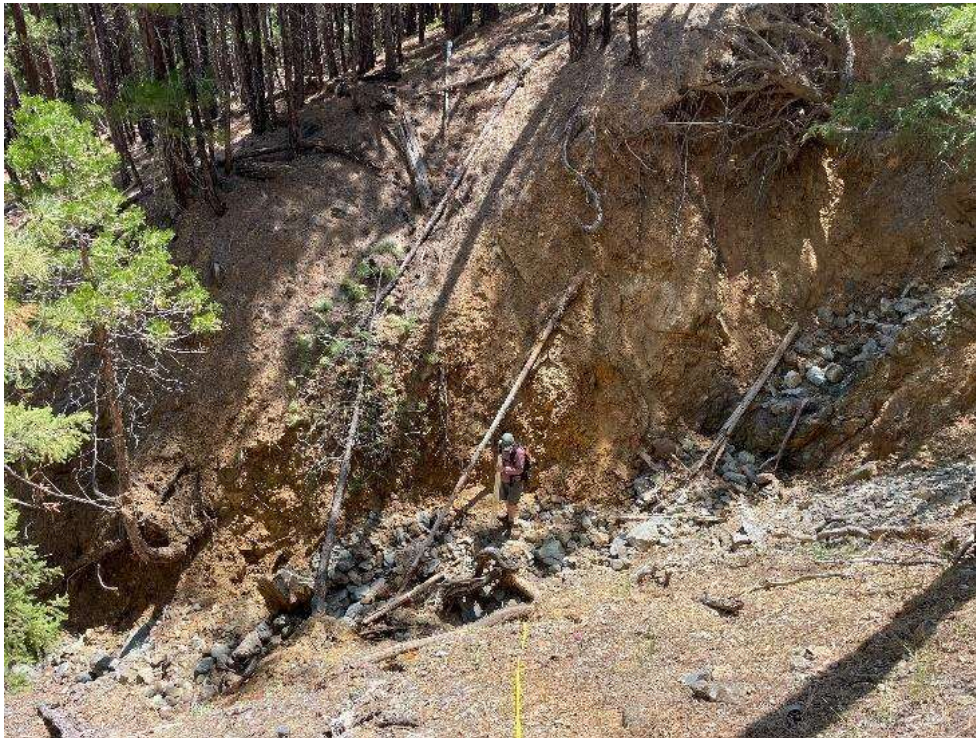
Photo 2.24: Maximum cross-section in Gully Complex 8 is 800 ft<sup>2</sup>. EFG8f. May 29, 2023.

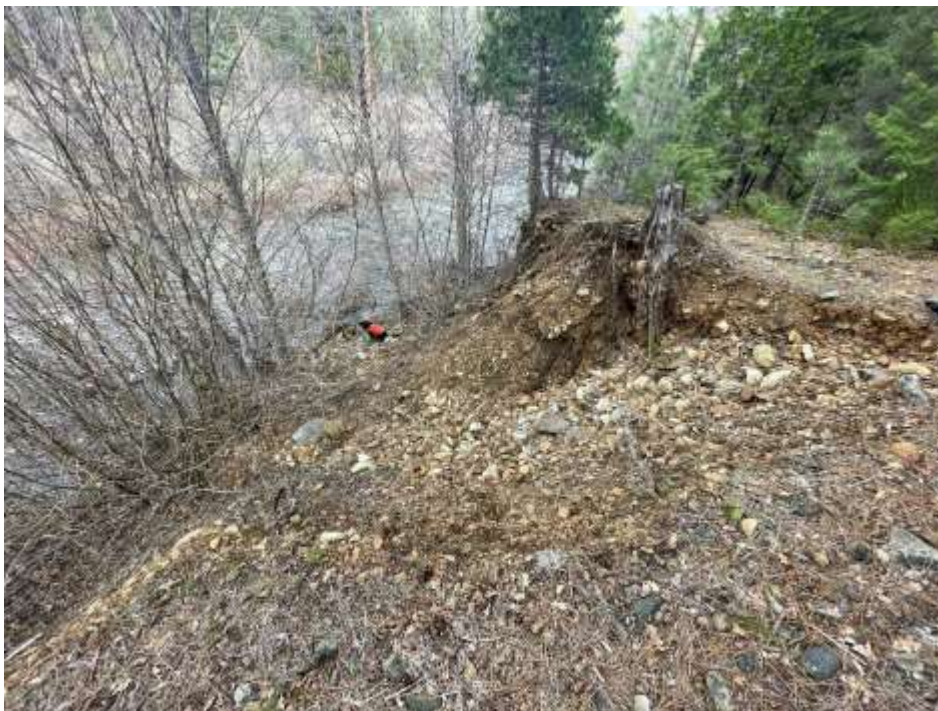
*Photo 2.32: Deep incision where EFG 8.3 discharges into the East Fork Scott River. EFG9. April 5, 2024.*

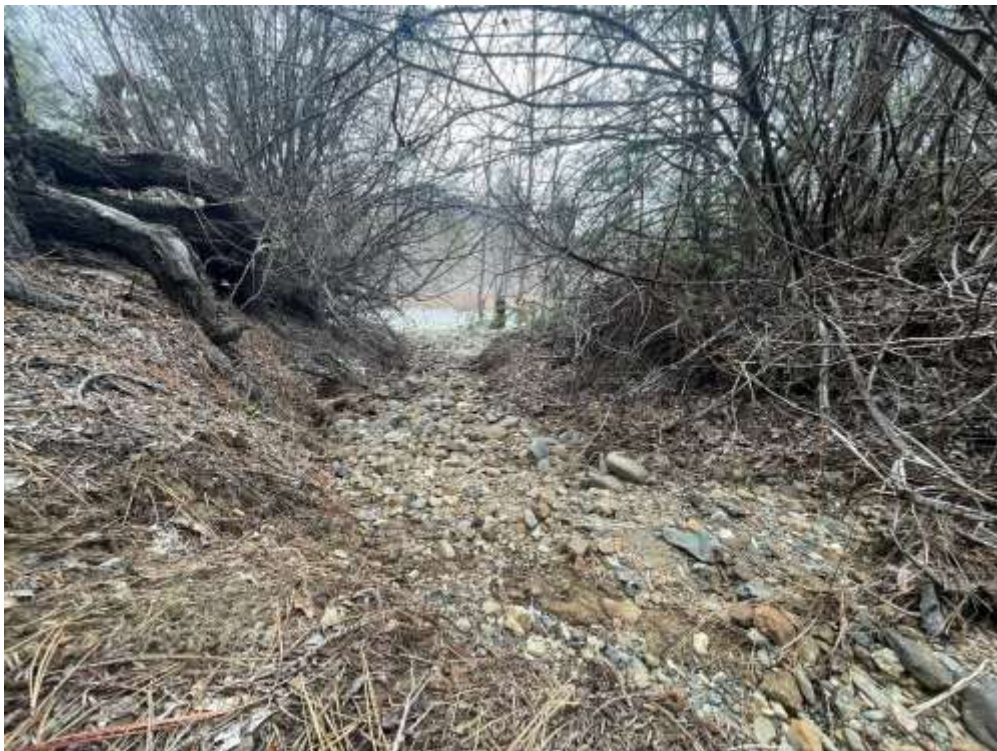
*Photo 2.34: Incision where EFG 8.4 discharges into the East Fork Scott River. EFG10e. April 5, 2024.*

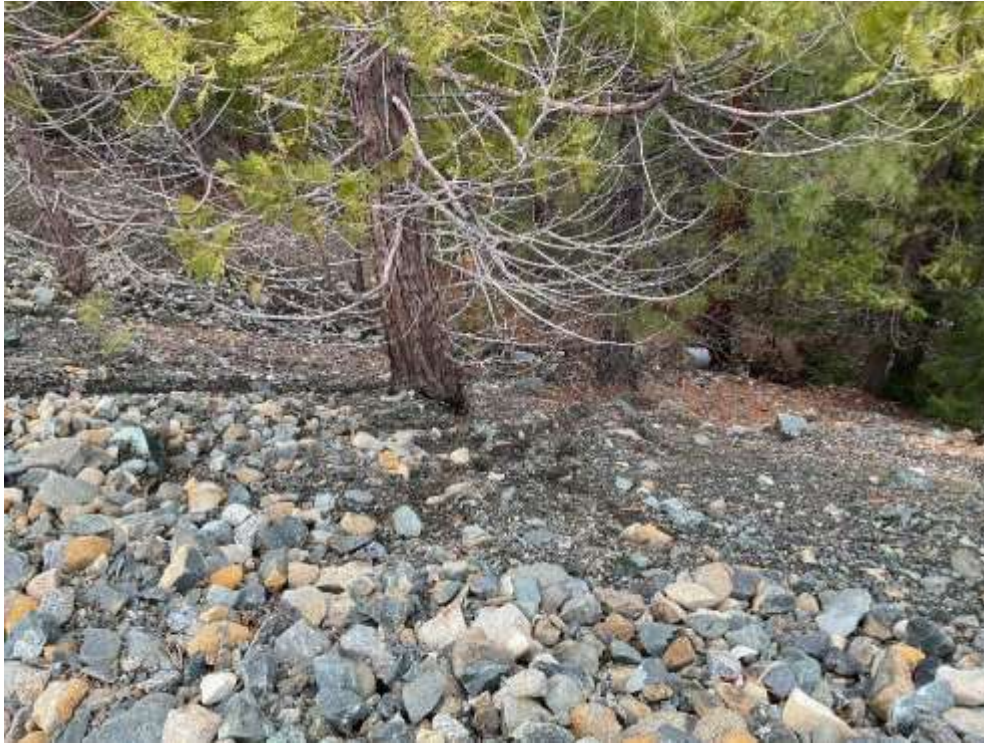
*Photo 2.35: Culvert discharges at the top of Gully Complex 12. January 18, 2024.*

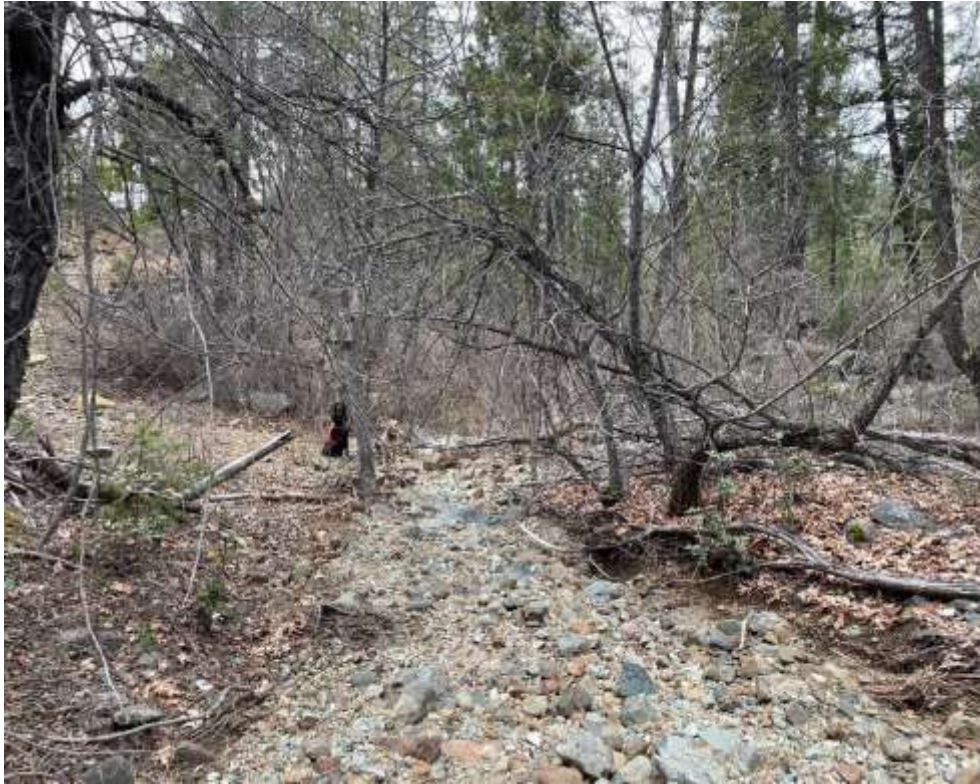
*Photo 2.43: The two branches of Gully Complex 12 flow into Mule Creek at the same point. EFG12e. April 5, 2024.*

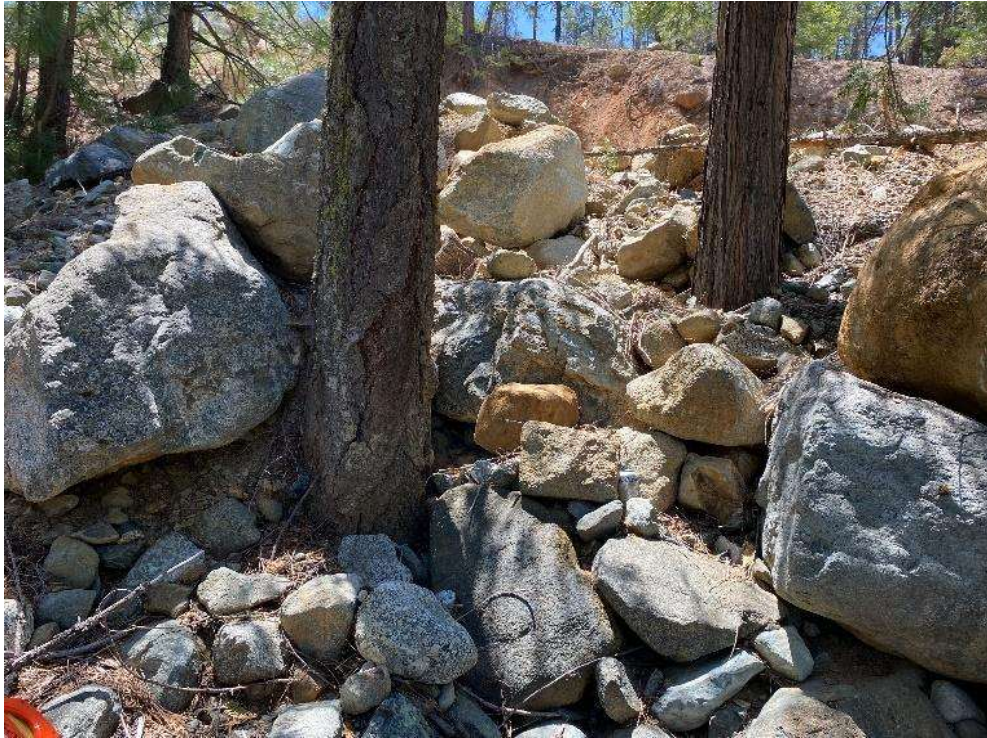
*Photo 2.45: Below Highway 3 outboard ditch. EFG6.5.2c. June 2, 2023.*

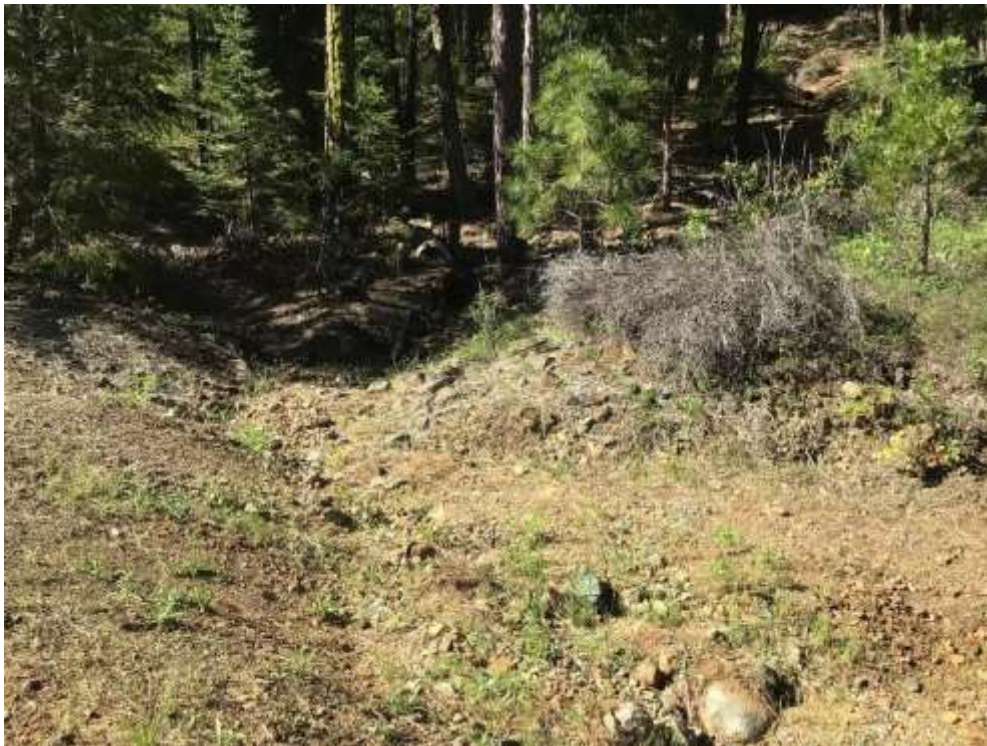
*Photo 2.46: Immediately above road crossing. EFR6. May 23, 2023.*

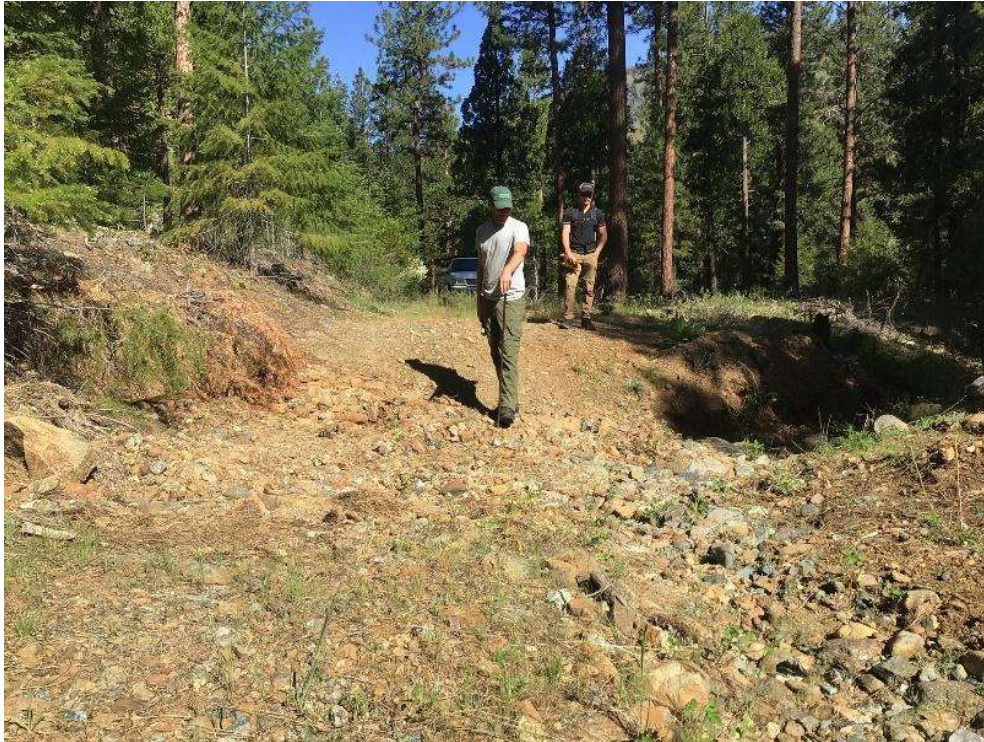
*Photo 2.47: Gully Complex 5 road crossing. EFR6. May 23, 2023.*

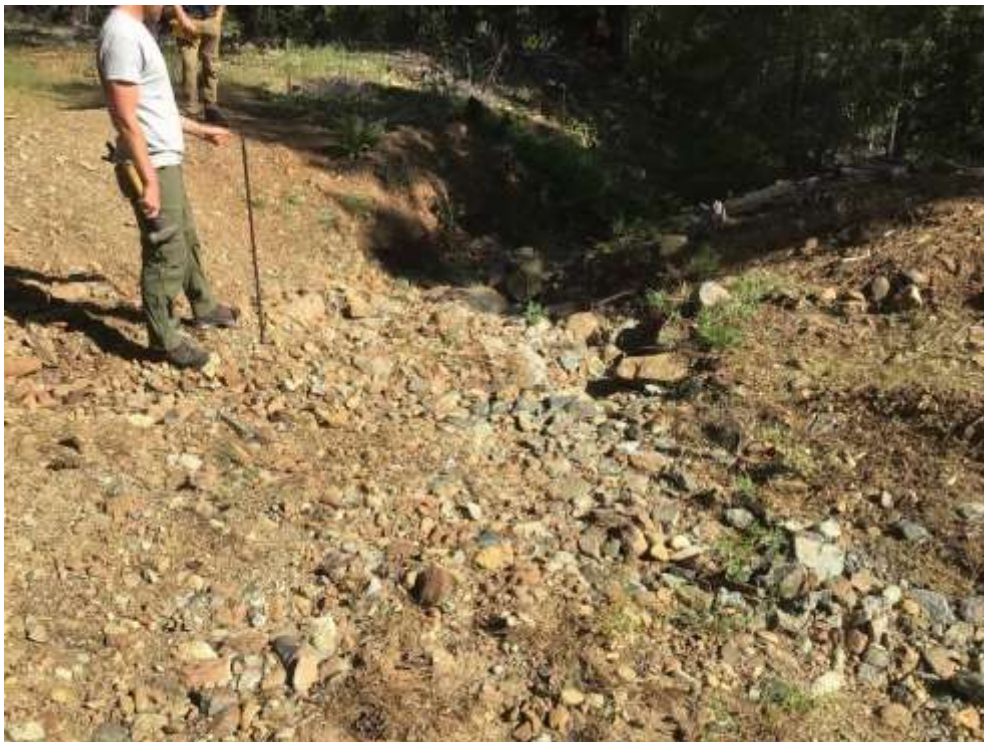
*Photo 2.48: Gully Complex 5 road crossing. EFR6. May 23, 2023.*

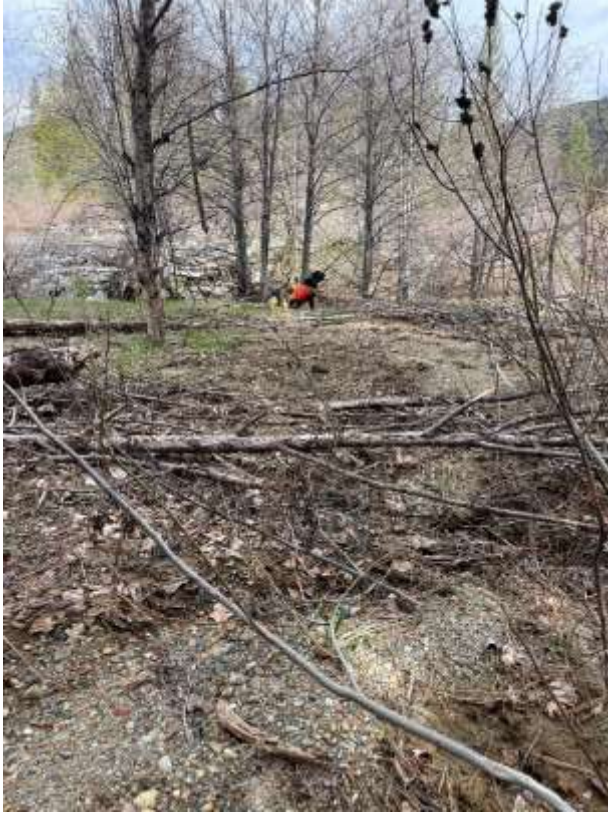
*Photo 2.49: EFGC 5 discharges into the East Fork Scott River. April 5, 2023*

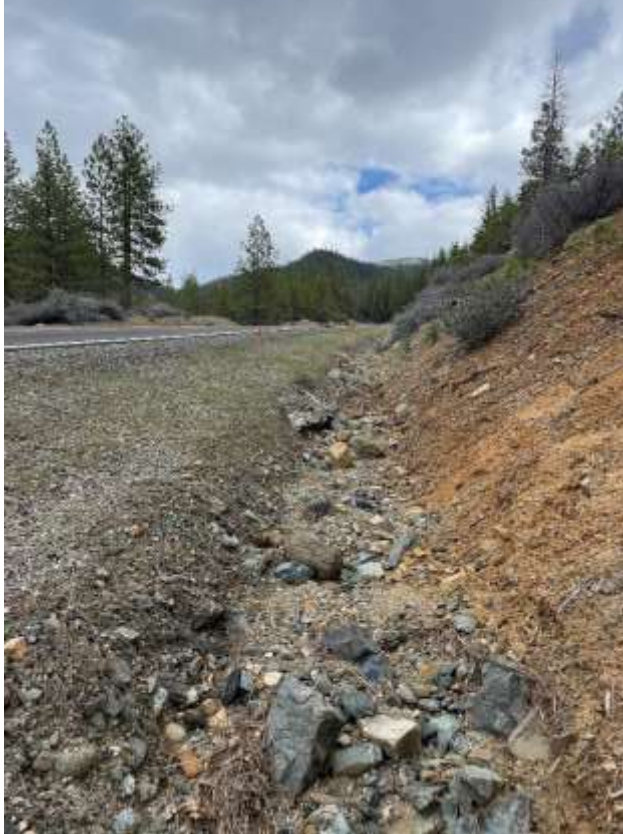
*Photo 2.50: This inboard ditch on Highway 3 is the source for EFG 24. EFG24a. April 5, 2024.*

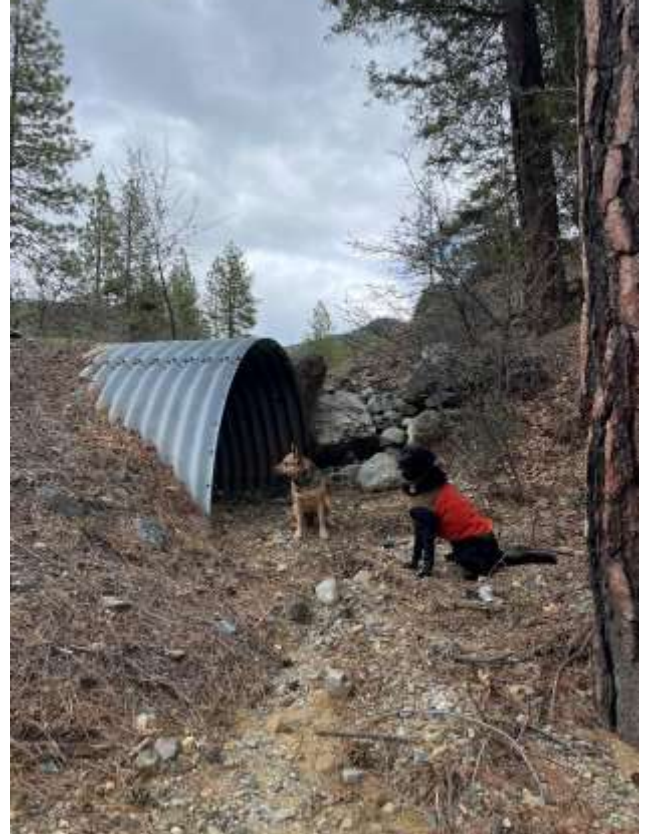
*Photo 2.51: Beginning of EFG 24. Inboard ditch flows past culvert. EFG24a. April 5, 2024.*

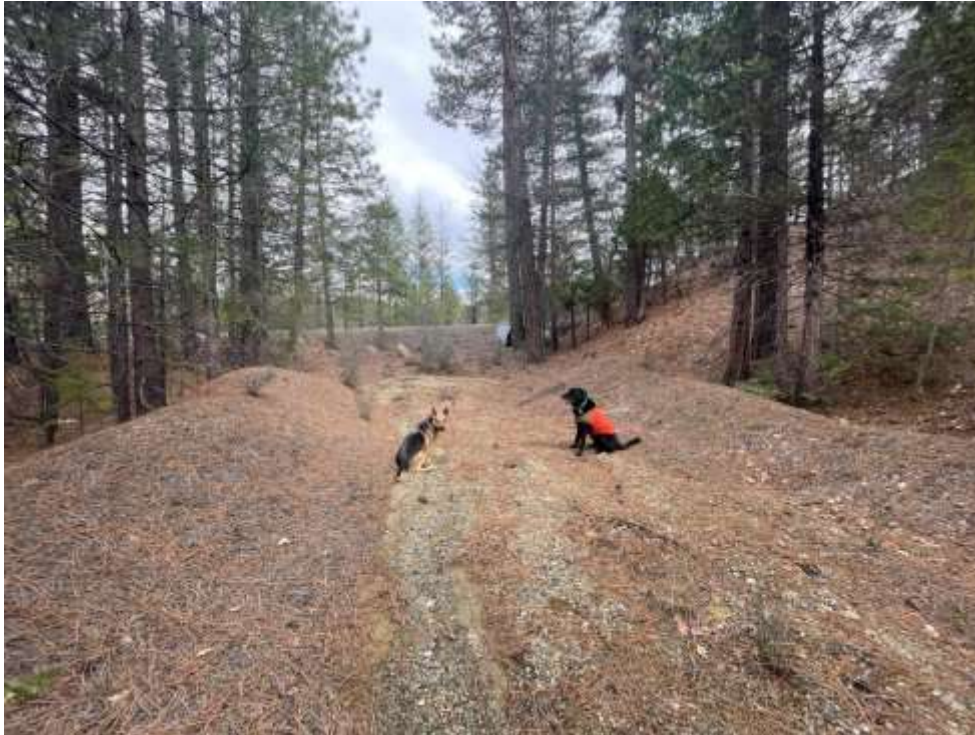
*Photo 2.52: EFG 24 downstream of bypassed culvert. April 5, 2024.*

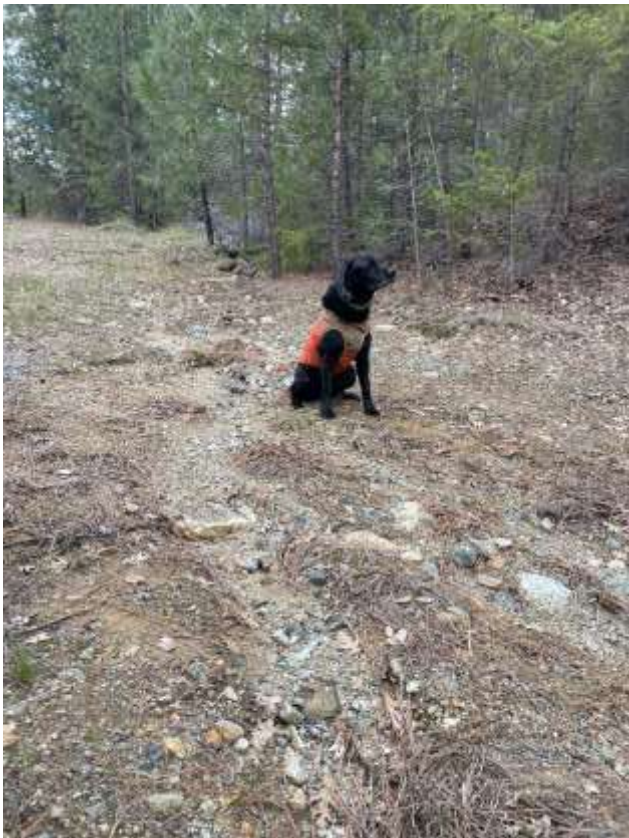
*Photo 2.53: EFG 24 crosses the private road. April 5, 2024.*

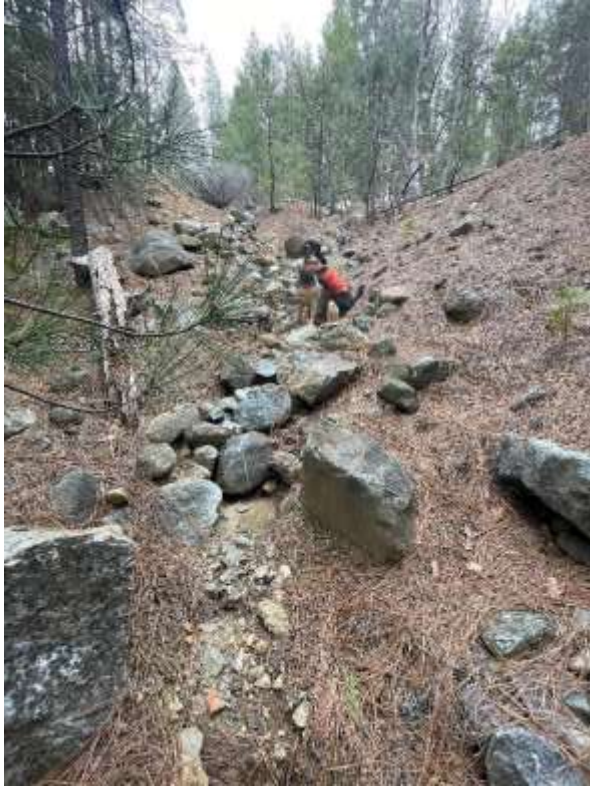
*Photo 2.54: EFG 24 below road. EFG24b. April 5, 2024. EFG24e. April 5, 2024.*

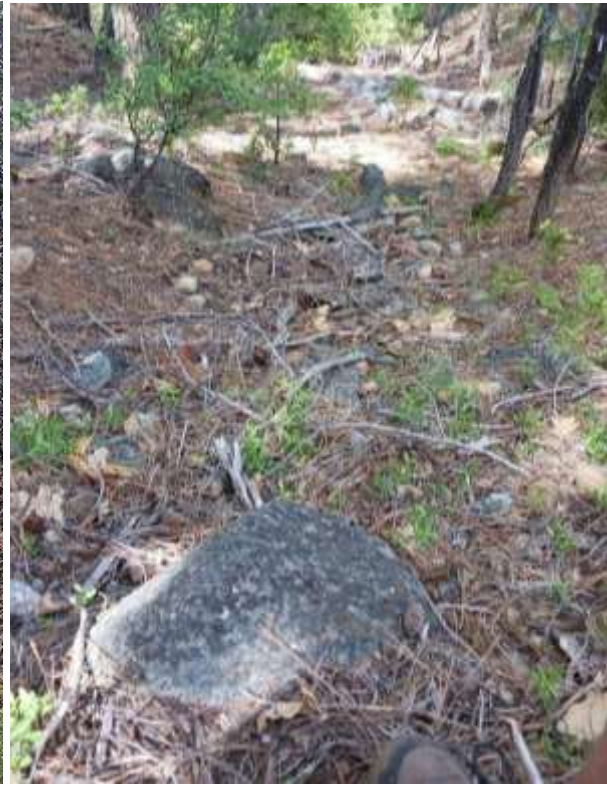
*Figure 2.57: Looking downslope from beginning of gully. EFG6.1a. May 29, 2023.*
