# ***Beaver Valley Headwaters Preserve: SRWC Final Report***

A Compendium of Natural Resource Information  
Collected to Inform Management Decisions  
Related to Riparian Habitat, Stream Channel  
Restoration and Enhancement & Forest Health  
Resiliency

*Prepared by Scott River Watershed Council  
May 1, 2024*

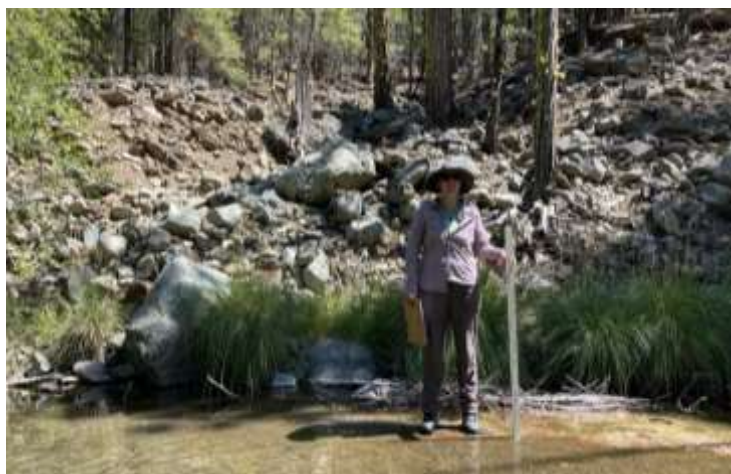
The first site where active erosion was documented in this reach is at transect EF-05, however, at this site the erosion was considered insignificant. But at the next transect (EF-06) severe and active erosion was documented (Photo 1.2). As illustrated in Figure 7, this is the site of a drainage entering the East Fork on river left that is causing instability of the streambank. In addition, due to the deposition of bedload into the East Fork from the unnamed gully, streamflow is impinged, creating a gravel bar and a large shallow pool which is likely subject to warming in the summer sun. While active erosion was documented at transect EF-07, this erosion was also considered insignificant.

Photo 1.2: Severely eroded gully located on river left at transect EF-06. August 24, 2022.

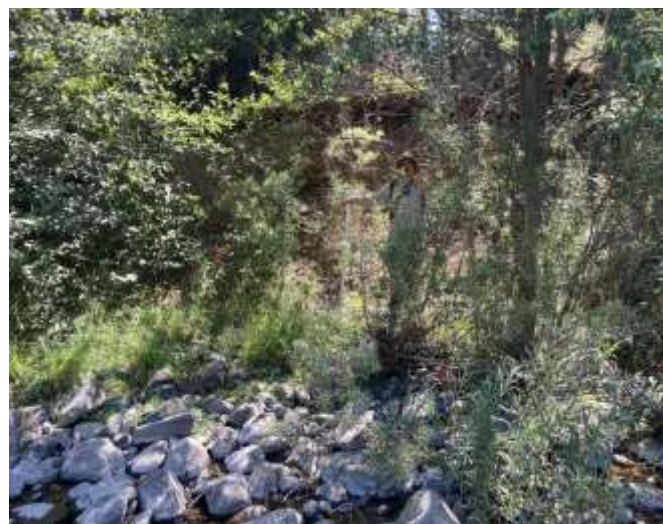
There is significant and severe erosion at transect EF-14 (Photo 1.4). Two types of erosion were observed here, a gully entering the East Fork Scott River and a large cut bank. The cut bank is approximately 12 feet high (Figure 1.4) and 165 feet long. There is a wide bar in the river due to depositional materials opposite the site of the erosion. Based on the topography the gully likely sends flashy flows into the East Fork and therefore, has created a cut bank. The erosion at EF-14 is addressed more completely elsewhere (Roads and Gullies in Chapter 2). At site EF-15, the field crews noted that the flows on September 1, 2022, were insufficient to keep the river connected and the flow goes underground. Cattle were observed in the creek at this location. As mentioned above and illustrated in Table 1.3, vegetation in the area is considered sparse.

Photo 1.4: Severe erosion site located at transect EF-14. September 1, 2022.

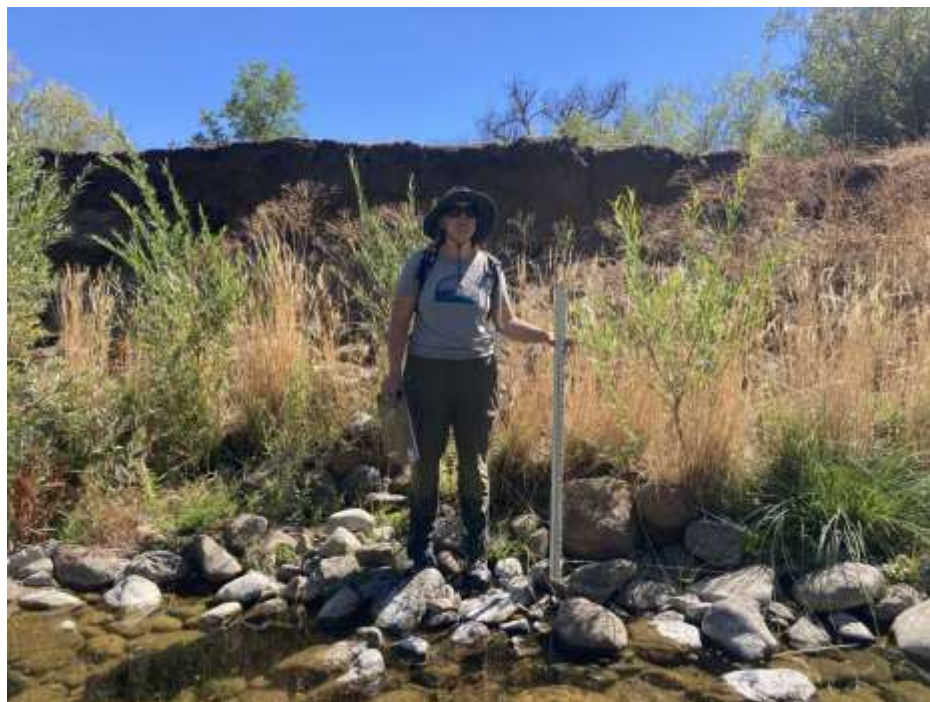
Photo 1.5: Significant active erosion occurring at Transect EF-20. September 1, 2022.

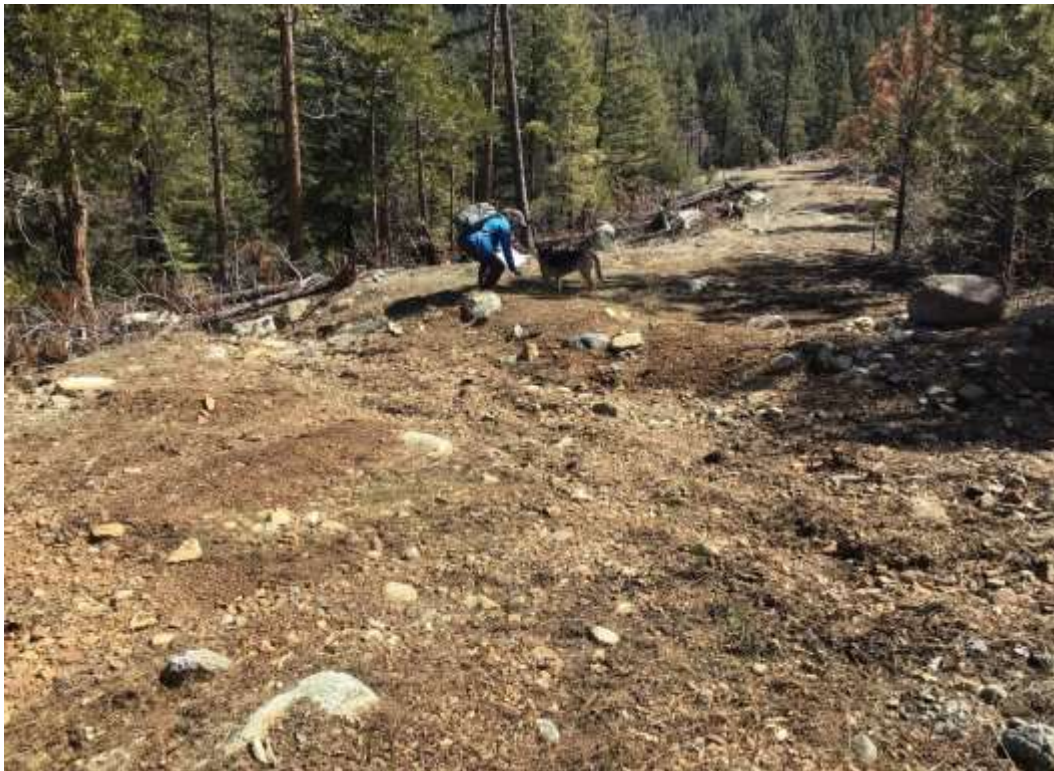
Photo 2.2: Example of moderate erosion point. EFR11.2, April 13, 2023.

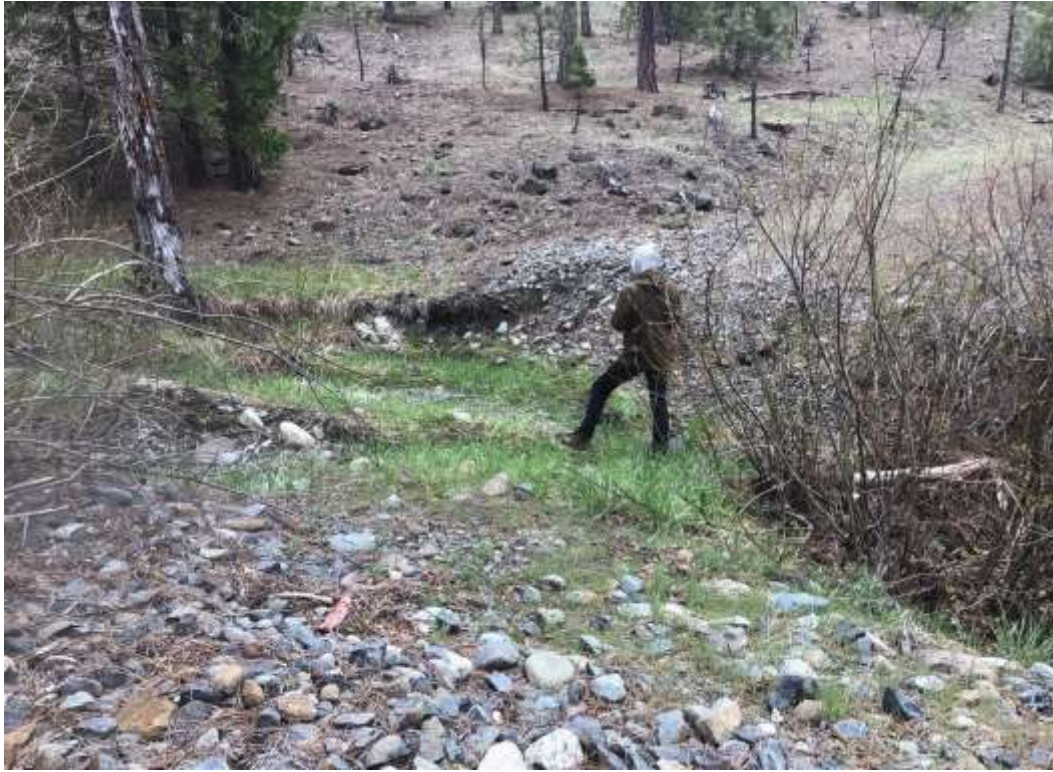
Extreme road or fill erosion were identified at 19 points. Of those, 12 were associated with gullies (Table 2.3) and will be incorporated into the gully analysis. Five of the remaining seven points did not discharge sediment to a stream or gully connected to a stream. Two of them are points where a road crosses an unnamed tributary that enters Noyes Valley Creek at RKM 1.6 (Photo 2.4 & 2.5).

Photo 2.4: Road crossing unnamed tributary to Noyes Valley Creek. EFR30. May 5, 2023.

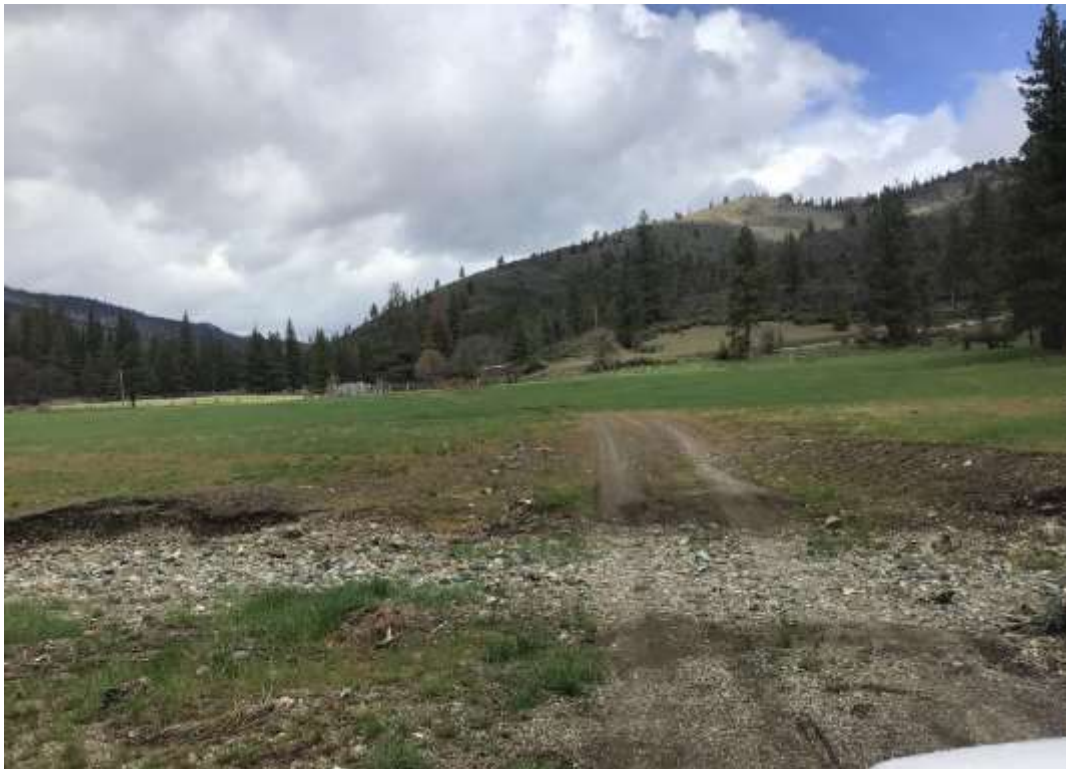
Photo 2.5: Road crossing unnamed tributary to Noyes Valley Creek. EFR49. August 5, 2023.

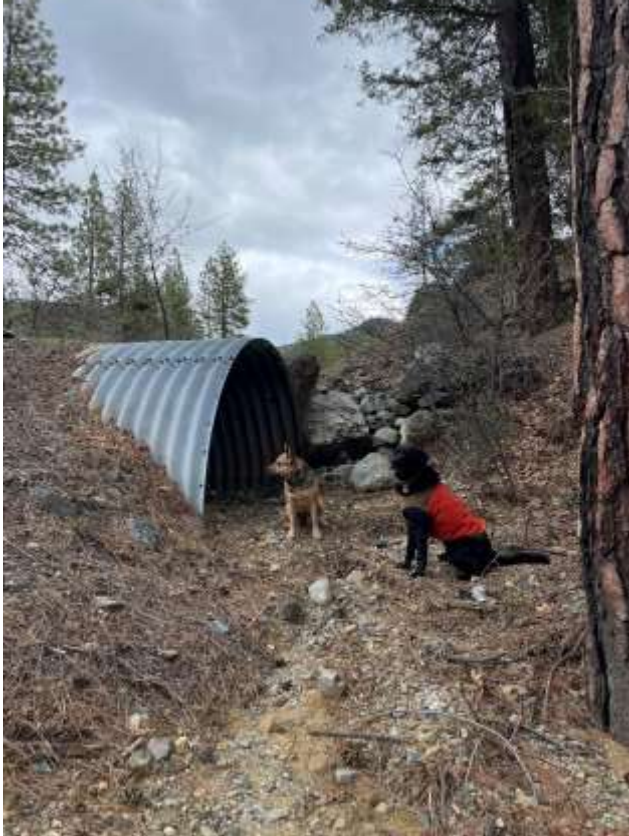
Gully 24 (Table 2.9) begins where the inboard ditch on Highway 3 flows past the mouth of a culvert instead of being directed into the culvert (Photo 2.17). Gully 24 continues on the inboard side of the highway, crosses the private road dirt road (extreme erosion) (Photo 2.18) and cuts down the bank to discharge in Big Mill Creek (Photos 2.19 and 2.20). Big Mill Creek joins the East Fork Scott River about 90 feet downstream.

Photo 2.17: Beginning of EFG 24. Inboard ditch flows past culvert. EFG24a; April 5, 2024.

Water management related to Highway 3 causes, or exacerbates, erosion in almost all the high severity gullies and gully complexes. While it may not be feasible to improve water handling on Highway 3, methods to slow the flow--and hence decrease erosion--could reduce sediment delivery to the East Fork Scott River and protect the private roads from further damage.

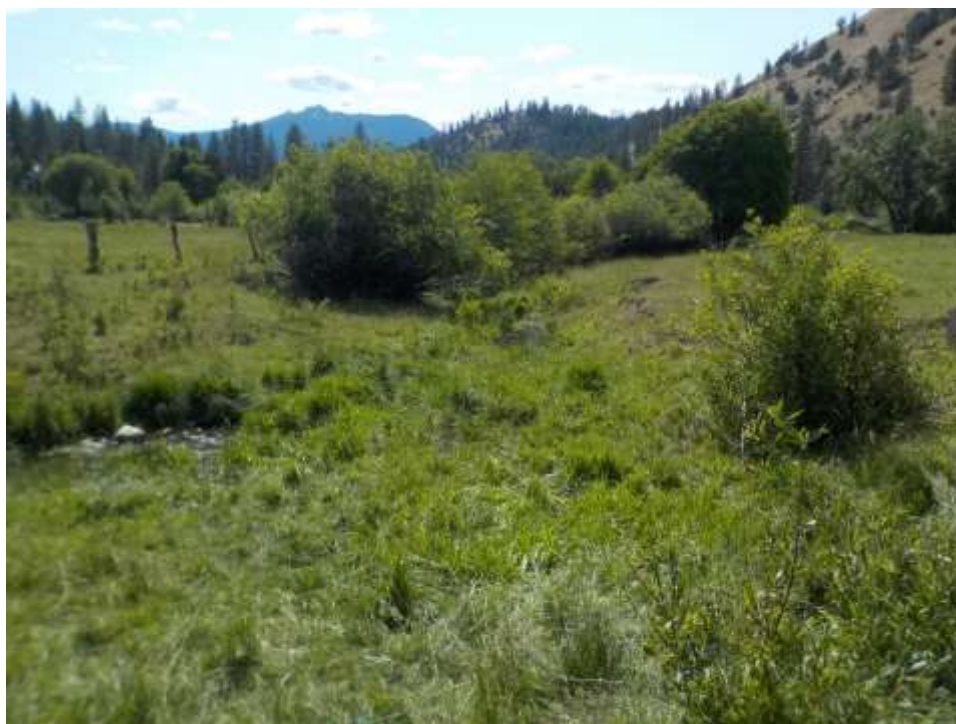
*Photo 6.7: Unfenced Noyes Valley Creek with limited vegetation - looking downstream. June 21, 2023.*

The SRWC installed cattle exclusion fencing along the East Fork Scott River and two stock water systems in the fall of 2022. Cattle exclusion fencing along Noyes Valley Creek is proposed (Map 6.15). Restoration designs are being developed for Lower Noyes Valley Creek with a potential realignment of the downstream section and confluence with the East Fork Scott River.

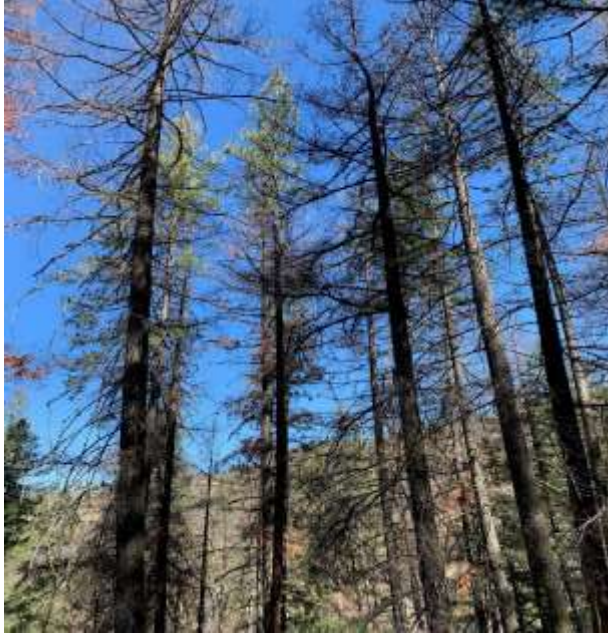
*Photo 7.2: Dead and dying conifer in proposed drought mortality treatment unit. March 25, 2024.*

Douglas-fir dominant mixed-conifer forests in the East Fork watershed are experiencing tremendous rates of mortality in areas near and below 3,500 feet in elevation. Plot data collected shows that approximately 83% of mature Douglas-fir trees within the proposed treatment units are either dead or dying (Photo 7.2). Stands on north-facing aspects are experiencing high levels of mortality in Douglas-fir while pine and oak, which are more tolerant of drought conditions, remain viable (Photo 7.3). Treatment is proposed for 63 acres in mixed conifer stands and only dead or dying trees will be removed. The resulting stand post-treatment in these areas will be a more open pine-oak association with scattered Douglas-fir. Douglas-Fir that regenerates on these sites will likely die when it grows to a size where water is a limiting factor (Bennett and Adlam 2023). Historically, frequent low intensity fires would have kept Douglas-fir from regenerating in these areas (Photo 7.4).

Current proposed drought mortality treatments should be implemented as soon as possible to reduce hazardous fuel loading and to utilize trees while they are still economical to remove. By removing the dead and dying trees using a combination of commercial harvest and the production of chips, this allows for a large quantity of the bulk material to be removed, eliminating excess mastication and/or burning methods. There is also the ability to couple instream restoration activities with the need for large wood. Using material from TWC can also aid in the goals of removal of the excess biomass and put it to work in instream habitat restoration projects, both on TWC and other areas of the Scott River watershed. Post-treatment monitoring should be conducted to limit the spread of invasive species and ensure that erosion control measures are succeeding.

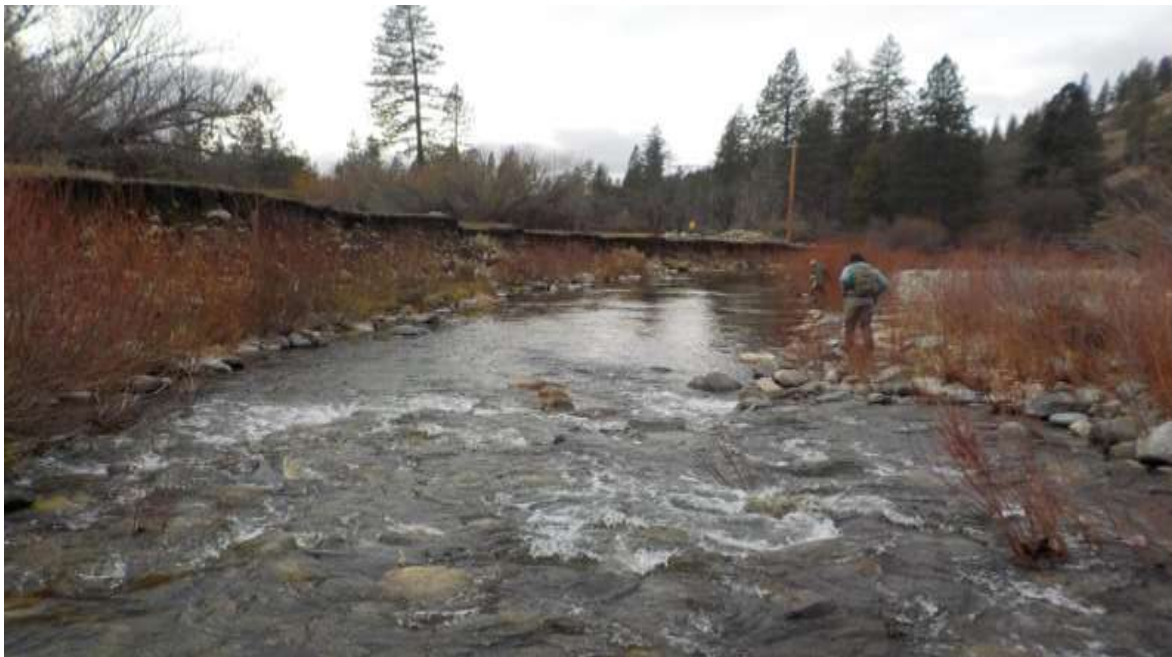
Cutbank at RKM 4.2 with thin band of willow on river left and river right bar - looking downstream

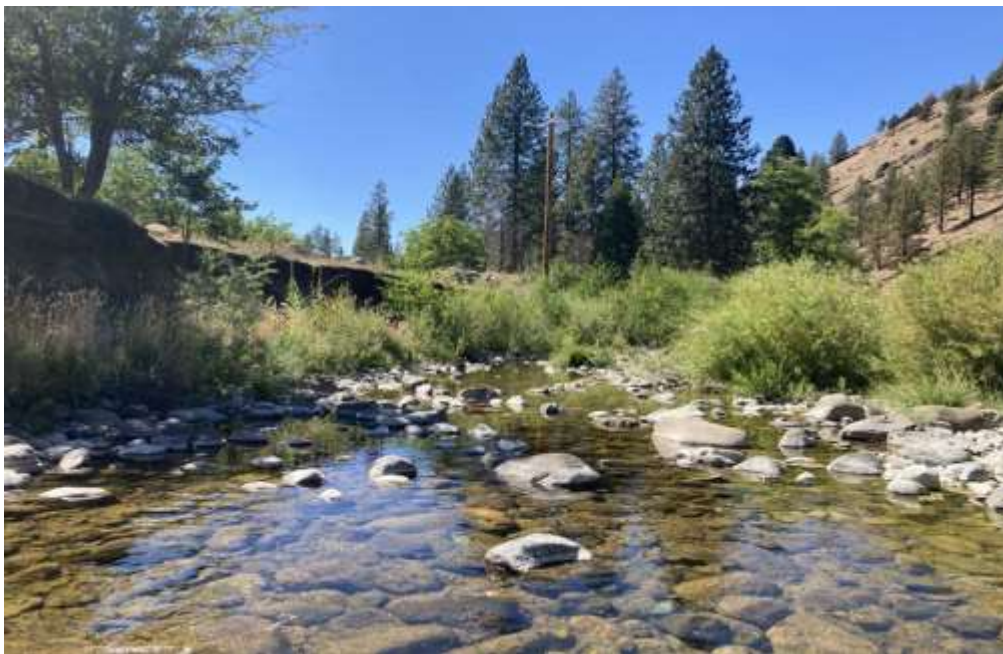
Cutbank at RKM 4.2 - Looking Downstream - Summer 2022

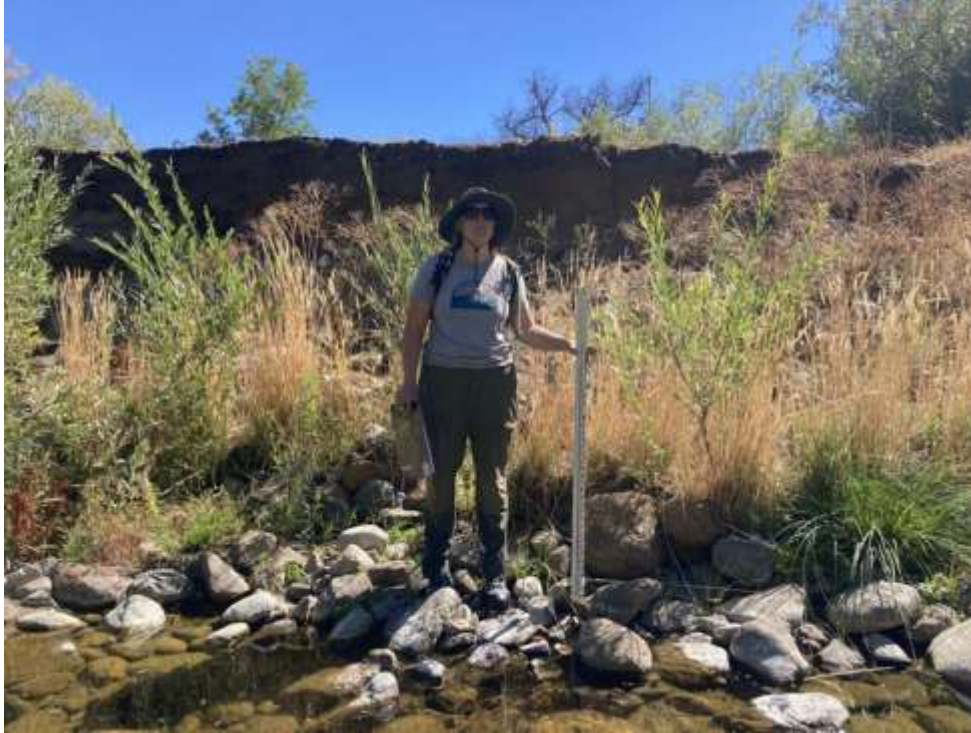
Cutbank at RKM 4.2 - illustrating riparian vegetation at toe of eroding bank

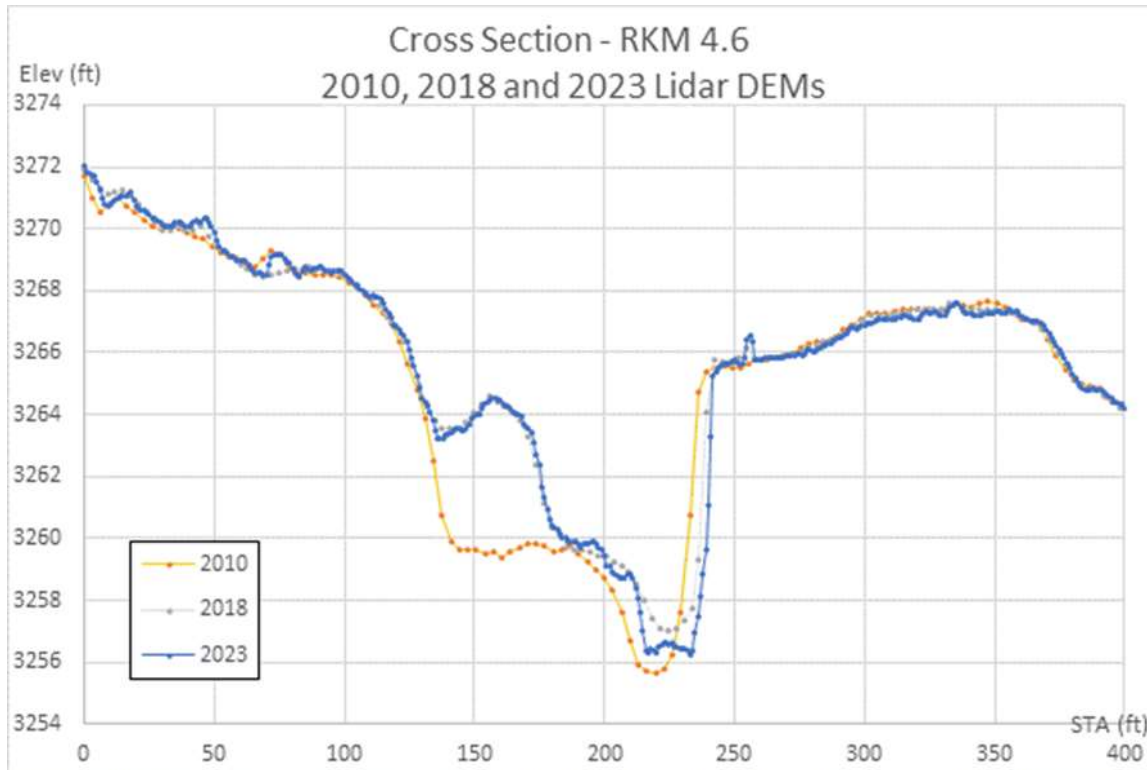
Figure 8 - 2010, 2018 and 2023 LiDAR Cross Section - East Fork Scott River RKM 4.6

At the RKM 4.6 cross section upstream of the Big Mill Creek confluence four feet of sediment deposition occurred on the river left bar between 2010 and 2018 with lateral streambank migration occurring at river right (Figure 8). Limited geomorphic change was observed at the RKM 4.6 cross section between 2018 and 2023. Three feet of aggradation of the main channel from 2010 to 2023 was observed at the RKM 4.65 cross section (Figure 9). Geomorphic changes were observed at

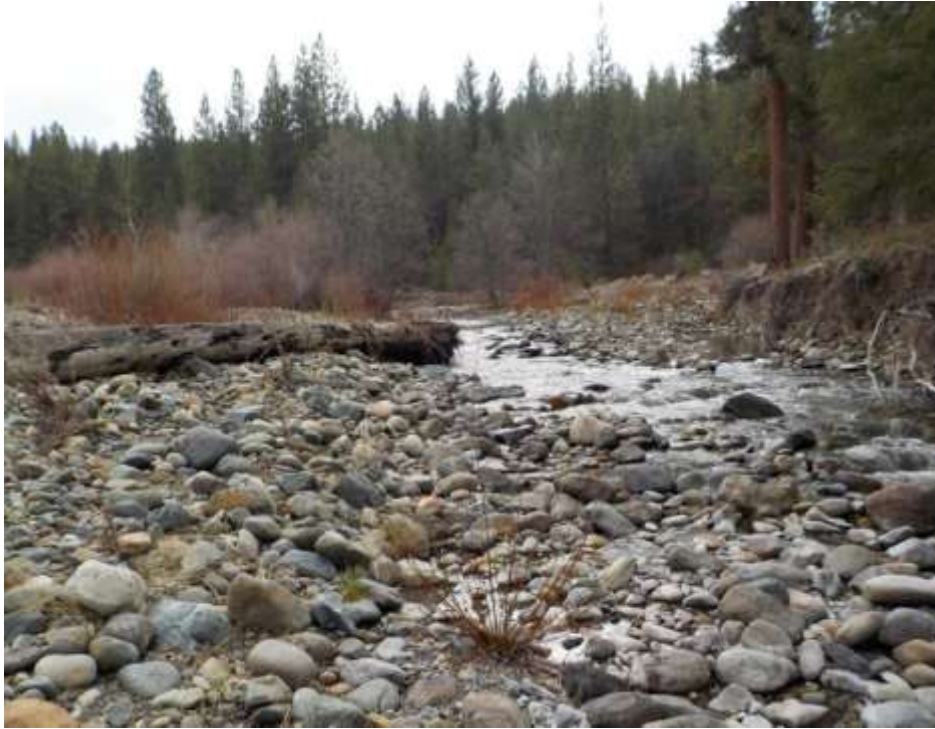
Upstream end of incised channel at RKM 5 with river left cutbank - looking upstream

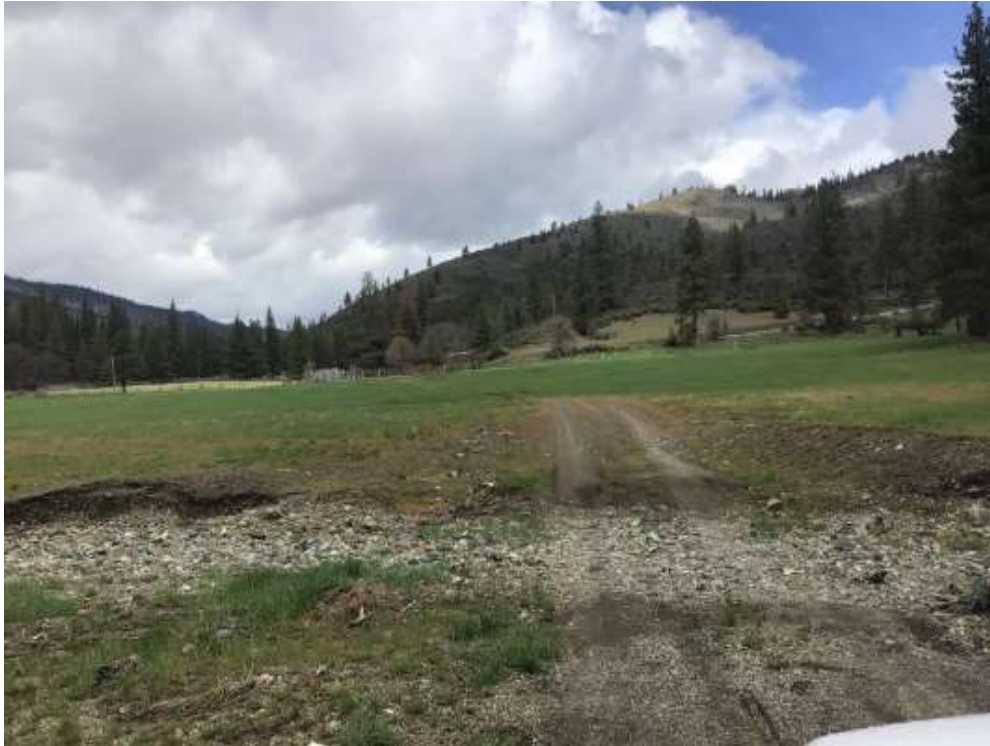
*Photo 2.2: road crossing Gully Complex 49 (natural stream). EFR49. August 5, 2023.*

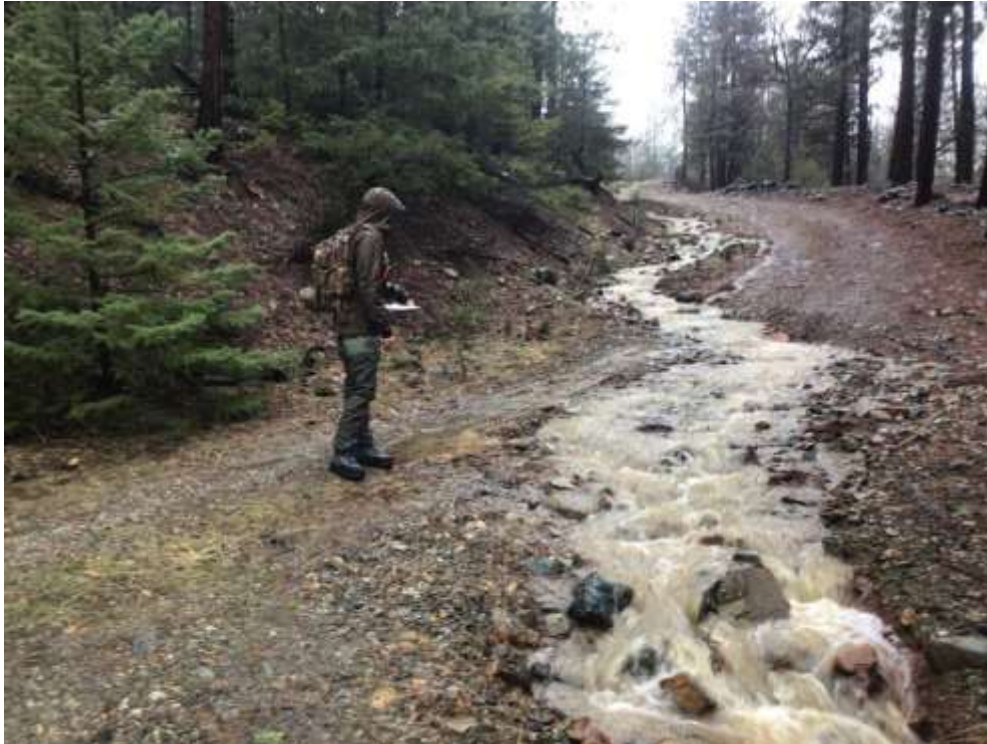
*Photo 2.5: Water during runoff event crossing road, looking upslope. EFR2. January 13, 2023.*

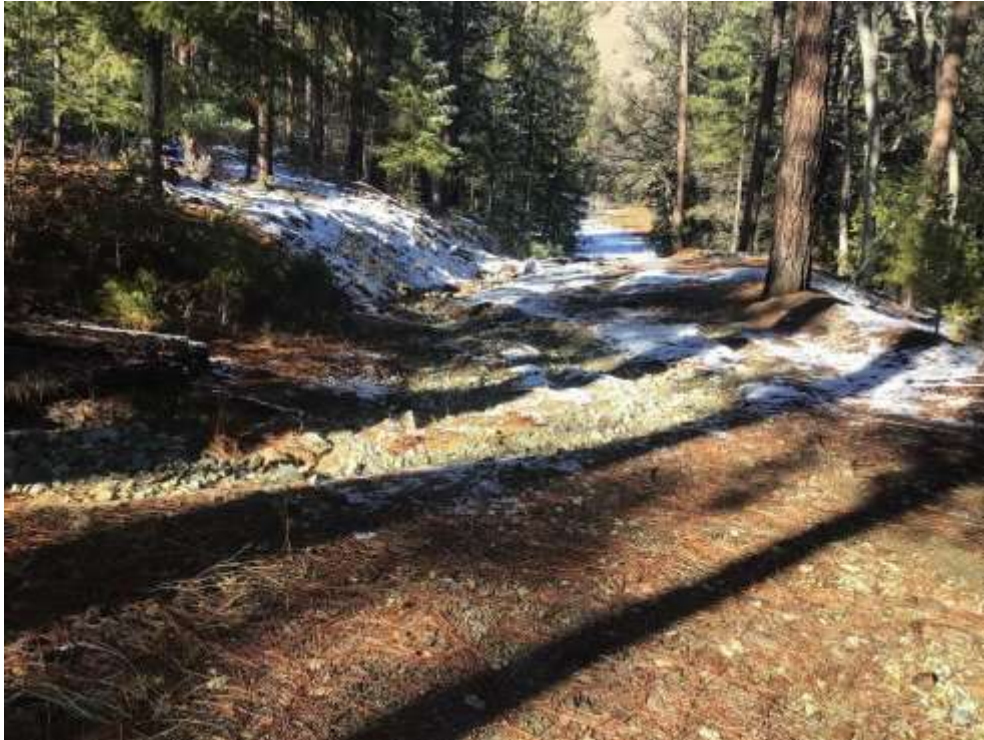
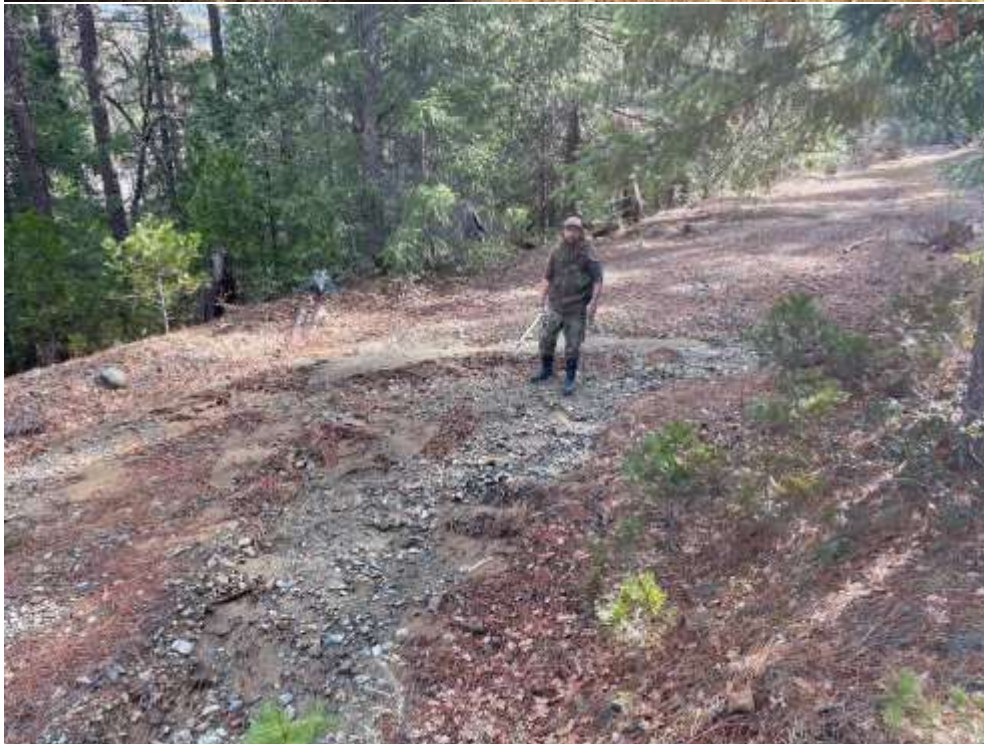
Photos 2.8 & 2.9: Flow path on road. EFR14; January 20, 2023. EFG2e. January 19, 2024.

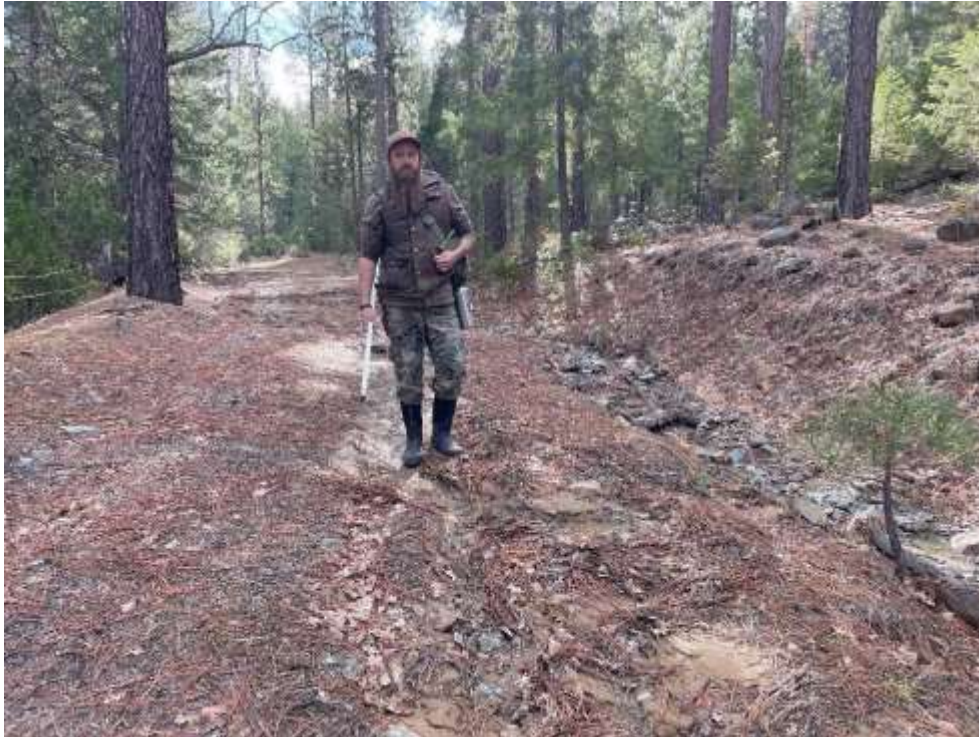
*Photo 2.10: Flow divided between road and un-engineered inboard ditch. EFG2e. January 19, 2024.*

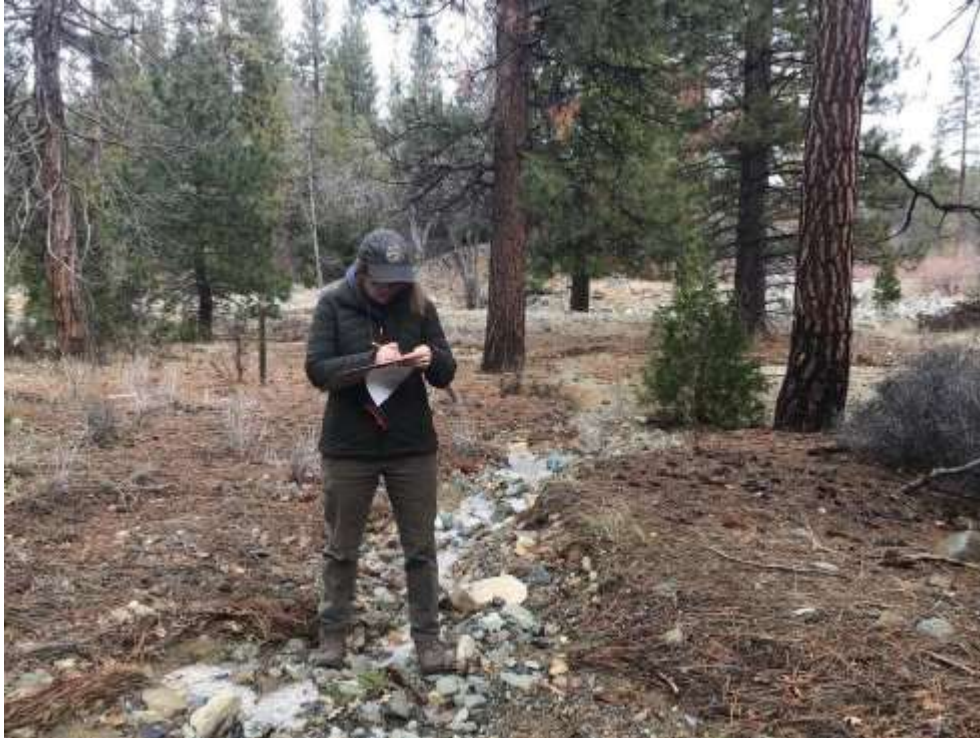
*Photo 2.12: Flow path leaving road. EFR13.1. February 10, 2023.*

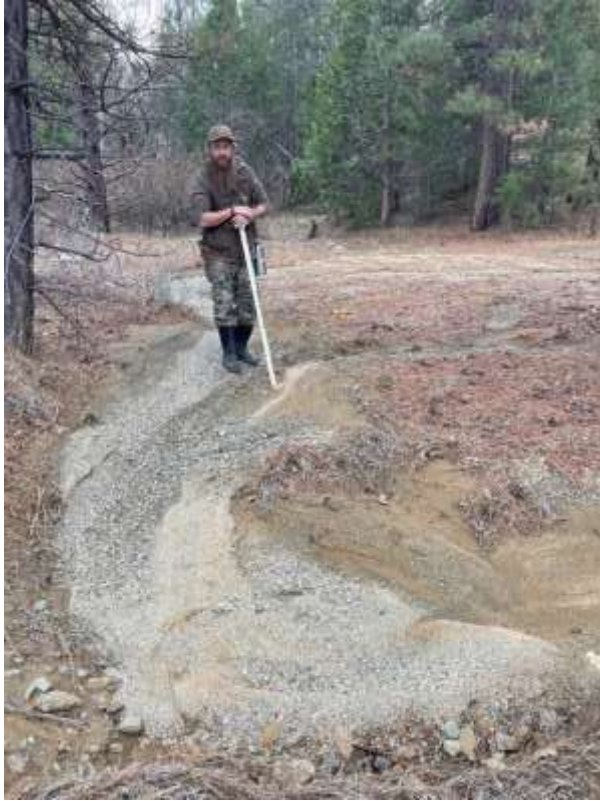
*Photo 2.13: Sediment deposited by Gully Complex 2. EFG2f. January 19, 2024.*

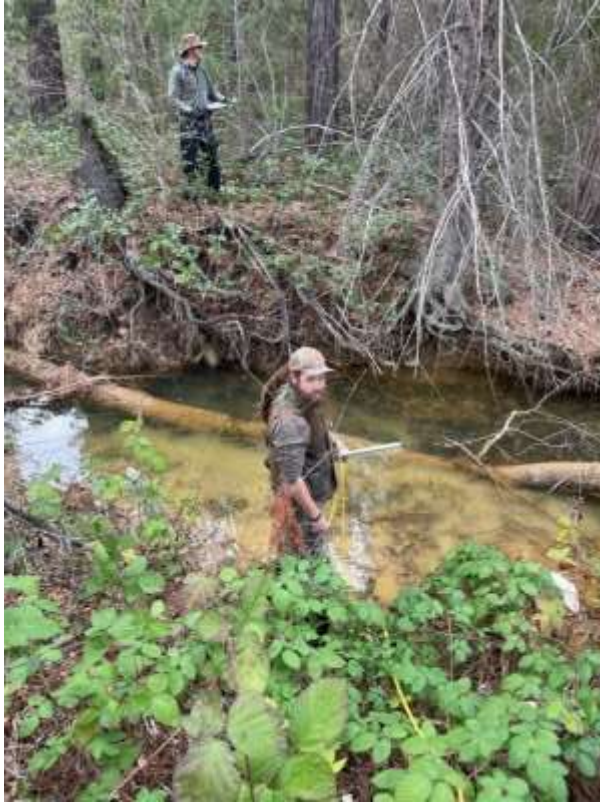
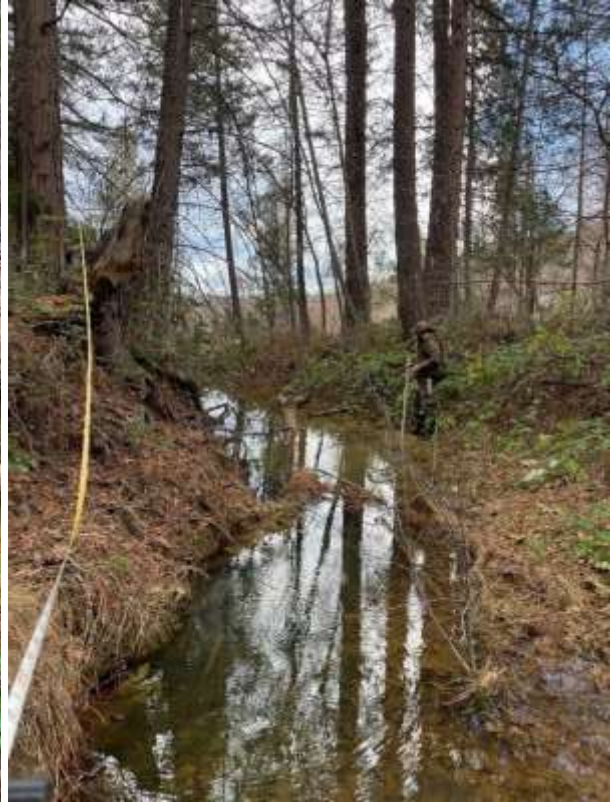
Photos 2.14 & 2.15: Maximum cross-section of Gully Complex 2 is 89 ft<sup>2</sup>. EFG2i. January 19, 2024.

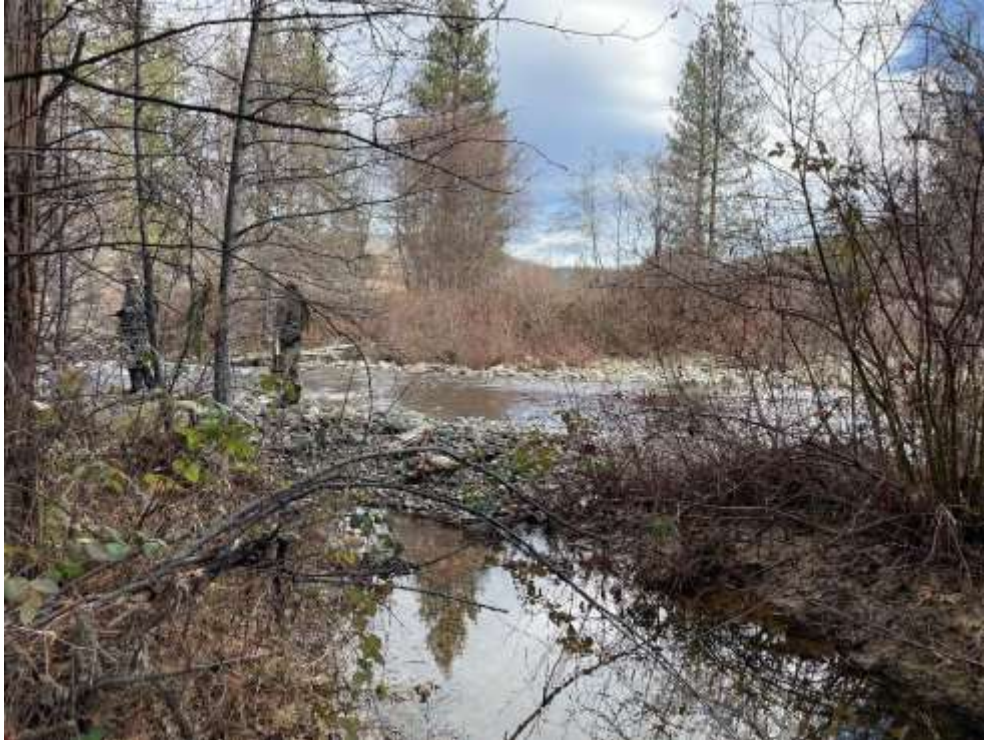
*Photo 2.16: Gully Complex 2 discharges into the East Fork Scott River. EFG2j. January 19, 2024.*

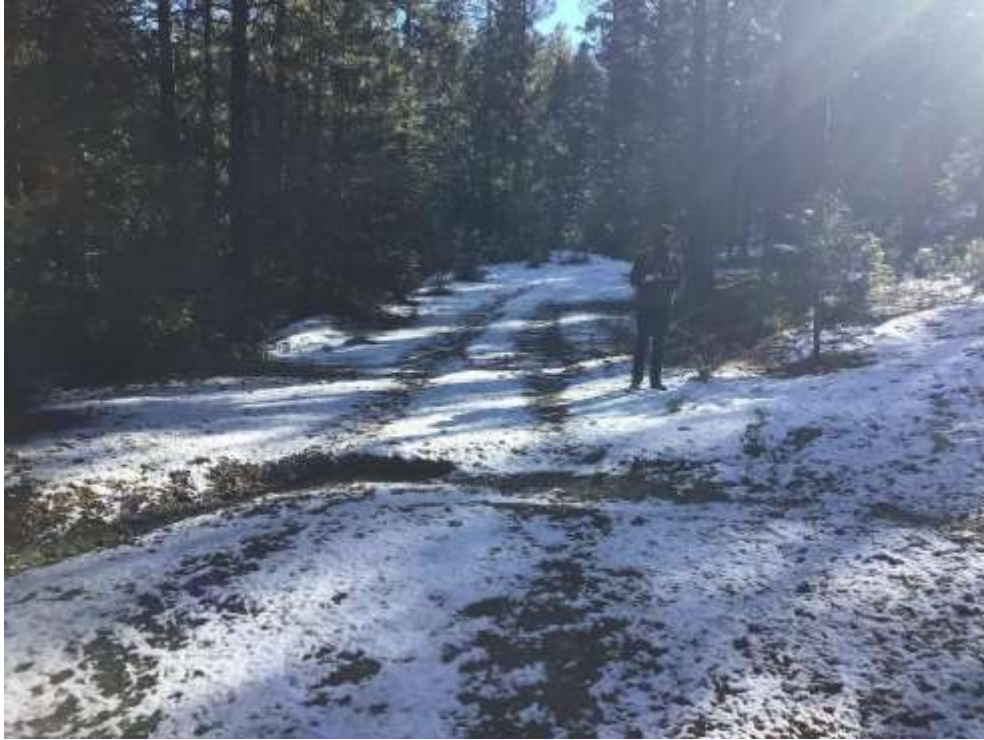
Gully 2.1 (photos below) is a smaller gully that leaves and returns to Gully 2

*Photos 2.17 & 2.18: Gully Complex 2 crossing lower road. EFR13. January 20, 2023.*

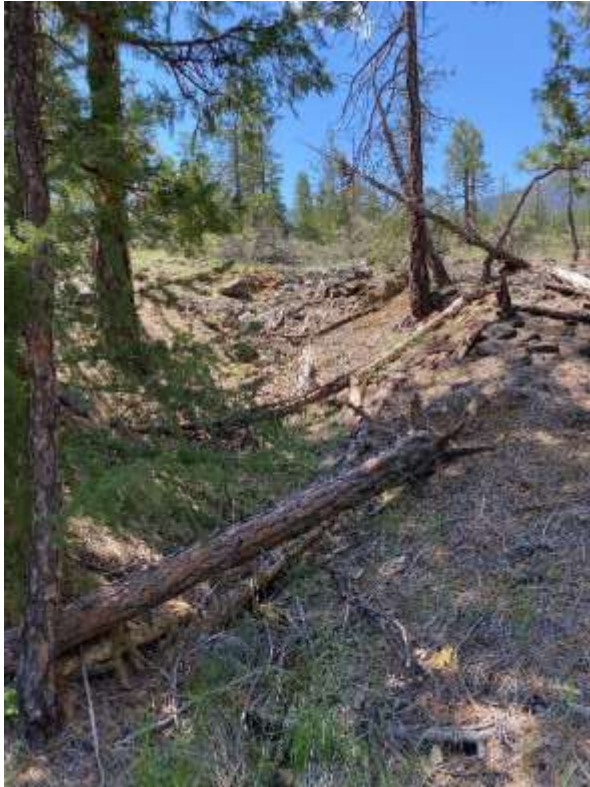
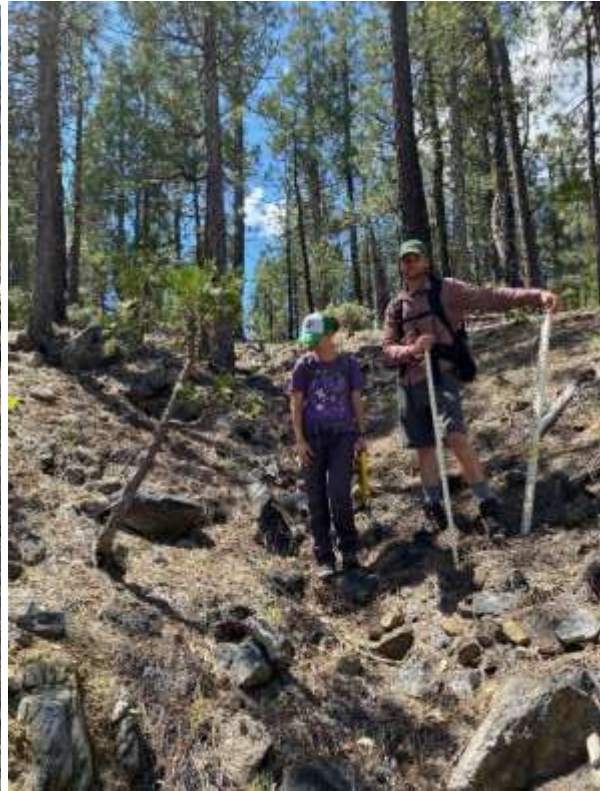
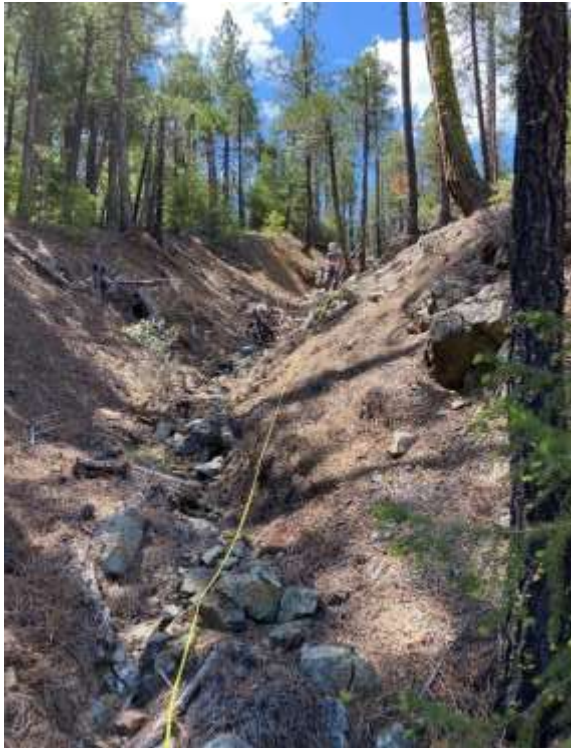
*Photos 2.19, 2.20 & 2.21: Gully 8 above Highway 3. EFG8c, EFG8d and EFG8.; May 29, 2023.*

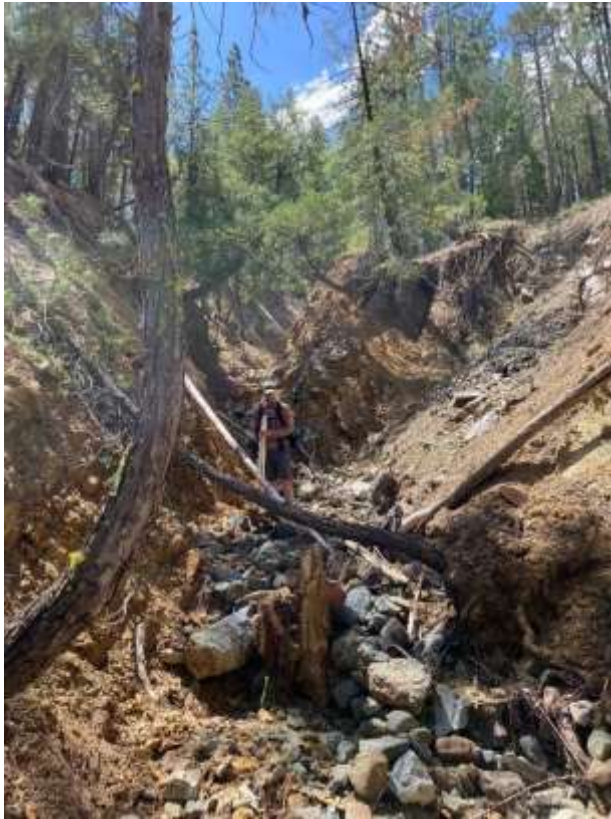
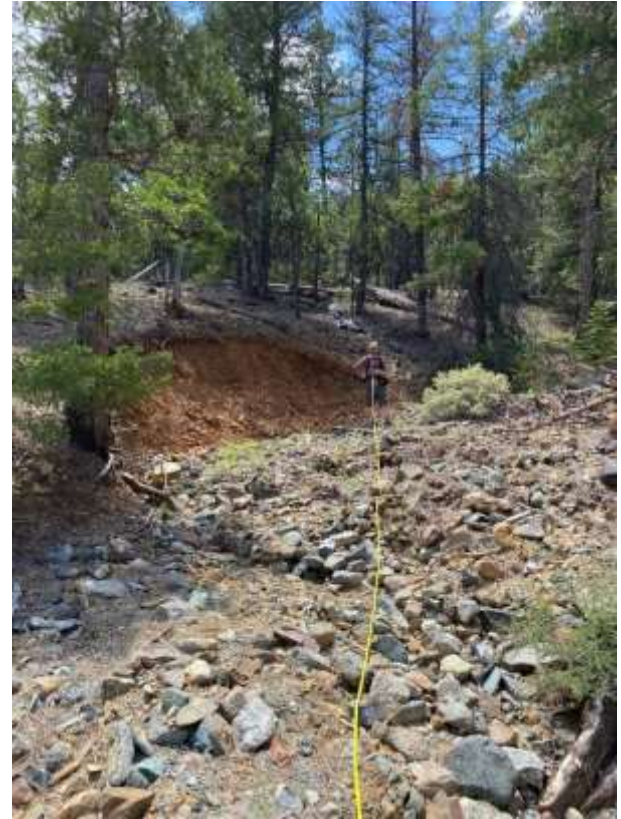
Photos 2.25 and 2.26: Left, maximum cross-section. EFG8f. Right, below bifurcation. EFG8h. May 29, 2023.

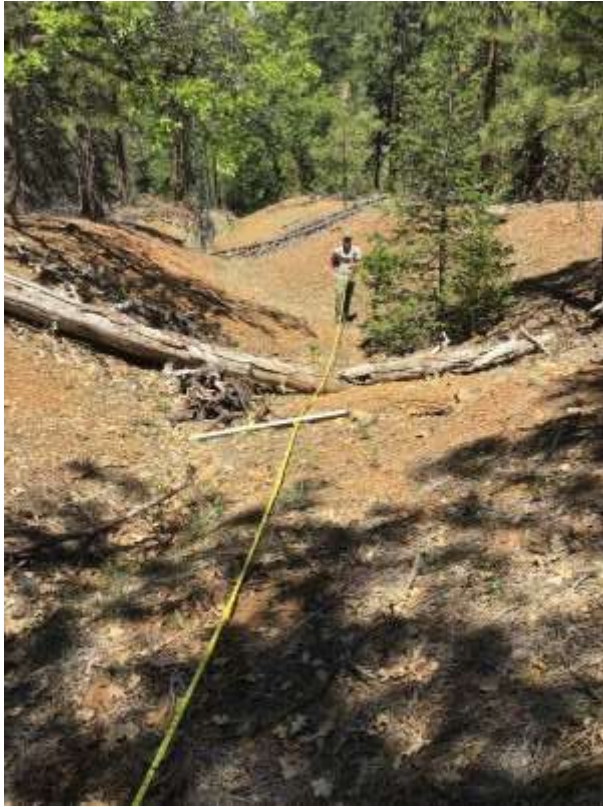
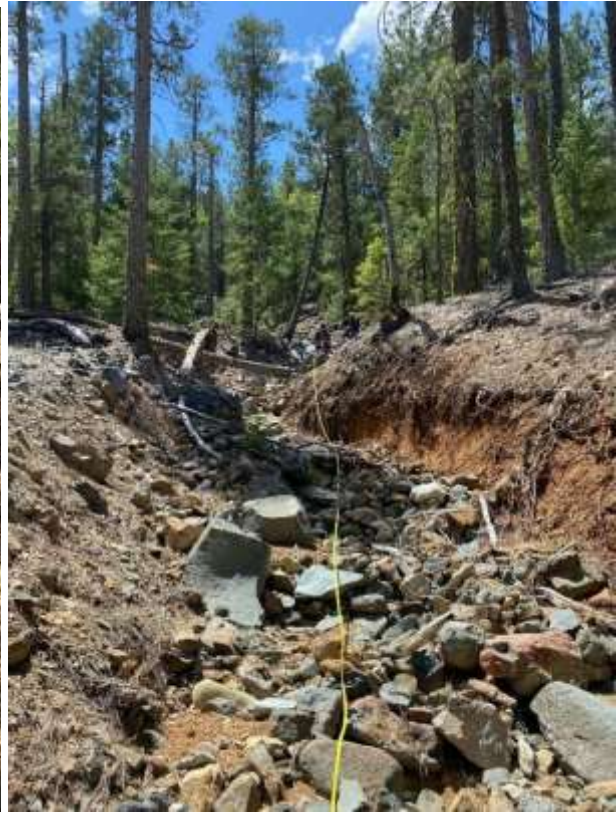
*Photos 2.27 and 2.28: Segments below bifurcation. EFG9b and EFG8g. May 29, 2023.*

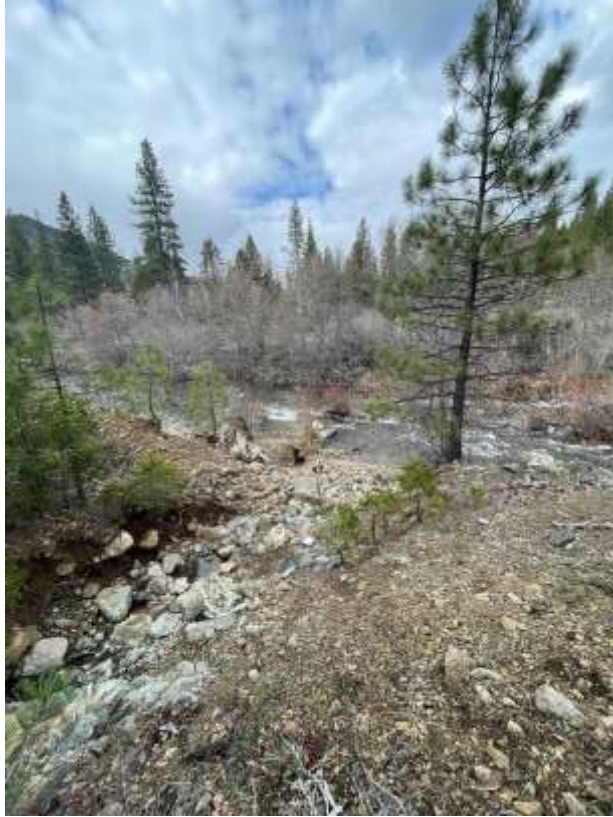
*Photo 2.29: EFG 8.2 discharges into the East Fork Scott River. EFG8j. May 29, 2023.*

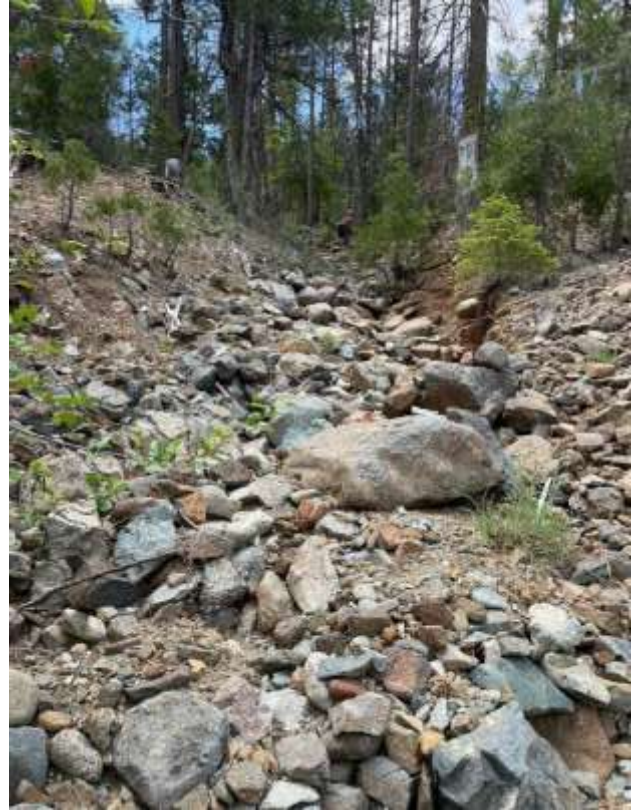
*Photo 2.30: Looking upslope from the confluence of EFG 8.2 and the East Fork Scott River. EFG8j. April 5, 2024.*
