# ***Beaver Valley Headwaters Preserve: SRWC Final Report***

A Compendium of Natural Resource Information  
Collected to Inform Management Decisions  
Related to Riparian Habitat, Stream Channel  
Restoration and Enhancement & Forest Health  
Resiliency

*Prepared by Scott River Watershed Council  
May 1, 2024*

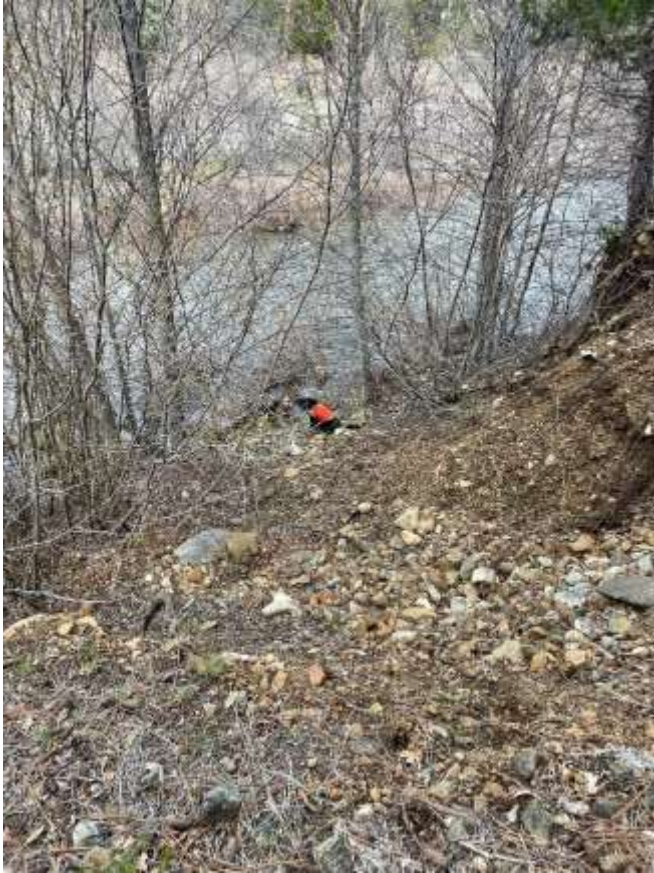
*Photo 2.31: EFG 8.3 discharges into the East Fork Scott River. EFG9. April 5, 2024.*

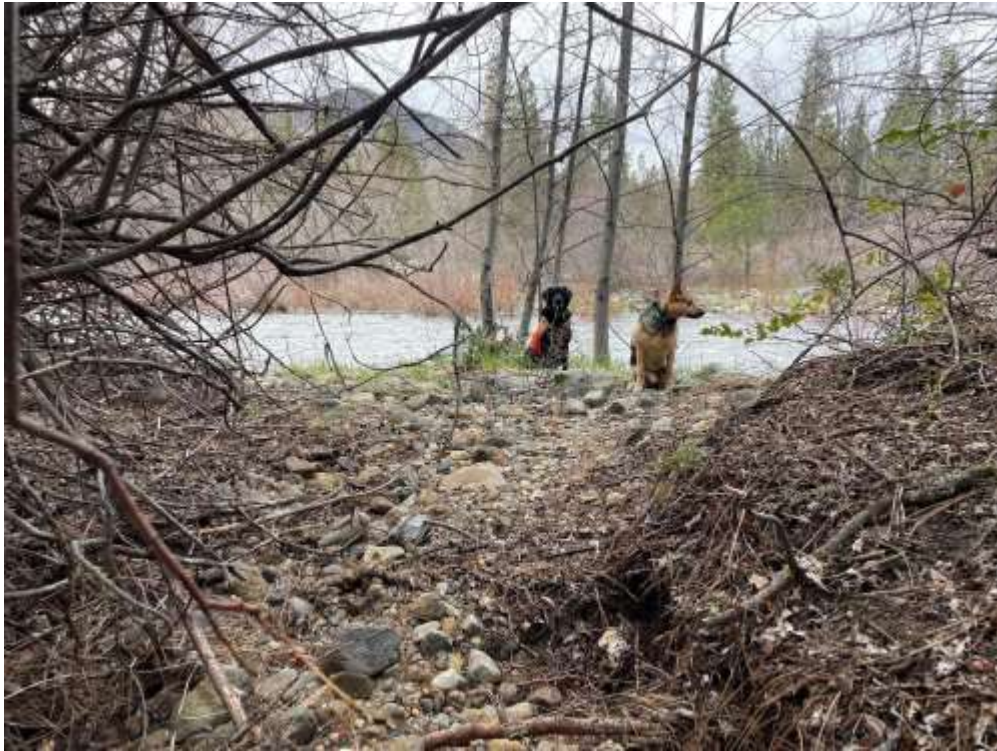
*Photo 2.33: EFG 8.4 discharges into the East Fork Scott River. EFG10e. April 5, 2024.*

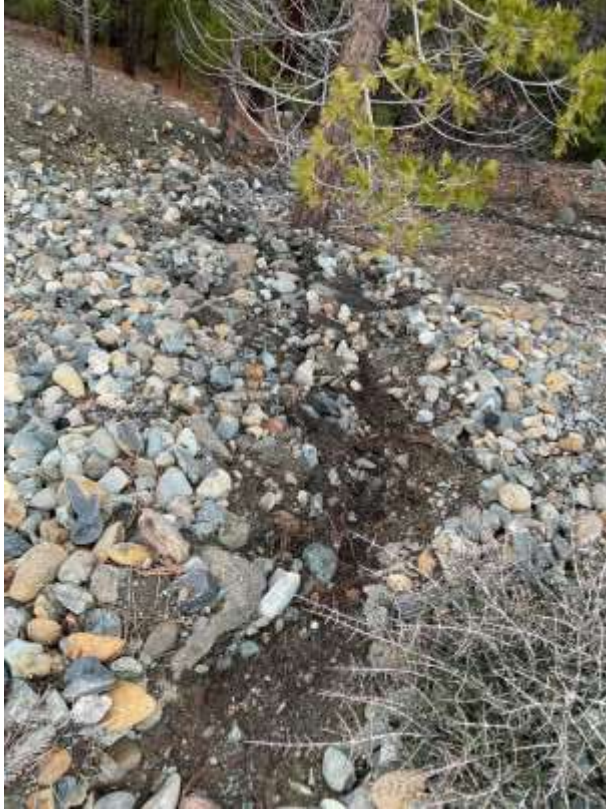
*Photo 2.36: Discharge from outboard ditch erodes fill at the top of Gully Complex 12. January 18, 2024.*

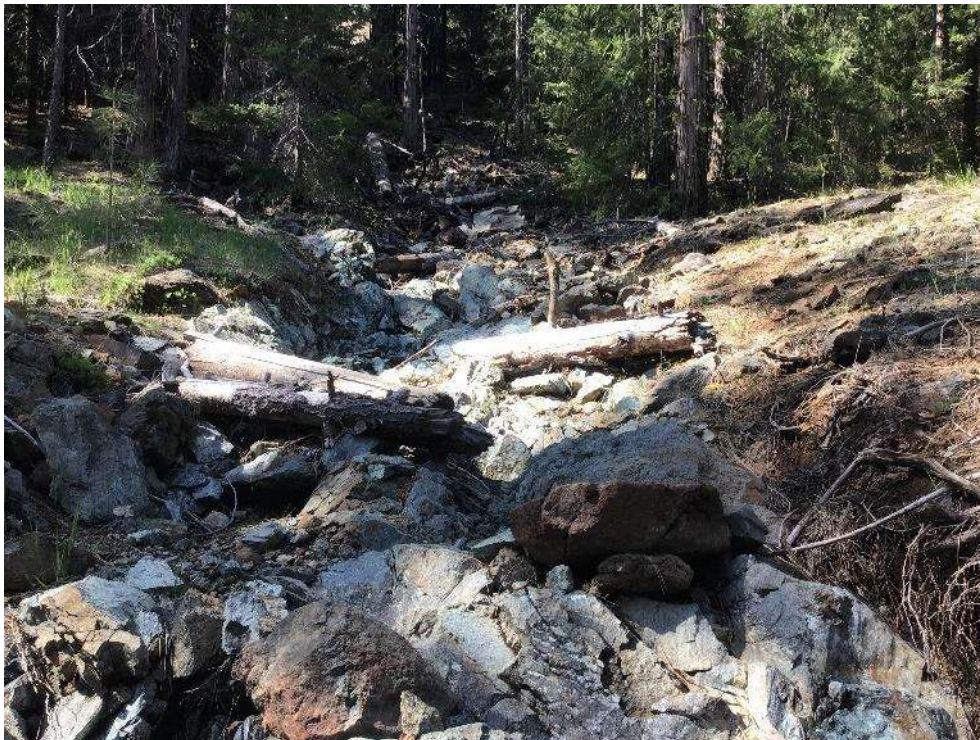
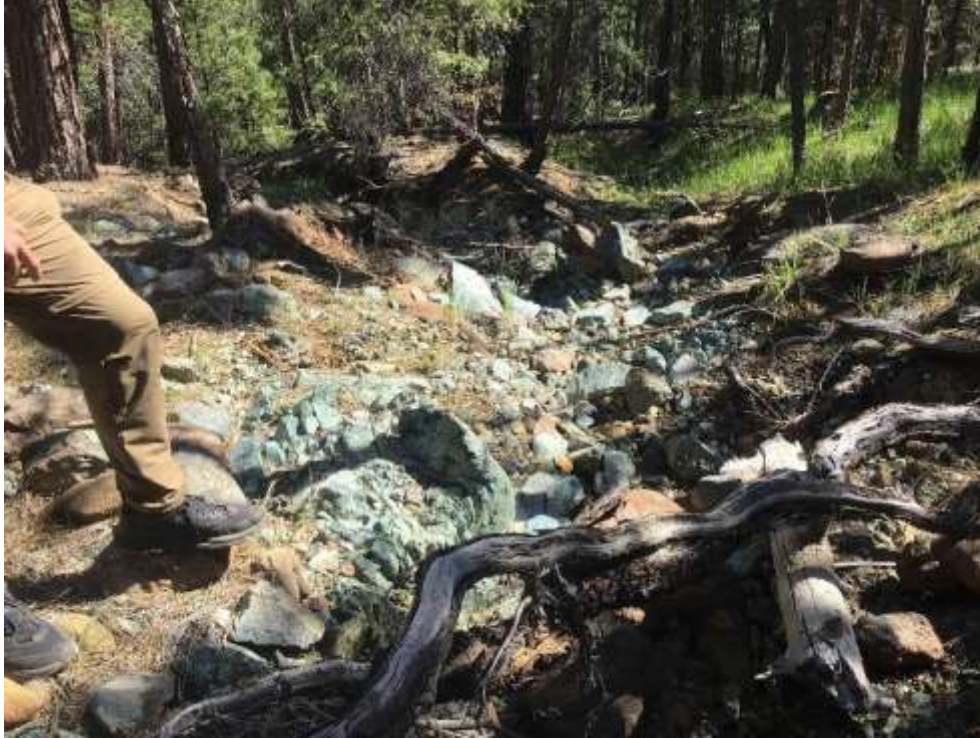
Photos 2.37 & 2.38: Typical features in Gully Complex 12. EFG12

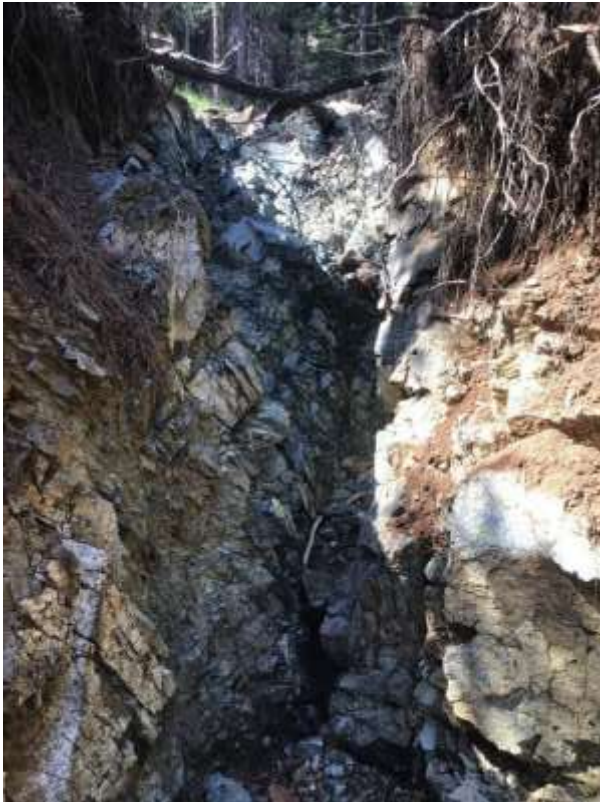
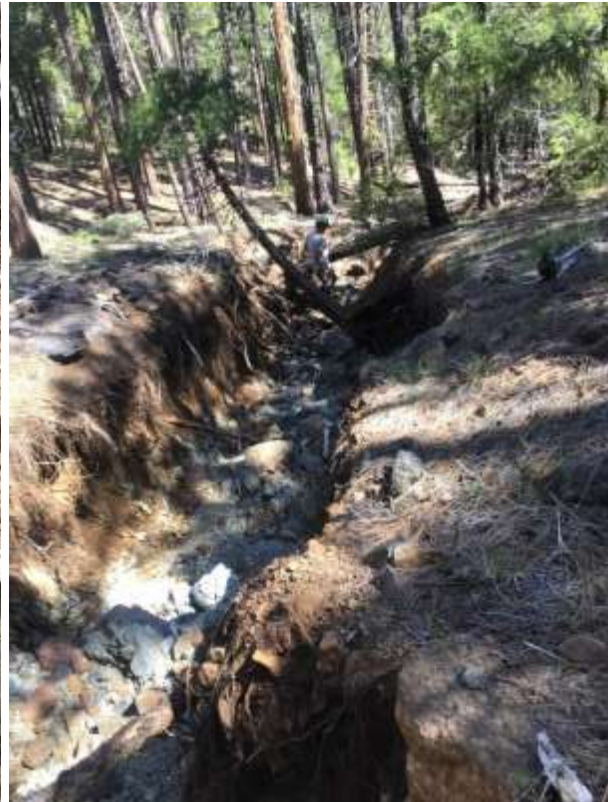
Photos 2.39 & 2.40: Greatest cross-section of Gully Complex 12 is 32 ft<sup>2</sup>; looking up and down the gully at that point.

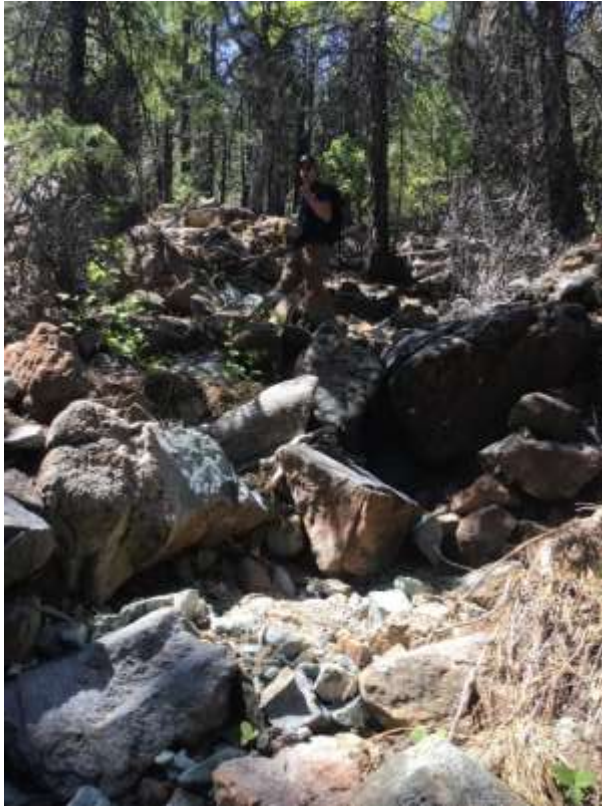
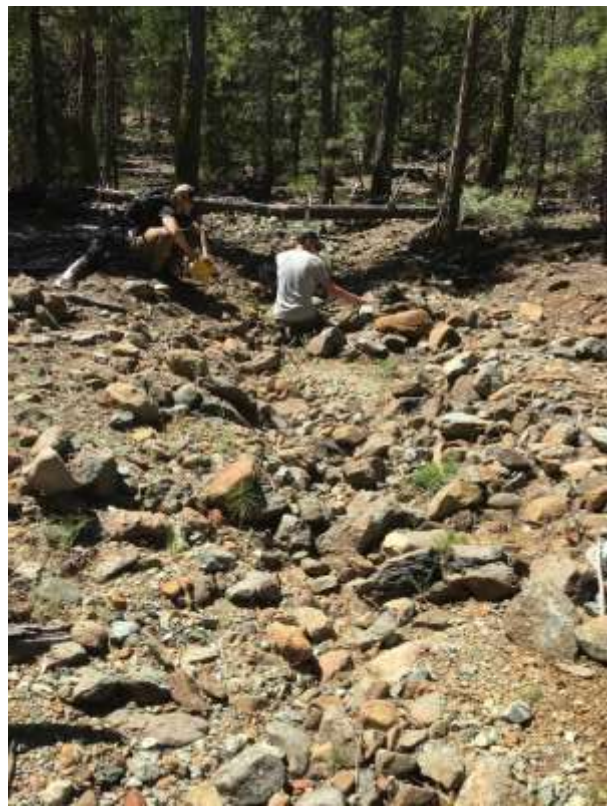
*Photos 2.41 and 2.42: Typical features in Gully Complex 12. EFG 12d and EFG12g. May 23, 2023.*

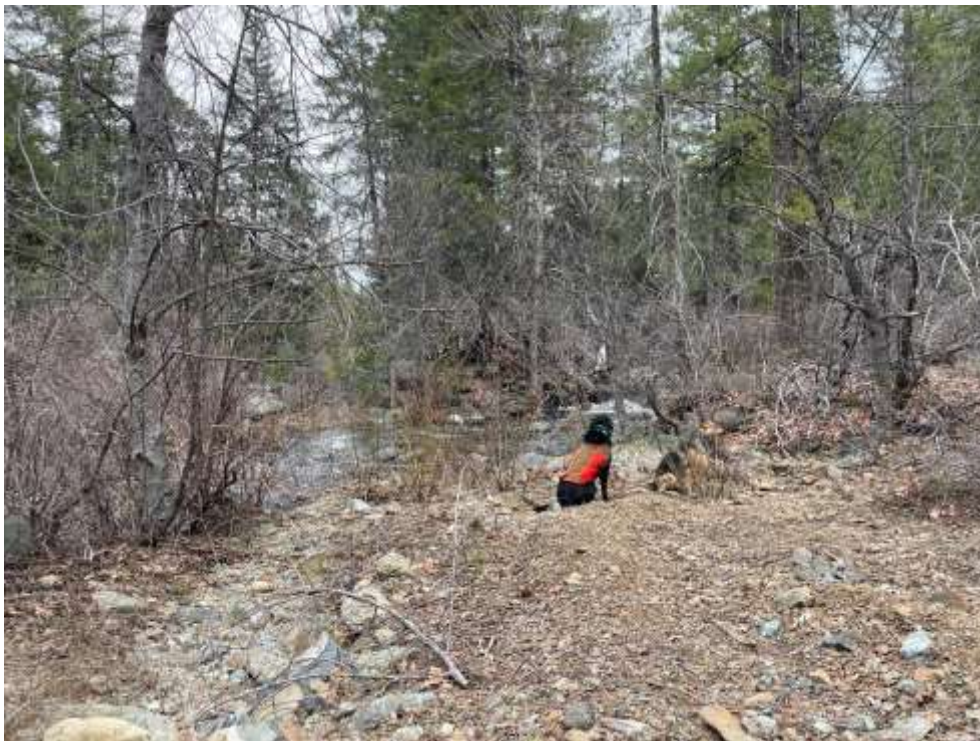
*Photo 2.44: The two branches of Gully Complex 12 flow into Mule Creek at the same point. EFG12e. April 5, 2024.*

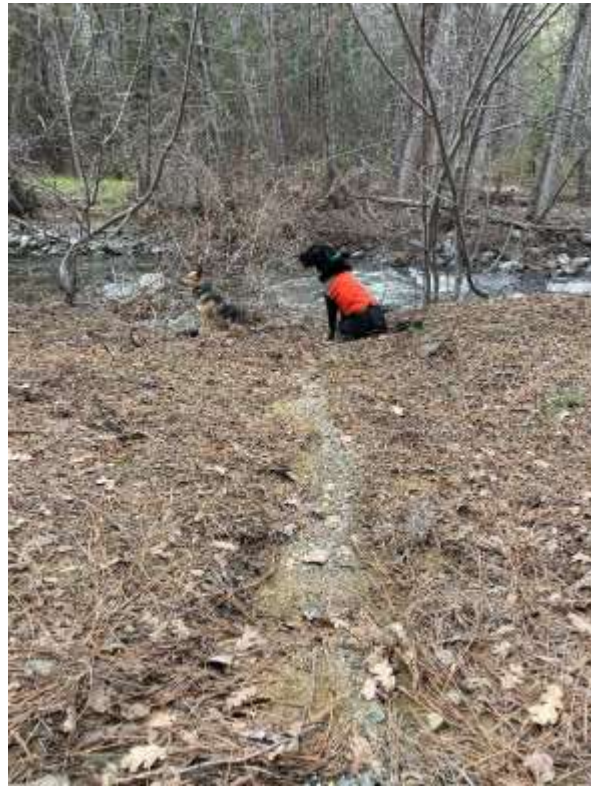
*Photo 2.55: EFG 24 discharges into Big Mill Creek.*

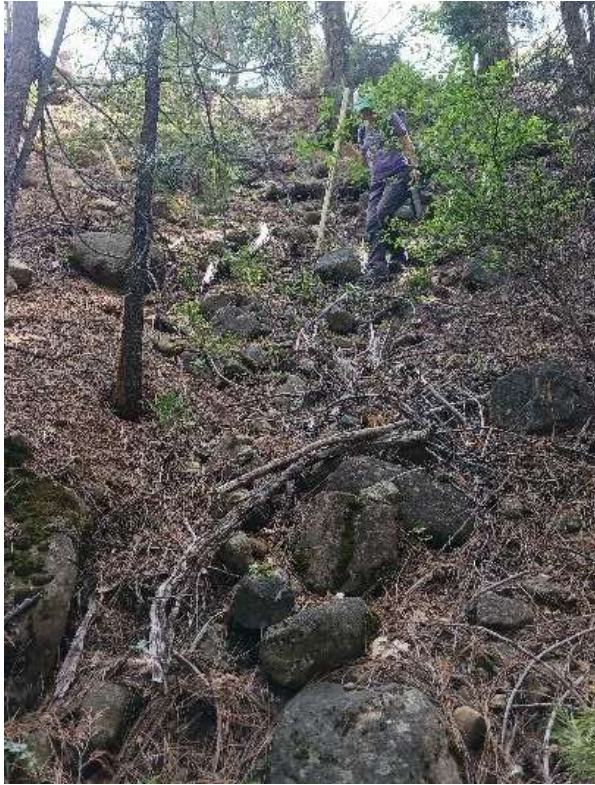
*Photo 2.56: Beginning of Gully 6. EFG6.1a. May 29, 2023.*

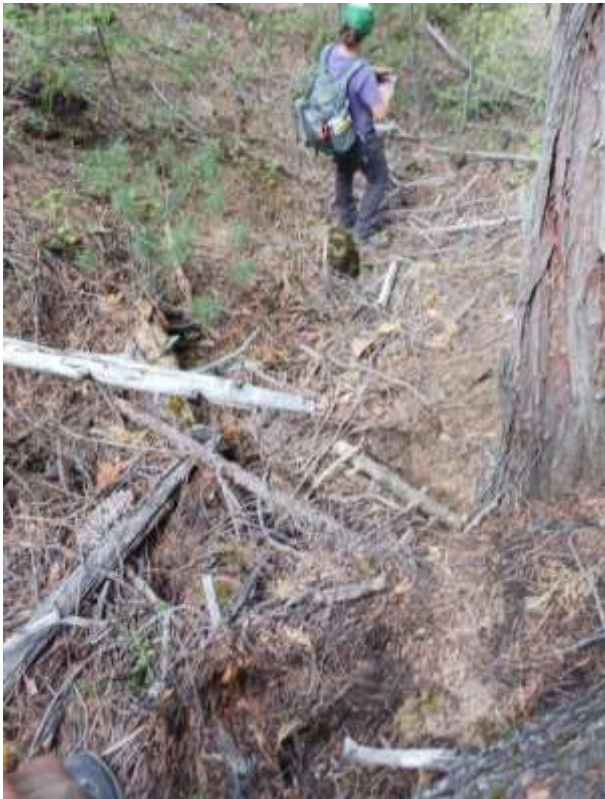
Photo 2.58: Significant layer of duff. EFG6g. May 29, 2023.
